To Inspect Vehicle No: SKS 8000S Insured: SKK 663

**ACCIDENT ON 11.06.18 INVOLVING SKS 8000S & SCK 66S
AT / ALONG RAFFLES AVENUE
CLAIMANTS: EXCLUSIVE LIMO & CAR RENTALS (Singapore UEN No. 52963858D)
ADDRESS: 30 RAFFLES PLACE #23 - 00 CALTEX HOUSE SINGAPORE 048622**

VEHICLE DAMAGE INSPECTION REPORT

Our File No: CS3/AIG18011087/UZ4D3S2
Date: 23/07/2018

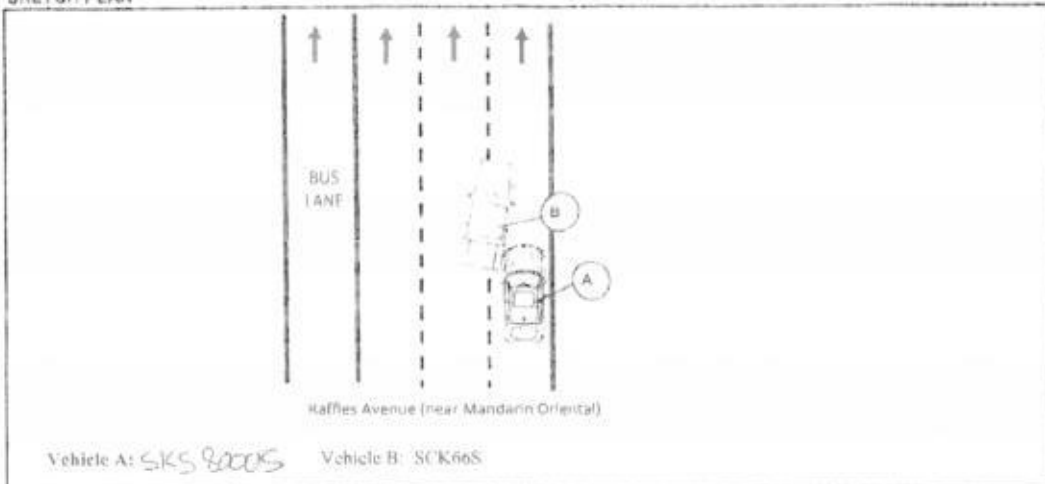
SKETCH PLAN

I had came out from Mandarin Oriental and while I was driving straight in my lane, Vehicle B suddenly encroached into my lane and side swiped the front left of my car.
