CS/CTI18015244/Kgd3ch

GBG 1132K

NIS NV200

VEHICLE DAMAGE INSPECTION REPORT

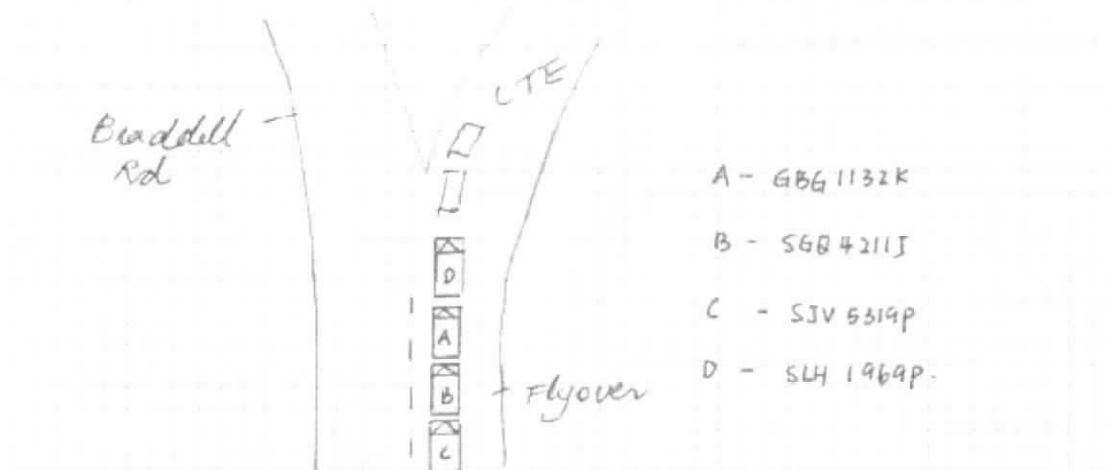
SKETCH PLAN

I was driving along flyover towards CTE traffic was slow, when vehicle in front stop, I also ~~stop~~ Brake and stop my van suddenly I feel an impact from my rear and ~~for~~ due to impact push my van to hit into front vehicle no SLH 1969P when I came down I notice my van was hit by vehicle no SGA 4211J and another vehicle no STV 5319P also involved in this accident.
