National Assessment Centre Services

1. Policy Particulars :- THIRD PARTY CLAIM

Insured Veh.	PC 3697P	Veh. Inspected	SHC 3055L
Policy No.	5089387025-01	Coverage (\$)	0.00
Claim No.		Excess (\$)	0.00
Assign From		Assign Date	21/08/2018

ADJUSTMENT ON REPAIR COST FOR VEHICLE NO. SHC 3055L

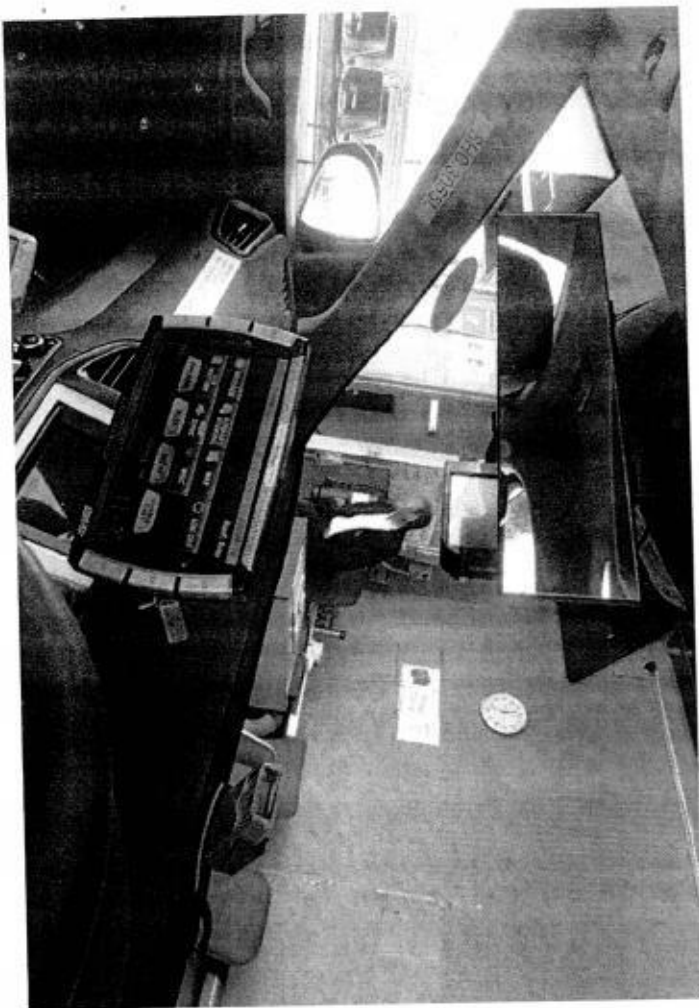
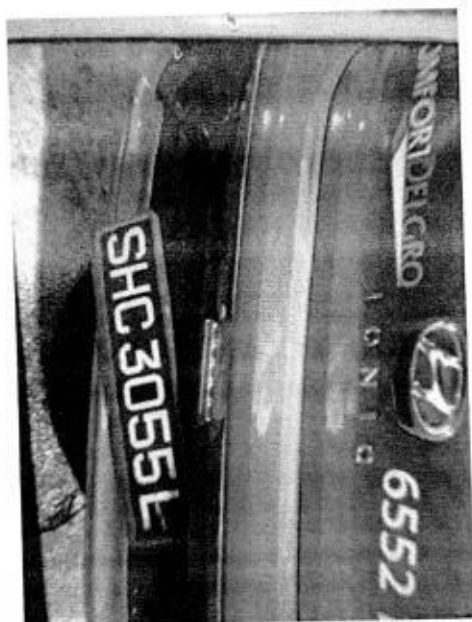
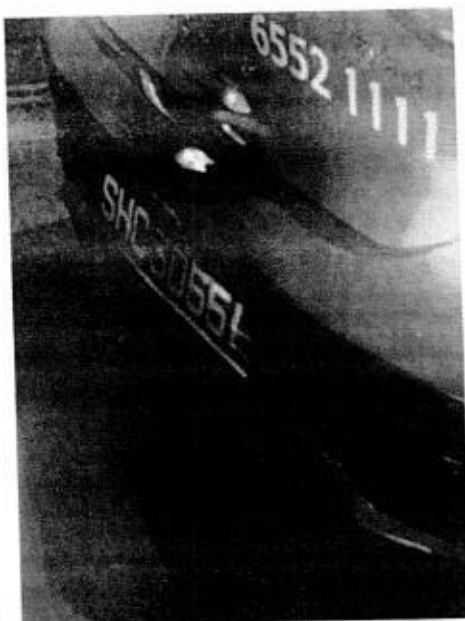
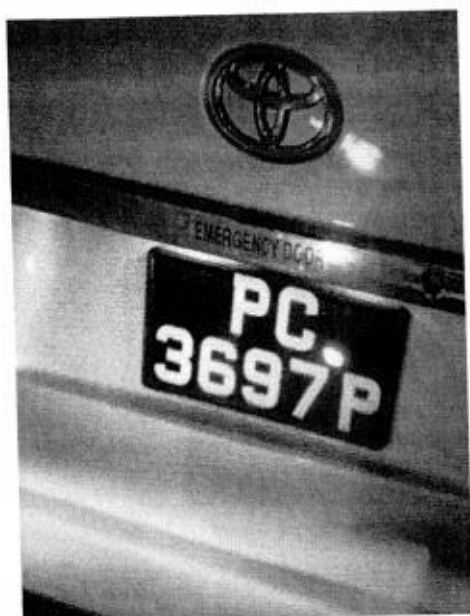
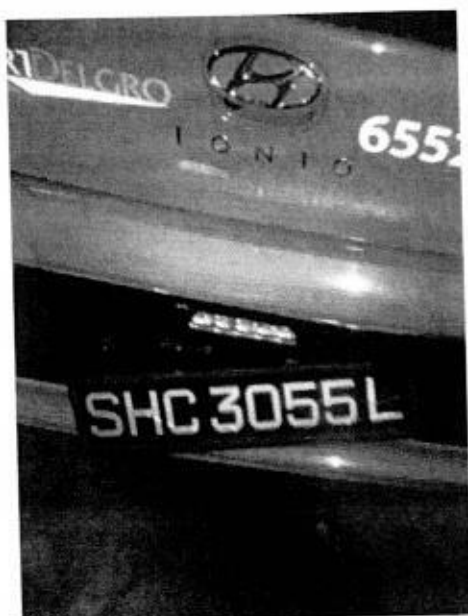
4. Description of Damages			
THE VEHICLE SUSTAINED DAMAGES AT THE REAR PORTION.			
DAMAGES SEE DETAILS.			
5. General Information			
Accident Date	19/08/2018	Inspection Date	21/08/2018
Survey held at	COMFORTDELGRO ENGINEERING PTE LTD 59 LOYANG DRIVE SINGAPORE 508969		
5a. Remarks			
A)THE INSPECTION WAS CONDUCTED ON A"WITHOUT PREJUDICE" BASIS. B)IN ACCORDANCE TO YOUR INSTRUCTIONS, WE HAVE NOT AUTHORISED REPAIRS.			
5b. Estimate Days of Repair			
ESTIMATED NORMAL PERIOD FOR REPAIR:		2 Working Days

Qty	Description of Parts	Condition	Estimate By Workshop (\$)	Our Adjusted (\$)
<u>REPLACEMENT OF PARTS</u>				
1	REAR BUMPER	DEFORMED	459.40	459.40
1	REAR BUMPER REINFORCEMENT (NPA)	SERVICEABLE	-	-
10	REAR BUMPER CLIP	NECESSARY	22.00	22.00
1	REAR BUMPER SPONGE (NPA)	SERVICEABLE	-	-
1	REAR BUMPER UNDER COVER (NPA)	SERVICEABLE	-	-
1	REAR BUMPER GARNISH (BLACK)	CRACKED	322.30	322.30
LESS 20% DISCOUNT			-160.74	-160.74
			642.96	642.96
<u>NETT ITEMS</u>				
1	REAR BUMPER REVERSE SENSOR (N)	SERVICEABLE	135.70	-
1	REAR NUMBER PLATE (N)	CRACKED	25.00	25.00
LESS 10% DISCOUNT			-	-2.50
			160.70	22.50
<u>LABOUR</u>				
PANEL BEATING.			400.00	200.00
SPRAY PAINTING CHARGE.			250.00	200.00
WIRING CHARGE.			50.00	-
REMOVE/REFIX REVERSE SENSOR.			120.00	30.00
			820.00	430.00
GRAND TOTAL			1,623.66	1,095.46
