1. Policy Particulars :- THIRD PARTY CLAIM

THE VEHICLE SUSTAINED DAMAGES AT THE REAR PORTION. DAMAGES SEE DETAILS.
--

ADJUSTMENT ON REPAIR COST FOR VEHICLE NO. SHC 8600E

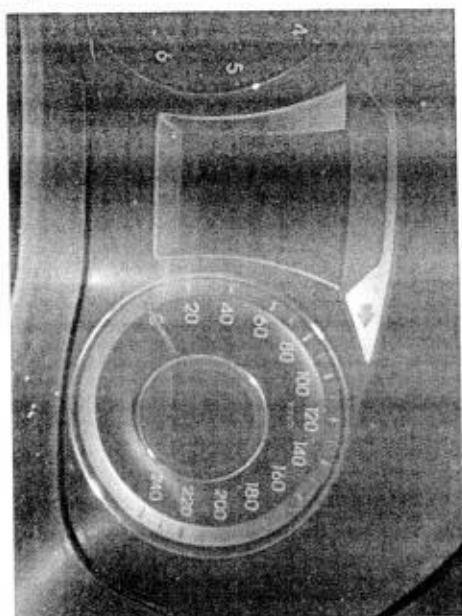
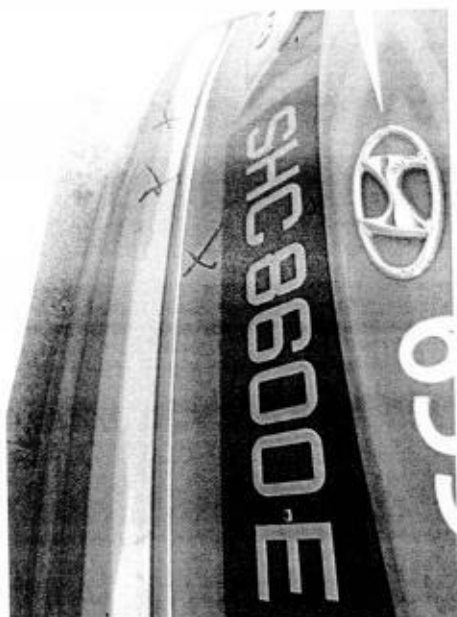
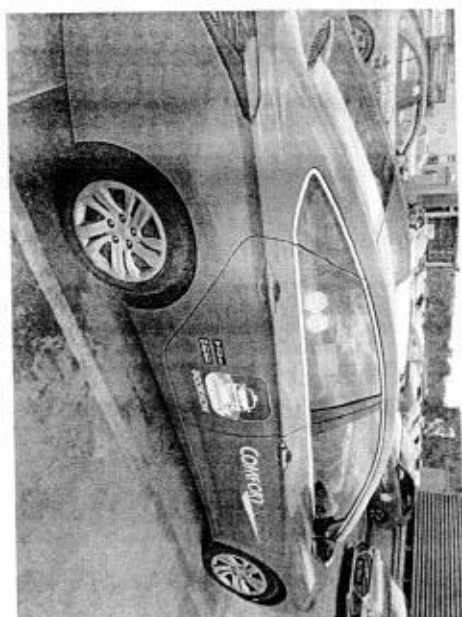
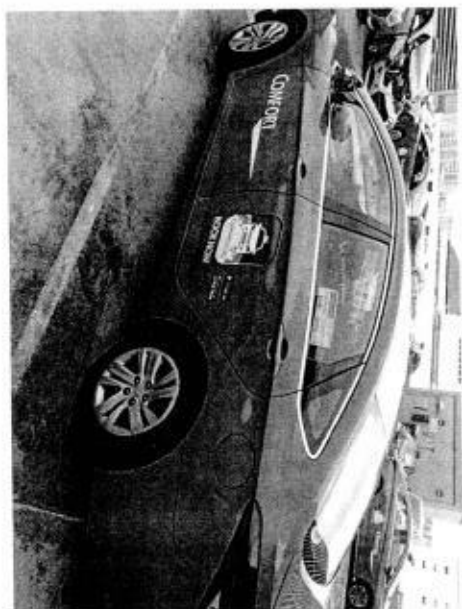
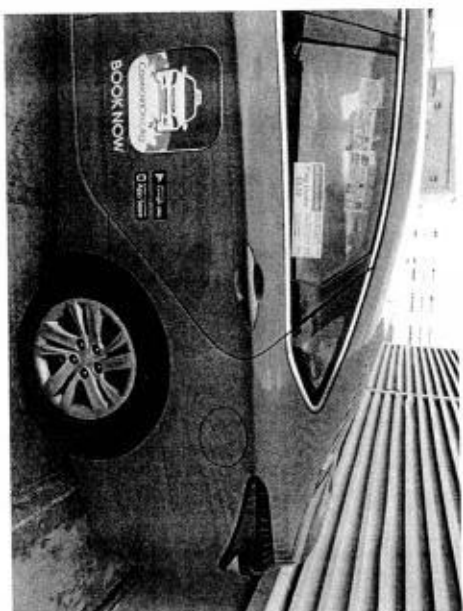
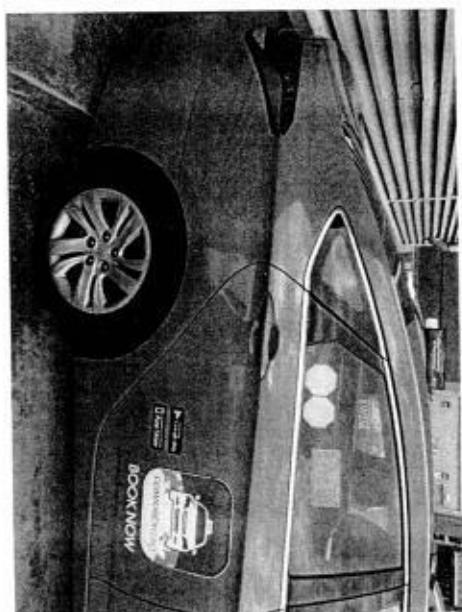
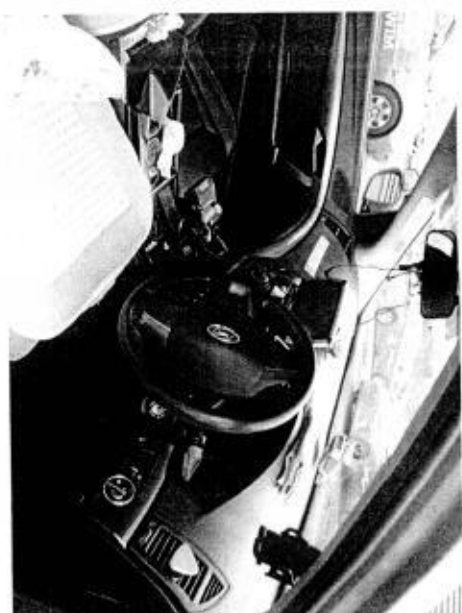
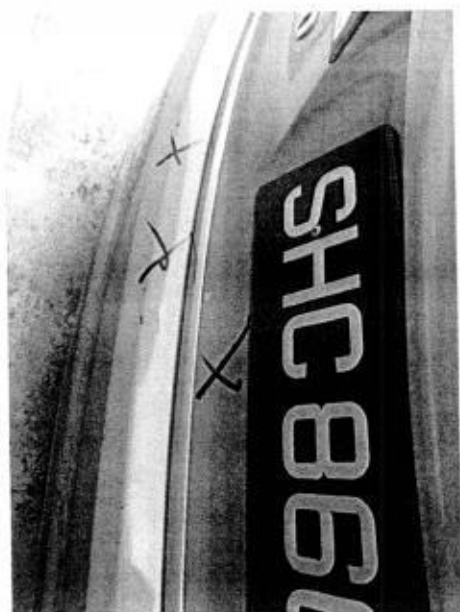
The U/C / Chassis frame / Body Structure affected due to collision.

Qty	Description of Parts	Condition	Estimate By Workshop (\$)	Our Adjusted (\$)
<u>REPLACEMENT OF PARTS</u>				
1	BOOT LID "H" EMBLEM	NOT NECESSARY	27.20	-
1	BOOT LID CRDI PLATE	NECESSARY	41.00	41.00
1	BOOTLID MOULDING	TO REPAIR SEE LABOUR	85.00	-
1	BOOTLID I40 EMBLEM	NECESSARY	41.00	41.00
1	BOOTLID LOWER GARNISH	TO REPAIR SEE LABOUR	398.00	-
1	REAR BUMPER	DEFORMED	603.60	603.60
1	REAR BUMPER REINFORCEMENT	SERVICEABLE	504.35	-
2	REAR BUMPER REINFORCEMENT BRACKET (LH/RH) @\$180.00	SERVICEABLE	360.00	-
2	REAR BUMPER SIDE BRACKET @\$49.00	SERVICEABLE	98.00	-
10	REAR BUMPER CLIPS	NECESSARY	22.00	22.00
1	REAR BUMPER SPONGE	SERVICEABLE	143.40	-
1	REAR BUMPER UNDER COVER	CUT	225.00	225.00
	LESS 20% DISCOUNT		-509.71	-186.52
			2,038.84	746.08
<u>SPECIAL NETT ITEMS</u>				
1	BOOT LID COMFORT LOGO & TEL NO STICKER (SN)	NOT NECESSARY	30.00	-

30.00	-
<u>LABOUR</u>				
	PANEL BEATING.INCLUSIVE OF THE REPAIR OF BOOTLID MOULDING AND BOOTLID LOWER GARNISH.		400.00	200.00
	SPRAY PAINTING CHARGE.		400.00	400.00
	WIRING CHARGE.	NOT NECESSARY	50.00	-
	TUFF KOTE.	NOT NECESSARY	50.00	-

900.00	600.00
GRAND TOTAL			2,968.84	1,346.08
RECOMMENDED COST OF LUMP SUM REPAIRS (TO ITS PRE-ACCIDENT CONDITION) (CONFIRMED)				1,100.00
