REF: C33 / ASM13011488 / Bsb⁵²-1

ASSIGNMENT (Office)

To Inspect Vehicle No: EW 213Y Insured: S8Q 4775H

ADJUSTMENT ON REPAIR COST FOR VEHICLE NO. EW 213Y

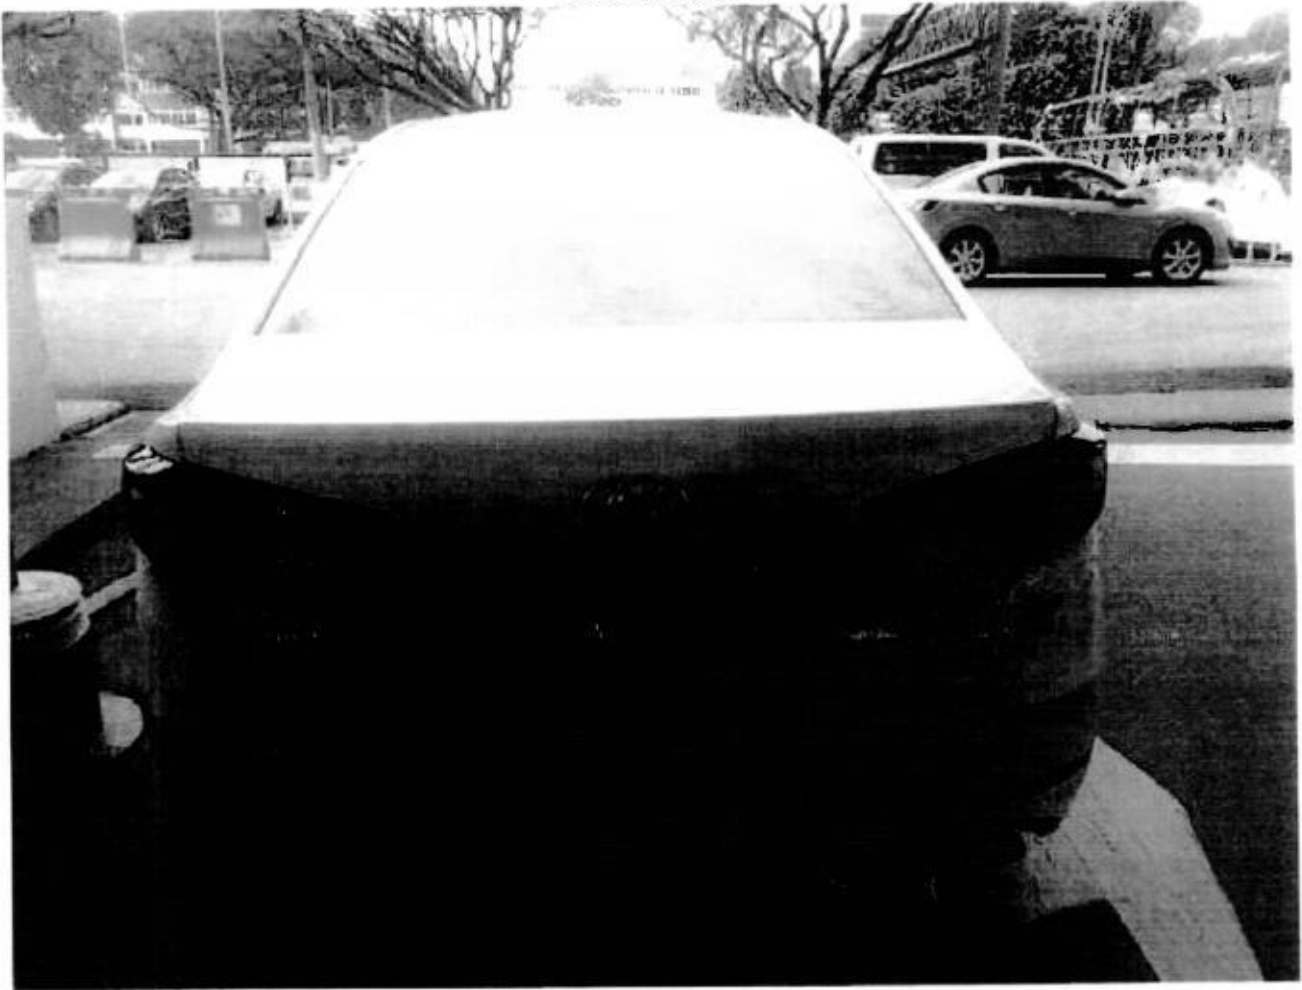
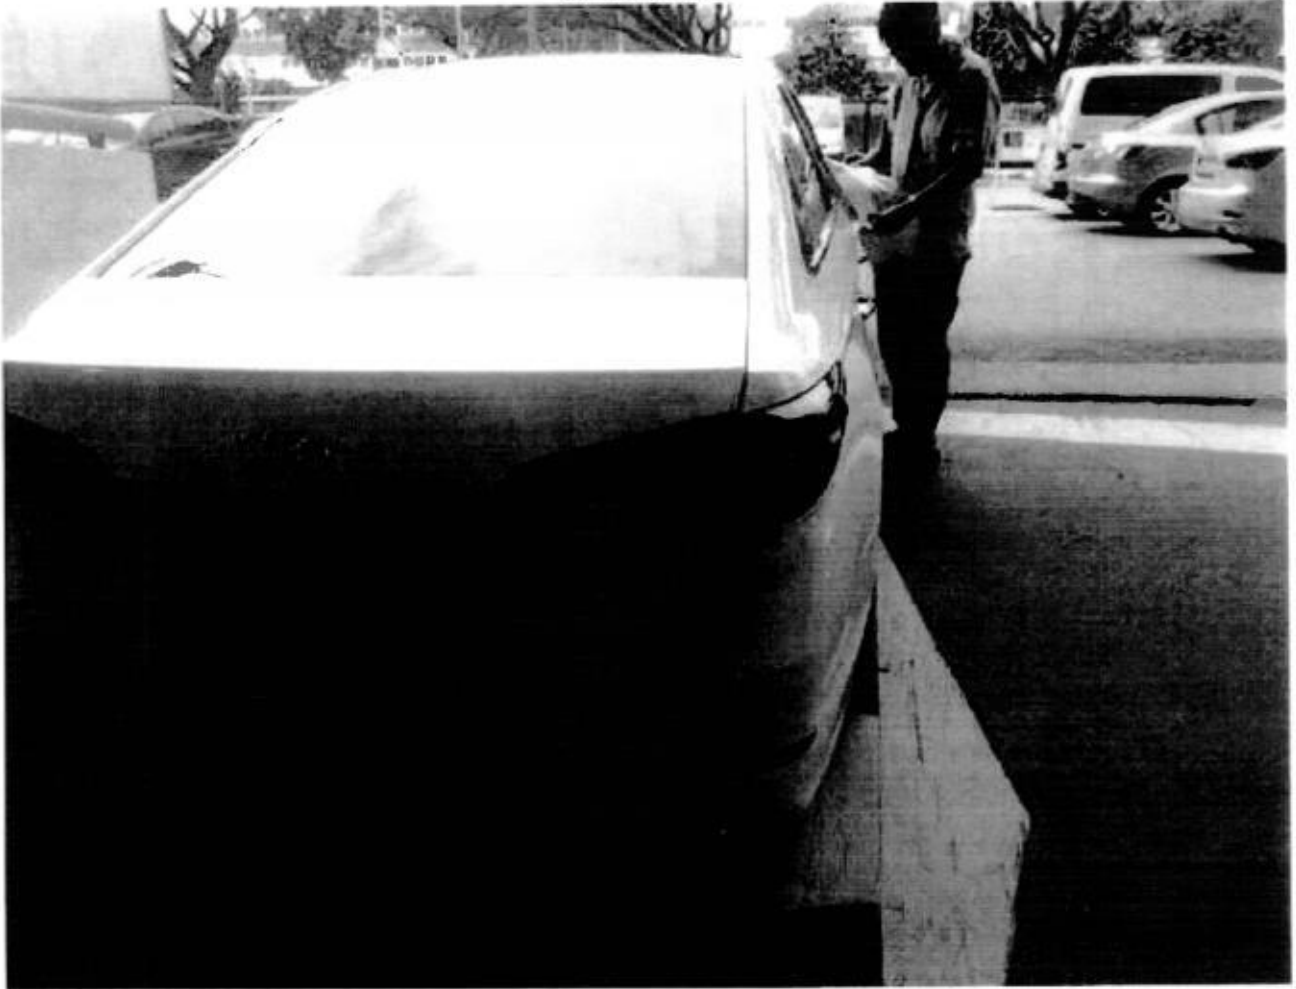
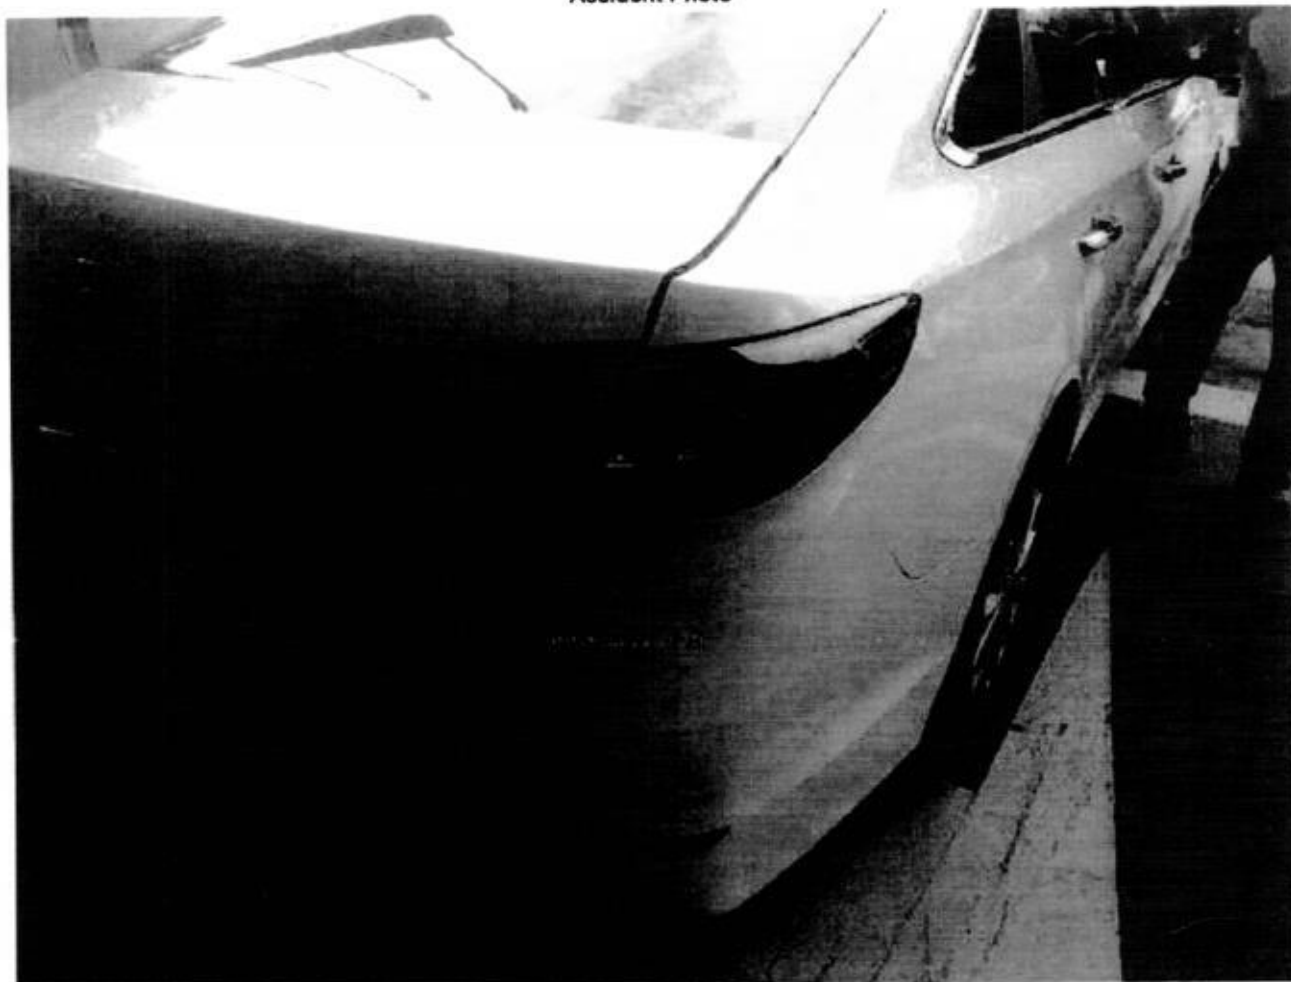
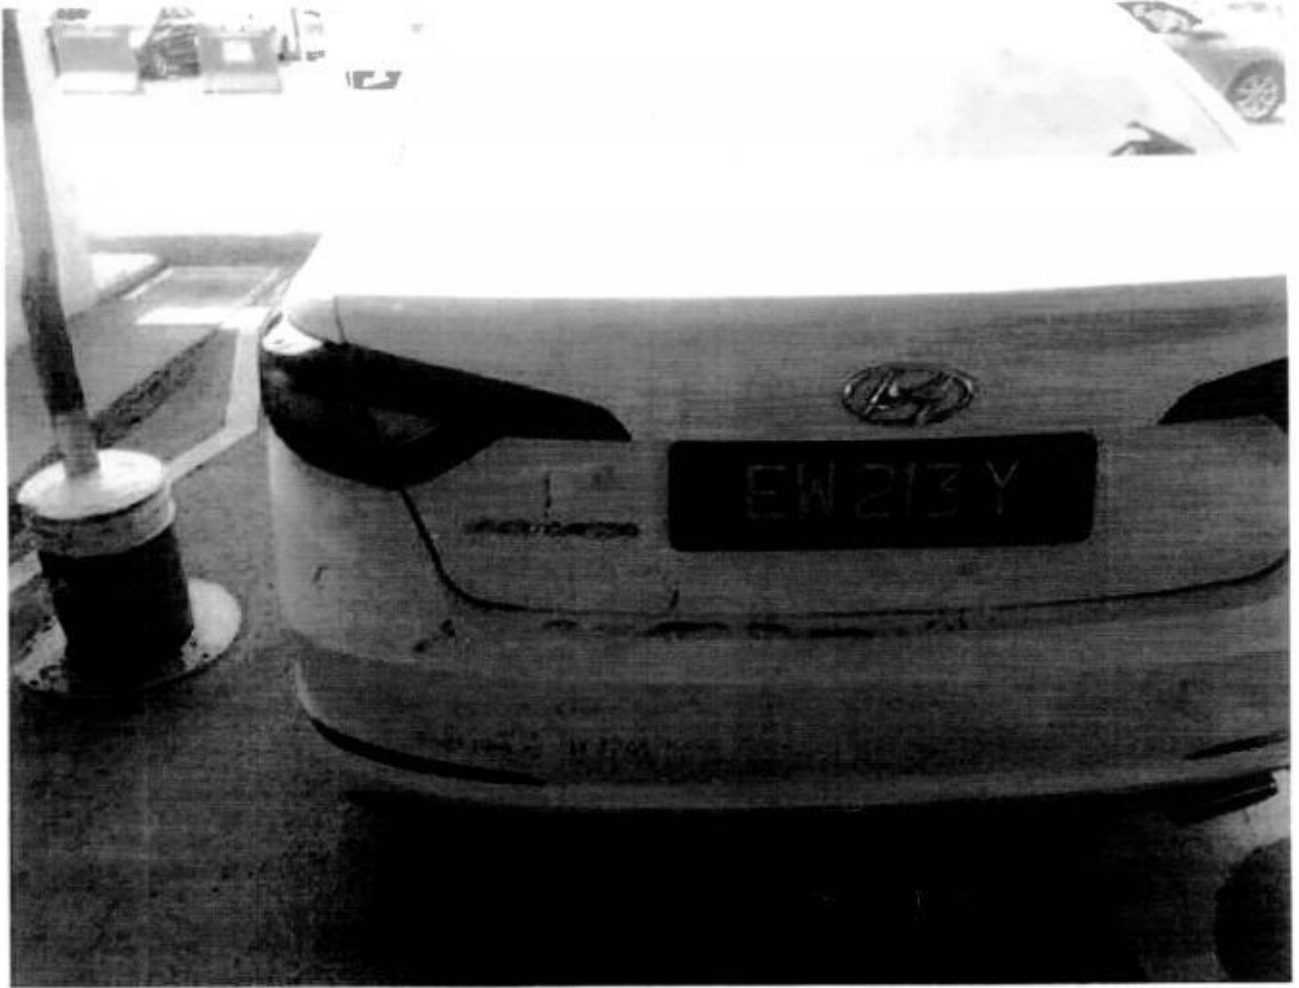
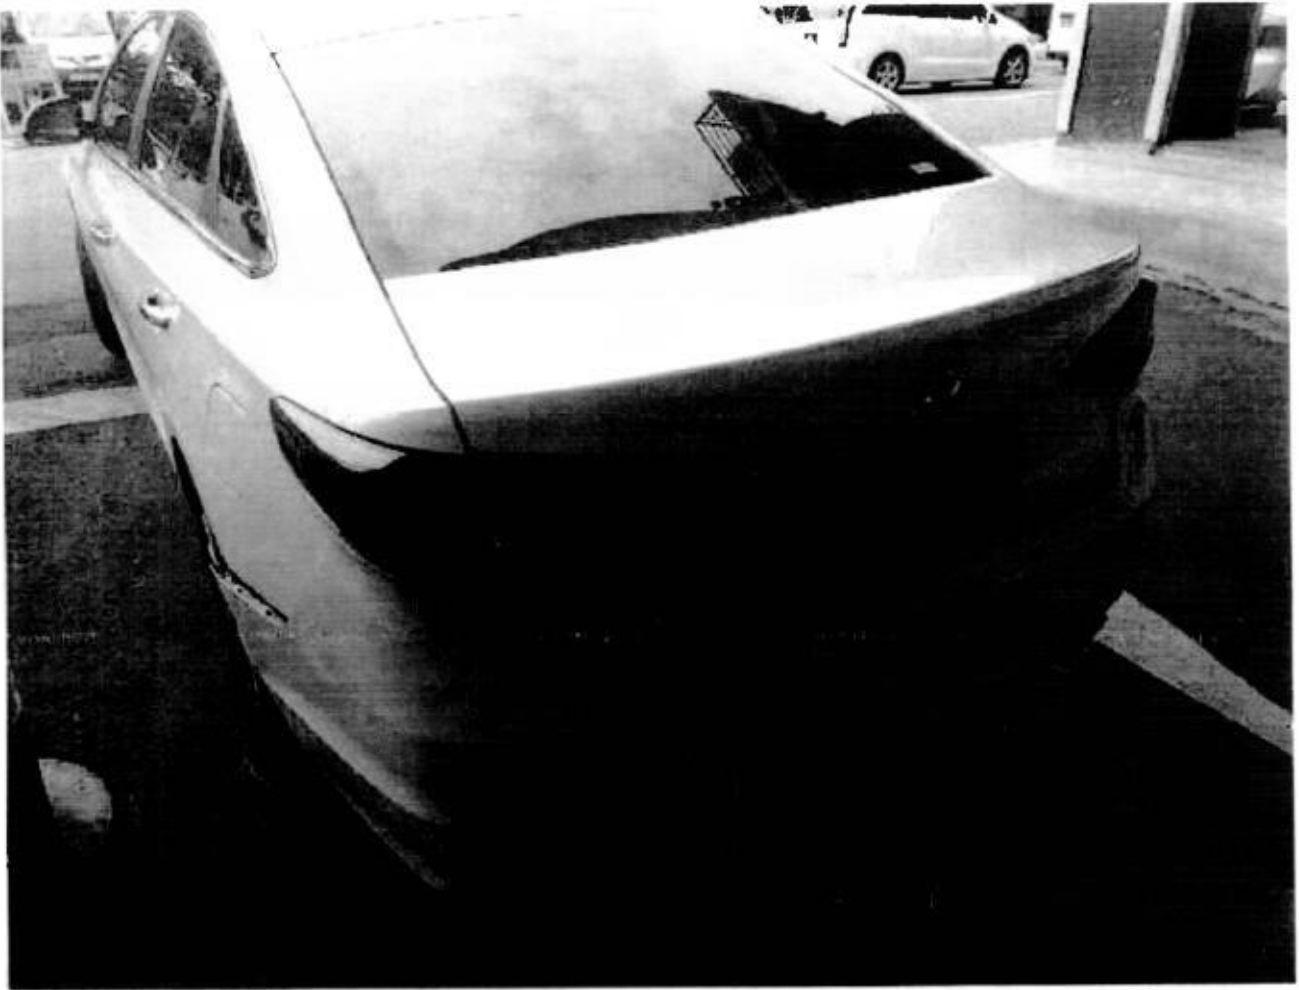
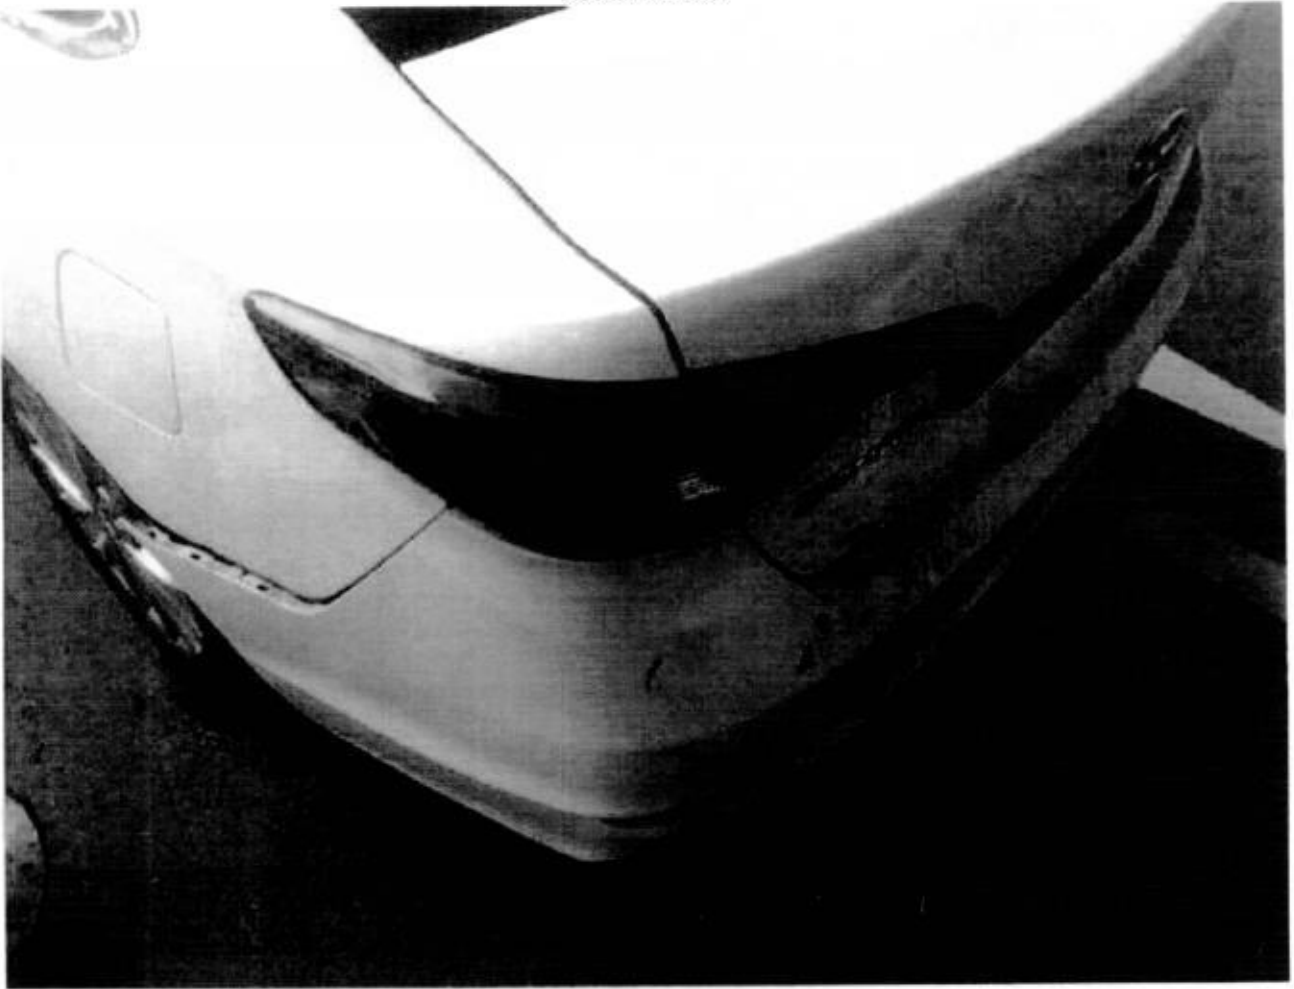
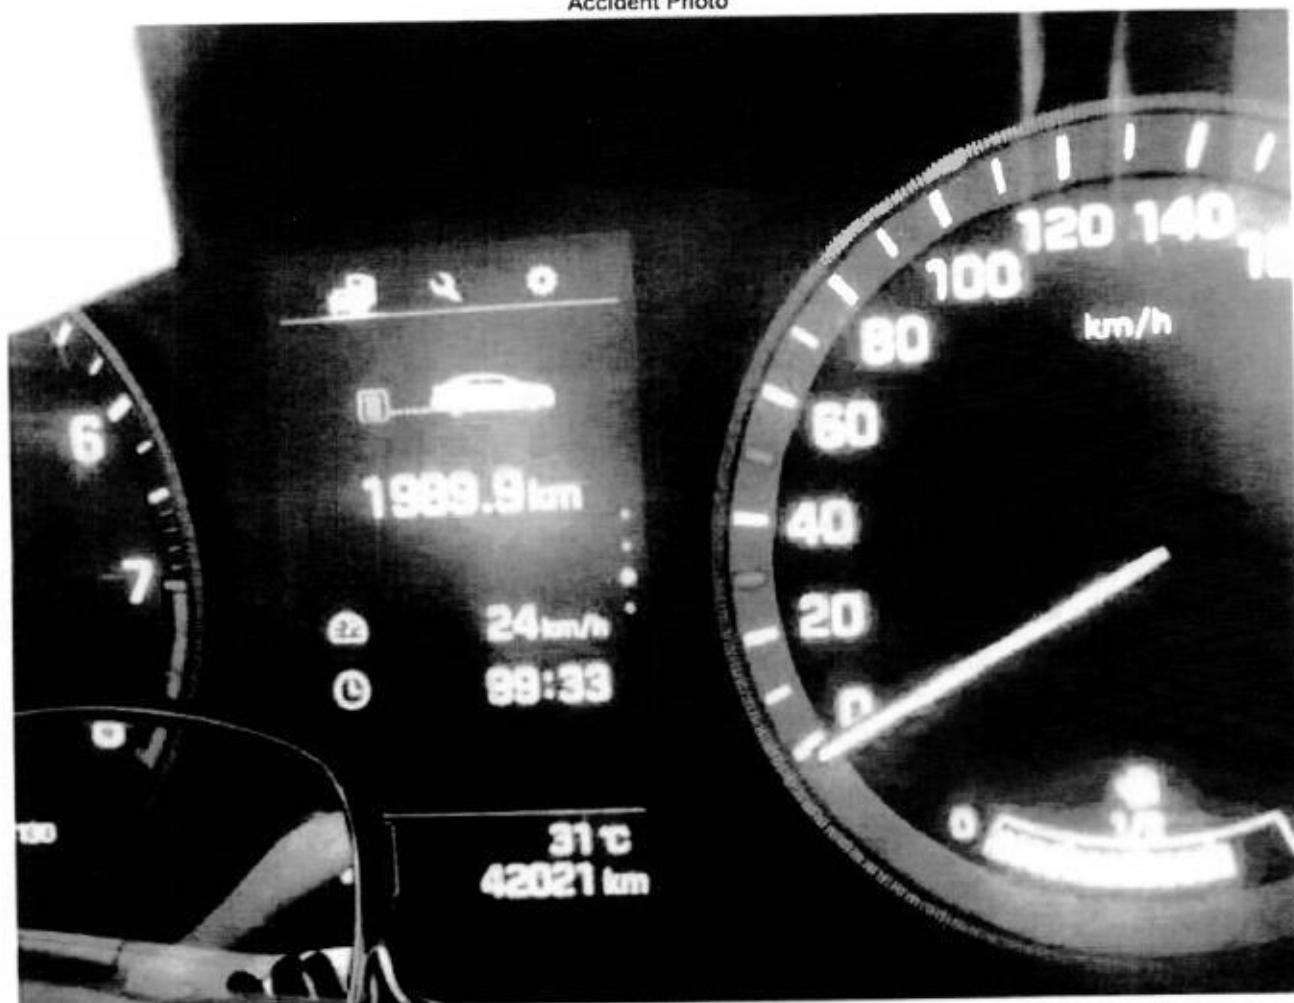
Accident Photo

The impact damages sustained on the vehicle at the time of inspection is on the rear portion.
(Details refer to the photographs attached)

The repairer has agreed to undertake the job at a **Lump Sum of \$ 9,200.00** on a contractual basis.

RECOMMENDED COST OF LUMP SUM REPAIRS (TO ITS PRE-ACCIDENT CONDITION)				6,850.00
