NS/INC18015576/K1q6

1. Policy Particulars :- THIRD PARTY CLAIM

4. Description of Damages			
THE VEHICLE SUSTAINED DAMAGES AT THE N/S FRONT PORTION. DAMAGES SEE DETAILS.			
5. General Information			
Accident Date	24/08/2018	Inspection Date	27/08/2018
Survey held at	COMFORTDELGRO ENGINEERING PTE LTD 59 LOYANG DRIVE SINGAPORE 508969		
5a. Remarks			
A)THE INSPECTION WAS CONDUCTED ON A"WITHOUT PREJUDICE" BASIS. B)IN ACCORDANCE TO YOUR INSTRUCTIONS, WE HAVE NOT AUTHORISED REPAIRS.			
5b. Estimate Days of Repair			
ESTIMATED NORMAL PERIOD FOR REPAIR:		2 Working Days

ADJUSTMENT ON REPAIR COST FOR VEHICLE NO. SH 6352C

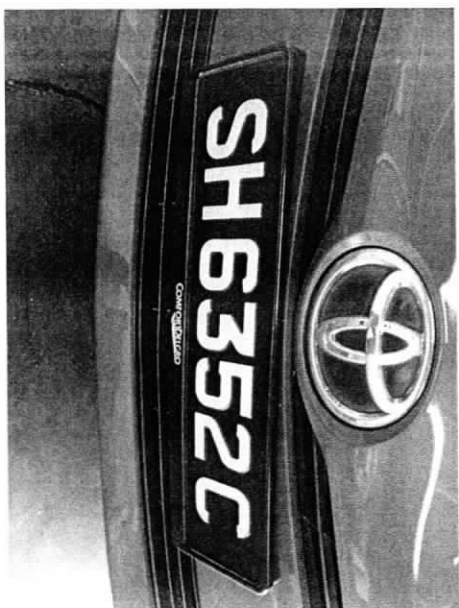
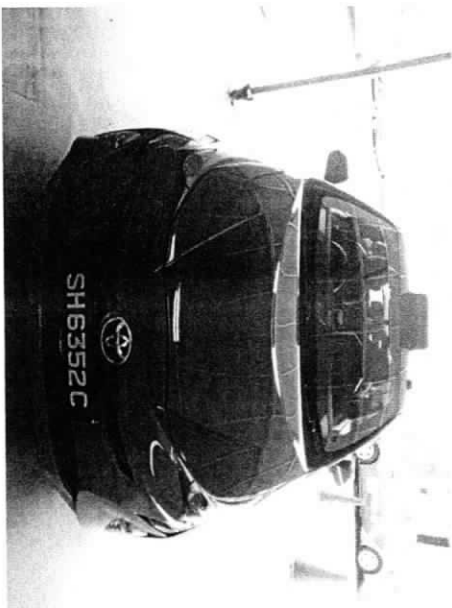
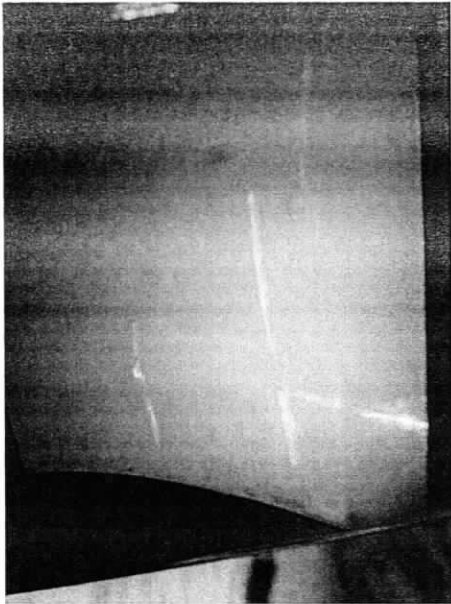
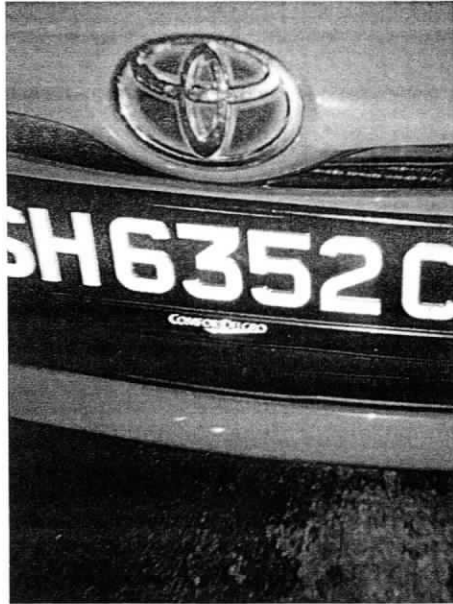
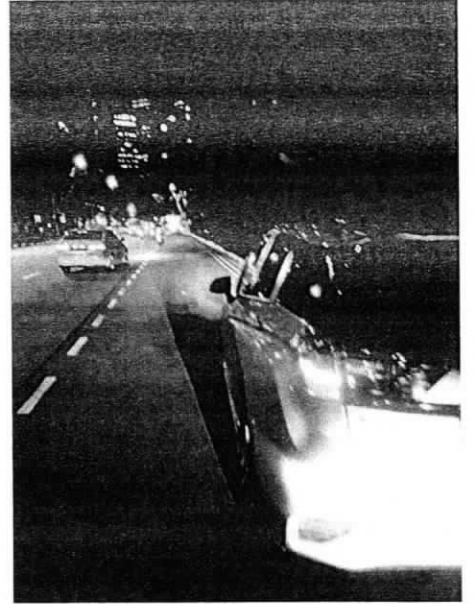
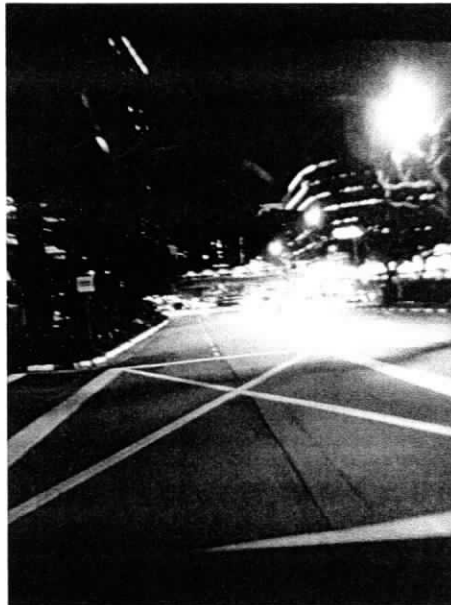
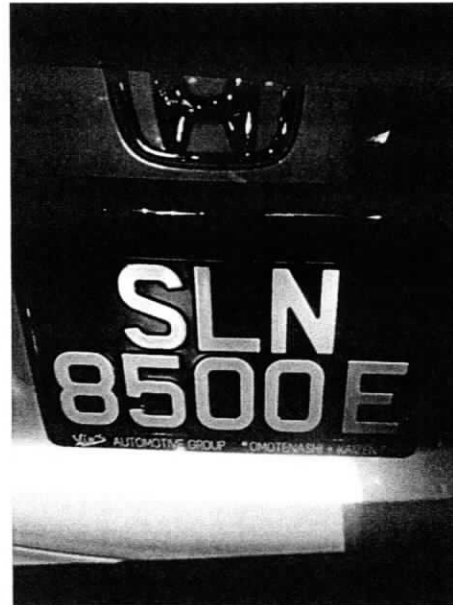
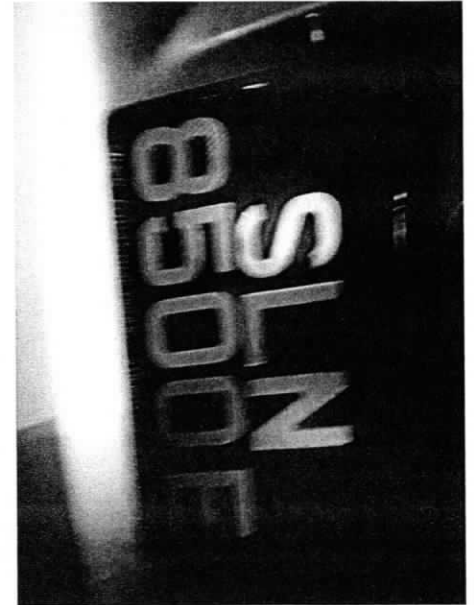
Remark: The veh had commenced its
repair at the time of inspection.

When I was entered opposite junction, suddenly Veh B encroached into my path in speedy manner from my left hand side. Due to this cause, Veh B it right rear portion hit and grazed onto the left front portion of my taxi.

Kalvin LKK
27/8/18 1100h
2 days
P/R
After Repair photo
