Your Ref: Toyota Engine
(number 2ZR2A66440)
Our Ref : CI/TP18015616/D

27 August 2018

INSPECTION REPORT OF A TOYOTA ENGINE WITH NUMBER 2ZR2A66440

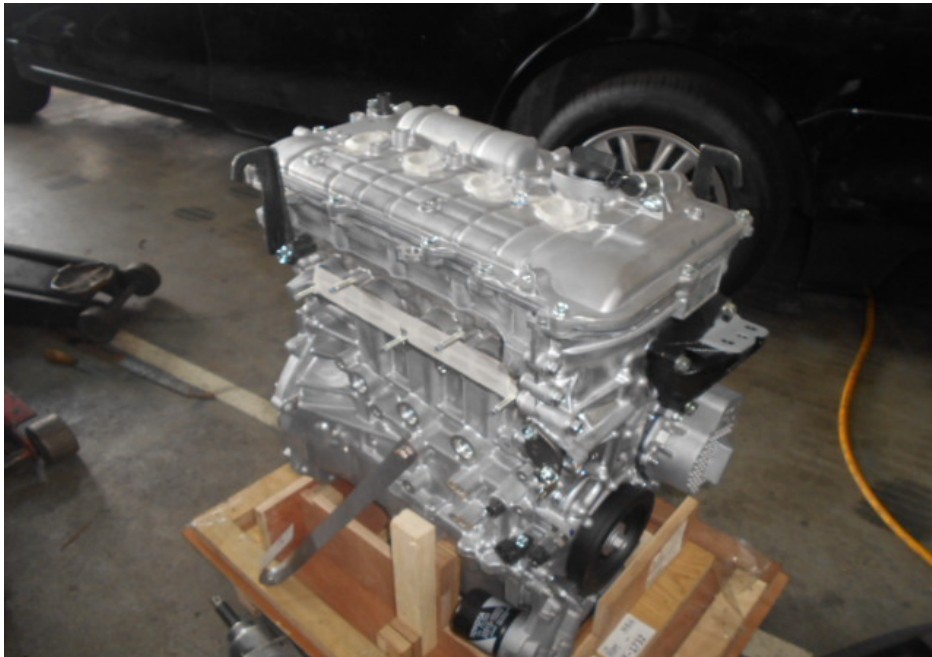
Photo 1 shows a general view of the Toyota engine that I had inspected. The Toyota engine was observed to be a new engine and was not fitted on any motor car. My visual examination of the engine housing revealed no crack and/or hole on the engine housing.

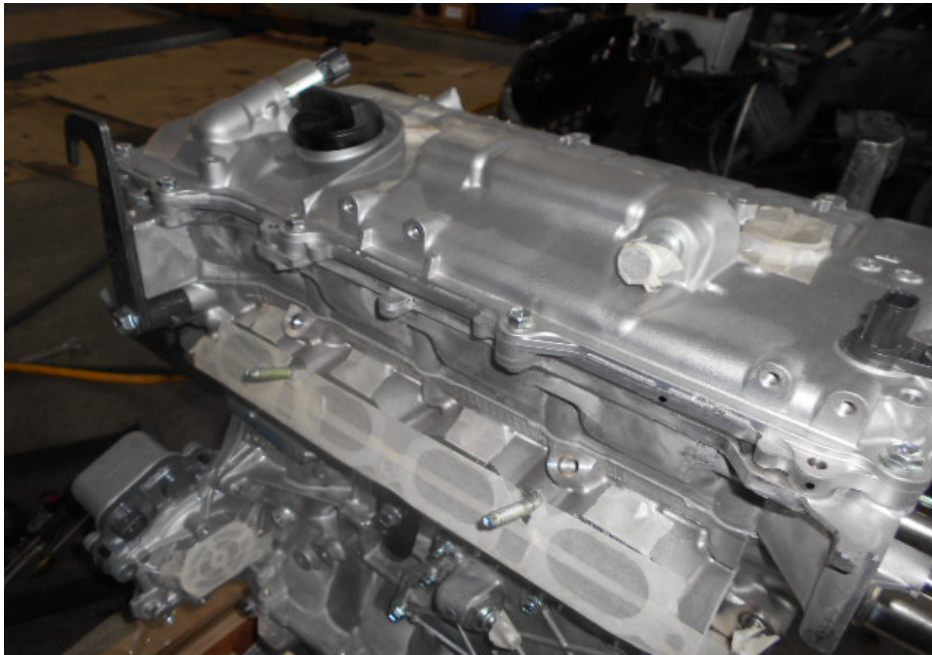
Photo 2 shows a general view of the Toyota engine that I had inspected. My visual examination of the engine housing revealed the housing to be of good condition. There was no crack and/or hole observed on the engine housing.

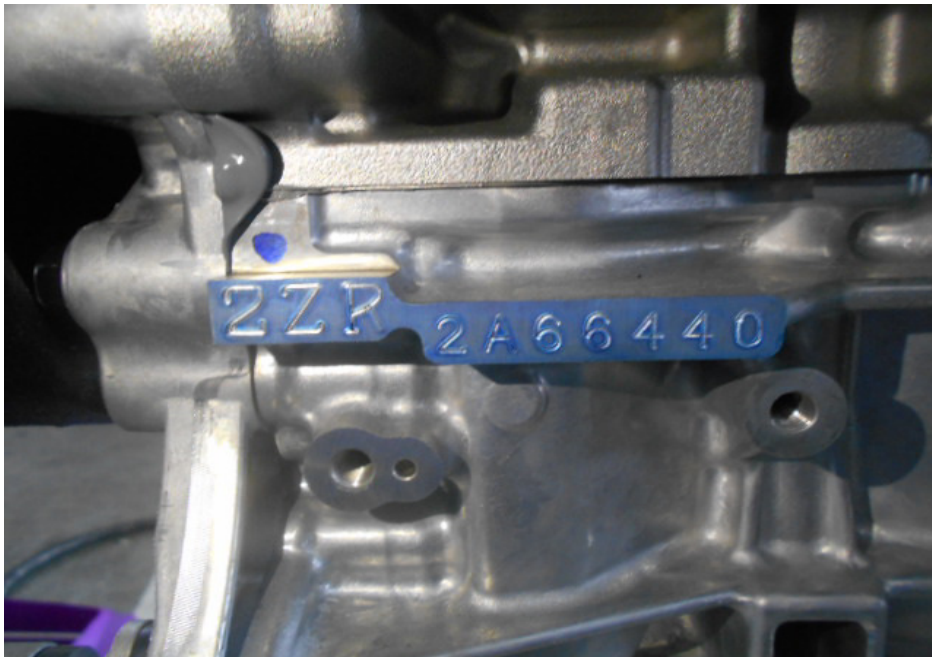
Photo 4 shows the engine number engraved on the housing of the Toyota engine that I had inspected. The engine number was 2ZR2A66440.

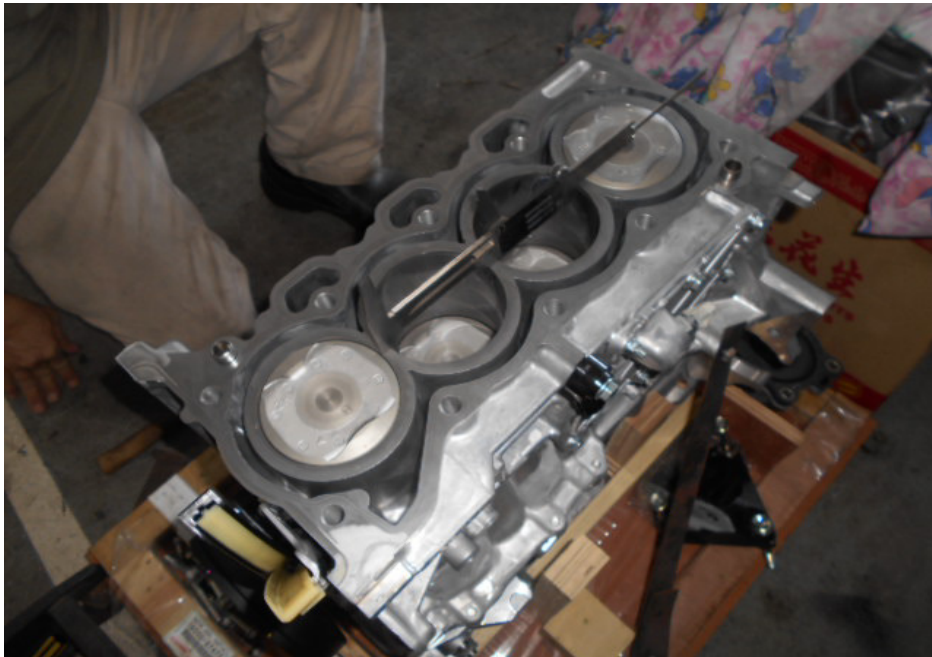
Photo 5 shows the bottom block of the Toyota engine. The top block was separated from the bottom block to facilitate my measurements of the bore and stroke of the Toyota engine. The measurements were carried out using a digital Vernier Caliper that was calibrated before the start of the measurements.

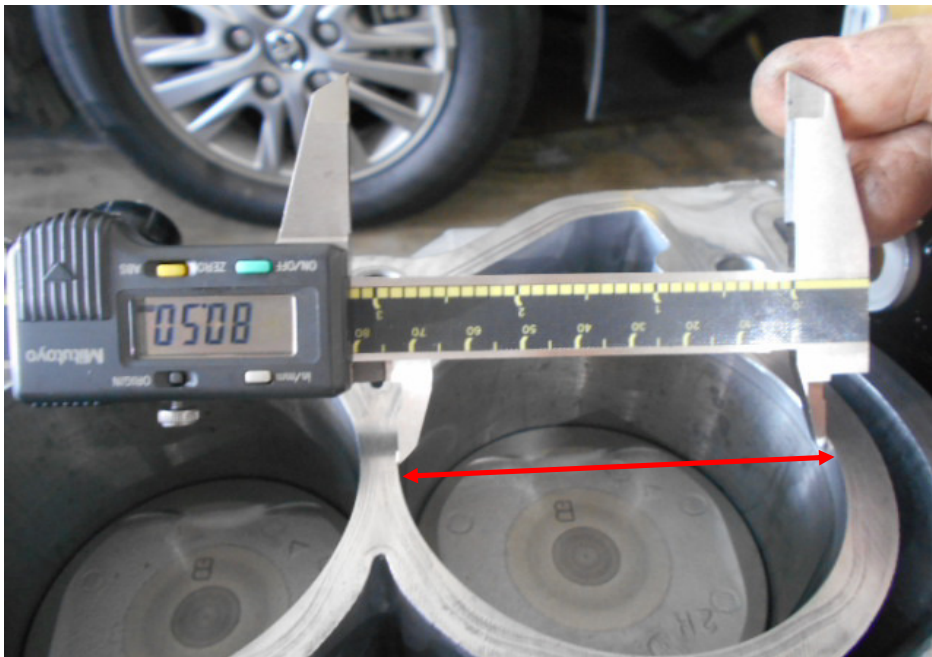
Photo 6 shows measurement being carried out to the bore (arrowed) of cylinder 1 of the Toyota engine. The bore measurement of cylinder 1 was recorded to be 80.50mm.

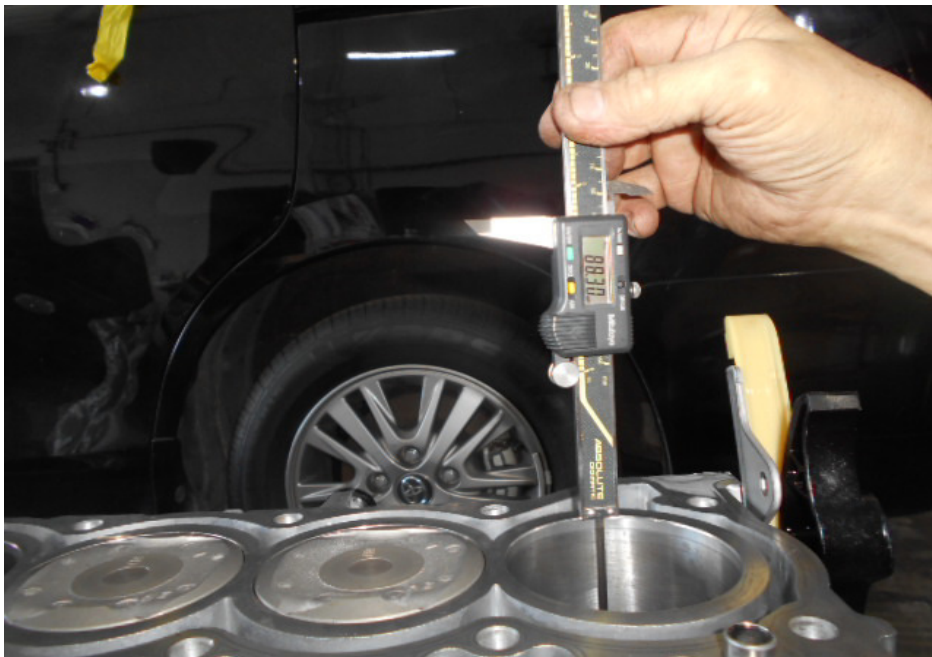
Photo 8 shows the stroke measurement of cylinder 1, which was recorded to be 88.30mm.

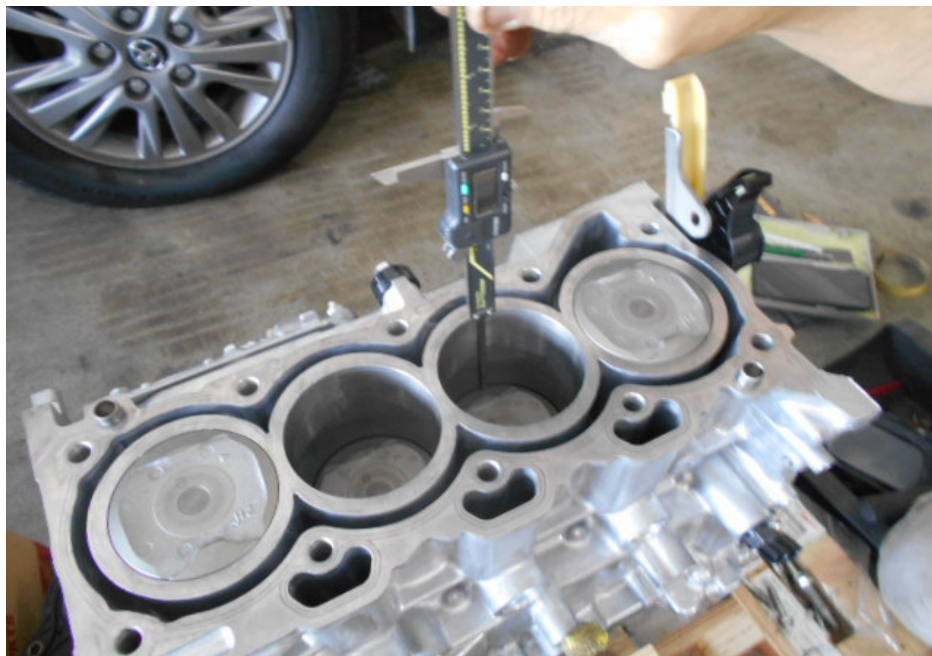
Photo 10 shows measurement of the stroke of cylinder 2 of the Toyota engine that I had inspected. The bore and stroke measurements of the Toyota engine were carried out using a digital Vernier Caliper, which was calibrated before the start of measurements.

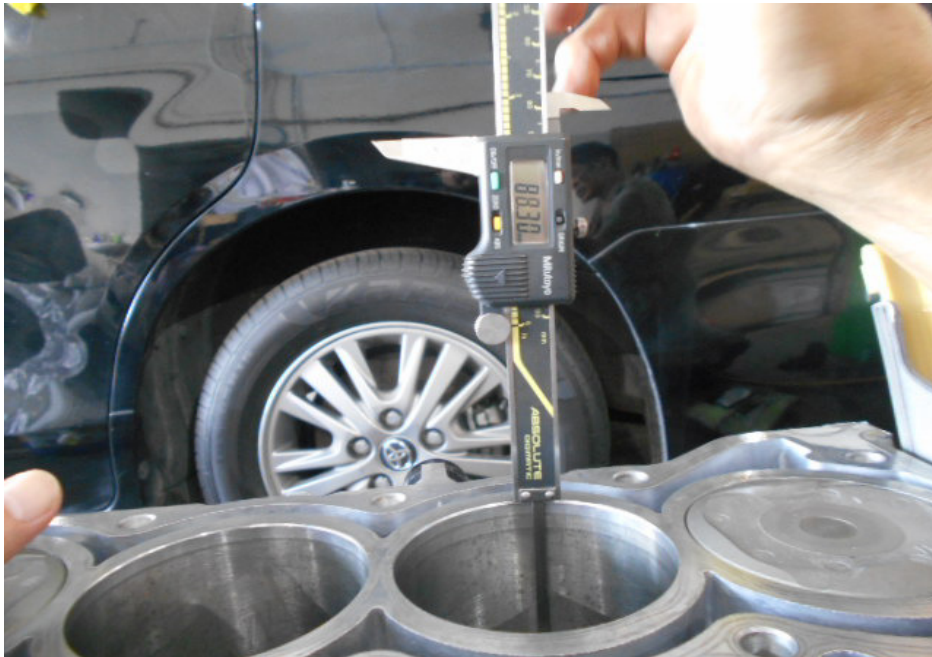
Photo 11 shows the stroke measurement of cylinder 2, which was recorded to be 88.30mm.

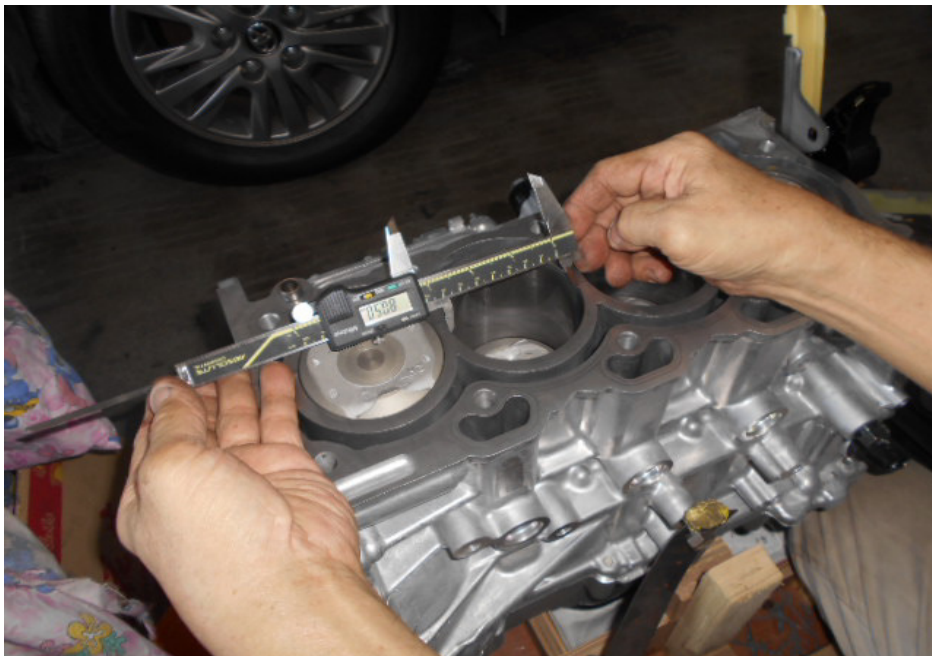
Photo 12 shows measurement being carried out to the bore of cylinder 3 of the Toyota engine. The bore and stroke measurements of the Toyota engine were carried out using a digital Vernier Caliper. The bore measurement of cylinder 3 was recorded to be 80.50mm.

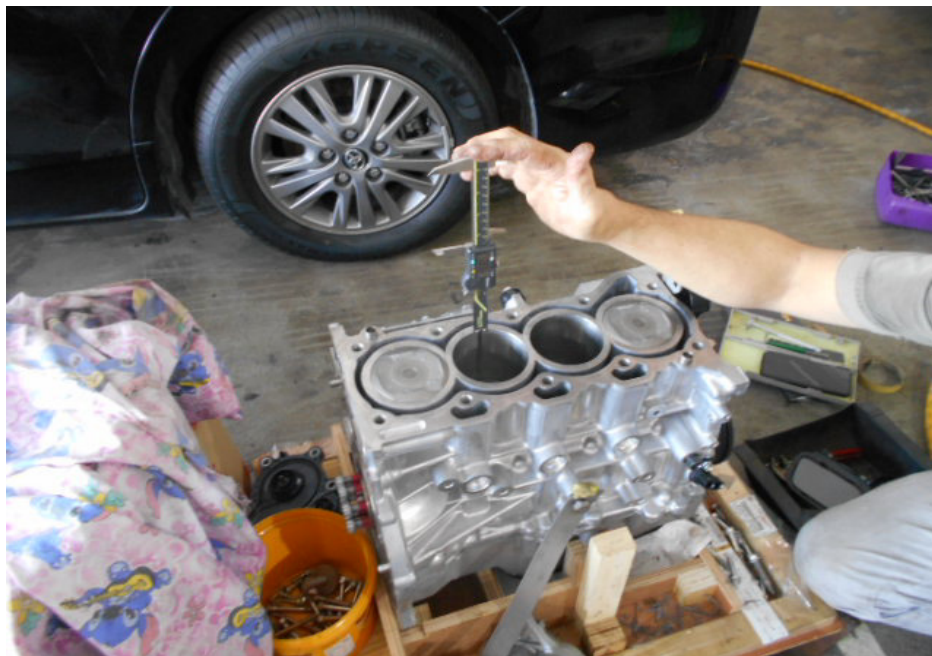
Photo 14 shows measurement of the stroke (arrowed) of cylinder 3 of the Toyota engine that I had inspected. The bore and stroke measurements of the Toyota engine were carried out using a digital Vernier Caliper that was calibrated before the start of measurements.

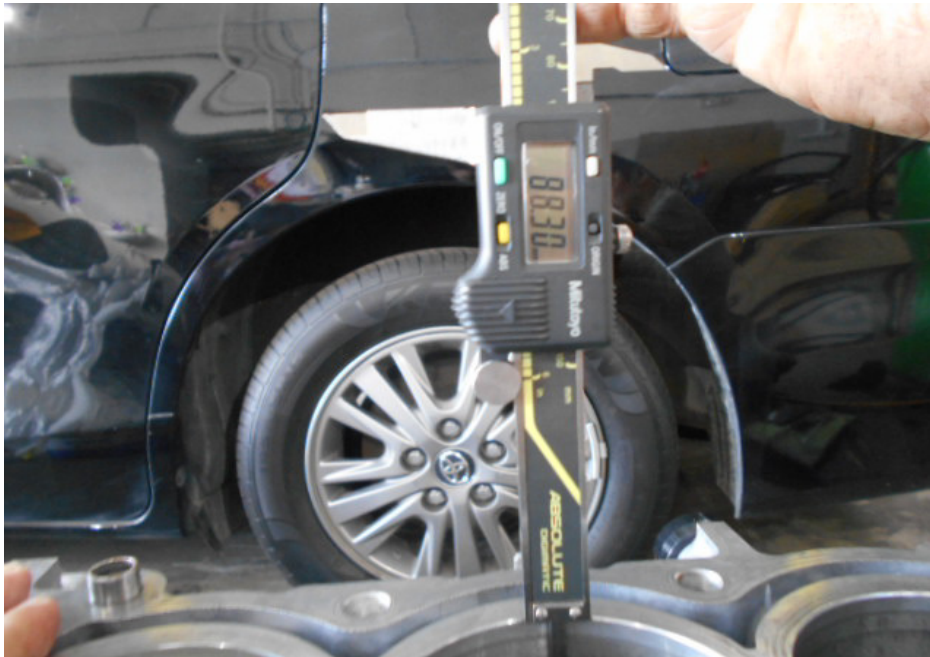
Photo 15 shows the stroke measurement of cylinder 3, which was recorded to be 88.30mm.

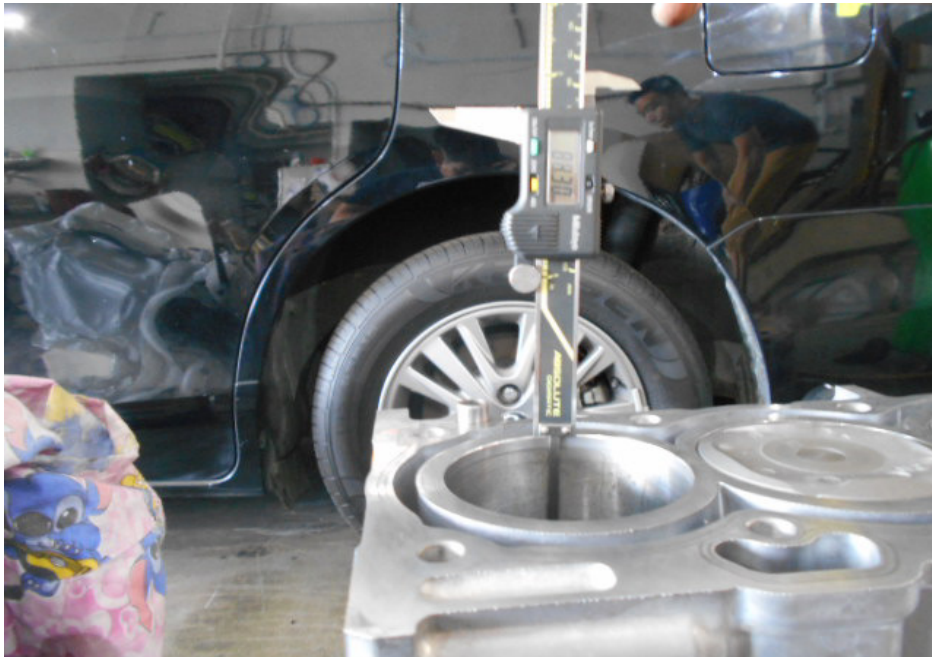
Photo 17 shows measurement being carried out to the stroke of cylinder 4 of the Toyota engine. The bore and stroke measurements of the Toyota engine were carried out using a digital Vernier Caliper that was calibrated before the start of measurements.

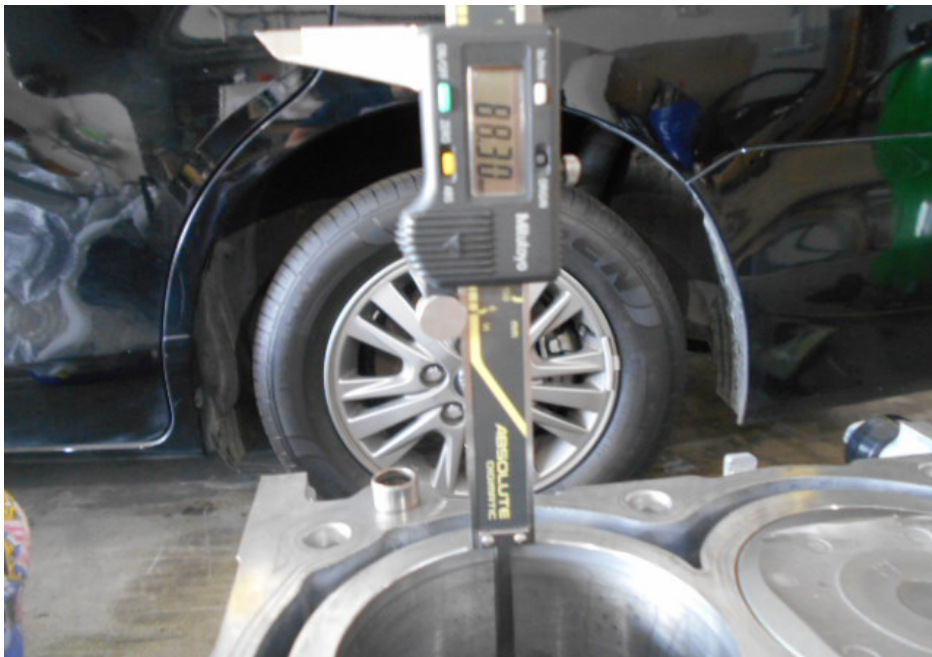
Photo 18 shows the stroke measurement of cylinder 4, which was recorded to be 88.30mm.
