- PRE-REPAIR INSPECTION - ACCIDENT INVOLVING OUR INSURE...

VEHICLE DAMAGE INSPECTION REPORT

Our File No: CS3/AIG18015683/AZ4D3E2

Reg No: **SKE3249Z**
 Make & Model: TOYOTA ESTIMA, 2.4 AERAS (A) Engine No: 2AZF070389
 Reg. Date: 26/09/2007 (Man. Year: 2007) Chassis No: ACR500048334
 Colour: Red Odometer: 168523 km
 Engine Capacity: 2362 cc
 Market Value/New Car Price: N/A
 Sum Insured (\$\$): **Market Value/New Car Price**

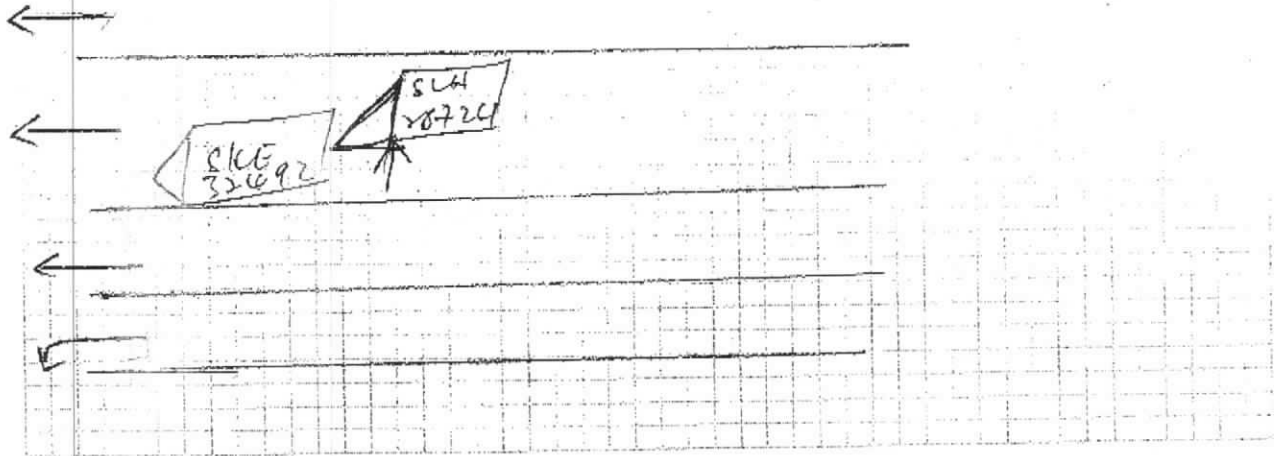
SKETCH PLAN

Holland Road

I was out in my lane and there ~~the~~
 it comes in very fast As you can see
 the picture on the slow sign on the right
 He suddenly hit my rear of my car
