Veh No: SHD 4312H Yr Regn: 28 Jan 2012

1. Policy Particulars :- THIRD PARTY CLAIM			
Insured Veh.	FY 5397U	Veh. Inspected	SHD 4312H
Policy No.	5087101947-01	Coverage (\$)	0.00
Claim No.		Excess (\$)	0.00
Assign From		Assign Date	30/08/2018

4. Description of Damages				
THE VEHICLE SUSTAINED DAMAGES AT THE REAR O/S PORTION. DAMAGES SEE DETAILS.				
5. General Information				
Accident Date	29/08/2018	Inspection Date	29/08/2018	
Survey held at	COMFORTDELGRO ENGINEERING PTE LTD 59 LOYANG DRIVE SINGAPORE 508969			
5a. Remarks				
A)THE INSPECTION WAS CONDUCTED ON A"WITHOUT PREJUDICE" BASIS. B)IN ACCORDANCE TO YOUR INSTRUCTIONS, WE HAVE NOT AUTHORISED REPAIRS.				
5b. Estimate Days of Repair				
ESTIMATED NORMAL PERIOD FOR REPAIR:		2 Working Days

ADJUSTMENT ON REPAIR COST FOR VEHICLE NO. SHD 4312H

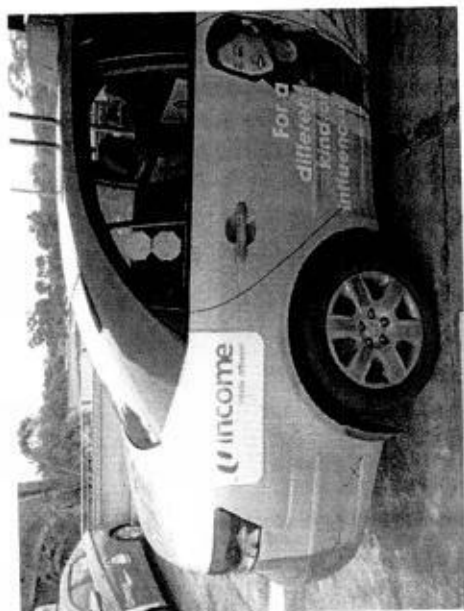
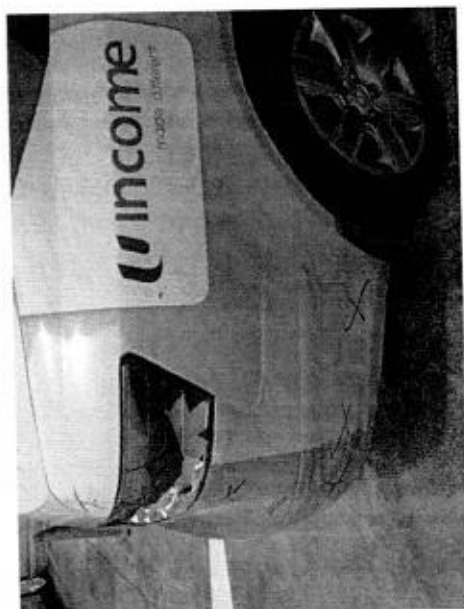
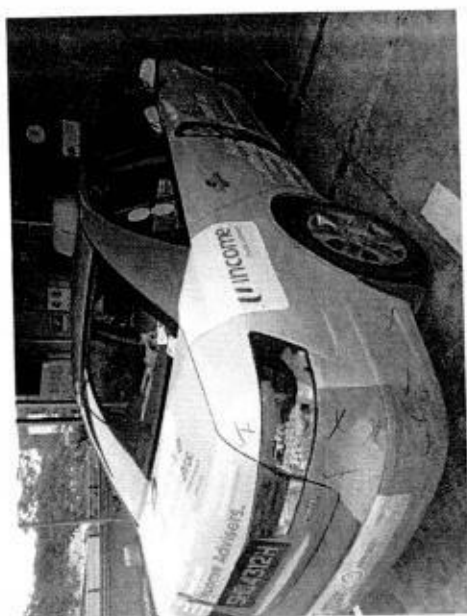
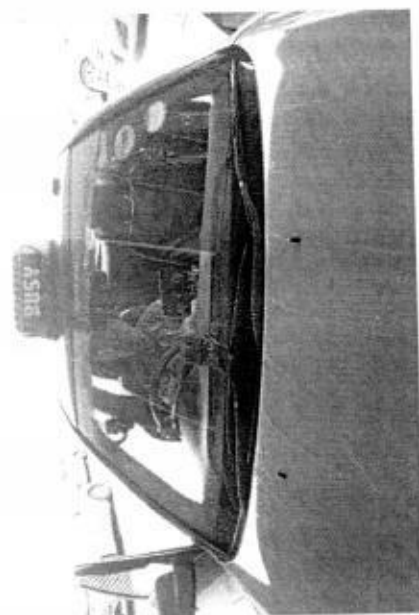
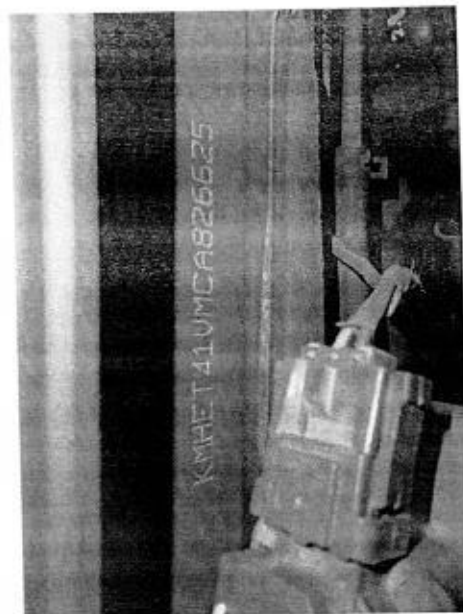
Rear o/s

The U/C / Chassis frame / Body Structure affected due to collision.

Qty	Description of Parts	Condition	Estimate By Workshop (\$)	Our Adjusted (\$)
<u>REPLACEMENT OF PARTS</u>				
1	REAR BUMPER	DEFORMED	578.40	578.40
1	REAR BUMPER REINFORCEMENT	SERVICEABLE	483.30	-
10	REAR BUMPER CLIP	NECESSARY	22.00	22.00
1	REAR BUMPER SPONGE	SERVICEABLE	137.40	-
1	REAR BUMPER UNDER COVER	SERVICEABLE	185.80	-
1	REAR BUMPER PROTECTOR (RH)	TO REPAIR SEE LABOUR	38.00	-
1	TAIL LAMP (RH)	CRACKED	344.00	344.00
1	REAR FENDER (RH)(NPA)	TO REPAIR SEE LABOUR	-	-
	LESS 20% DISCOUNT		-357.78	-188.88
			1,431.12	755.52
<u>SPECIAL NETT ITEMS</u>				
1	REAR BUMPER REVERSE SENSOR (SN)	SERVICEABLE	135.70	-
1	REAR BUMPER RUBBER MAT (SN)	NECESSARY	50.00	50.00
1	REAR BUMPER ADVERTISEMENT LOGO (SN)	NECESSARY	50.00	50.00
1	REAR FENDER ADVERTISEMENT LOGO (RH)(SN)	NECESSARY	100.00	100.00

335.70	200.00
<u>LABOUR</u>				
	PANEL BEATING INCLUSIVE OF THE REPAIR OF REAR BUMPER PROTECTOR (RH) AND REAR FENDER (RH).		350.00	200.00
	SPRAY PAINTING CHARGE.		500.00	400.00
	WIRING CHARGE.	NOT NECESSARY	50.00	-
	REMOVE/REFIX REVERSE SENSOR.		120.00	30.00

RECOMMENDED COST OF LUMP SUM REPAIRS (TO ITS PRE-ACCIDENT CONDITION) (CONFIRMED)			1,250.00
--	--	--	----------
