1. Policy Particulars :- THIRD PARTY CLAIM

4. Description of Damages

REPORT OF A TRAFFIC ACCIDENT

ADJUSTMENT ON REPAIR COST FOR VEHICLE NO. SHD 3566Z

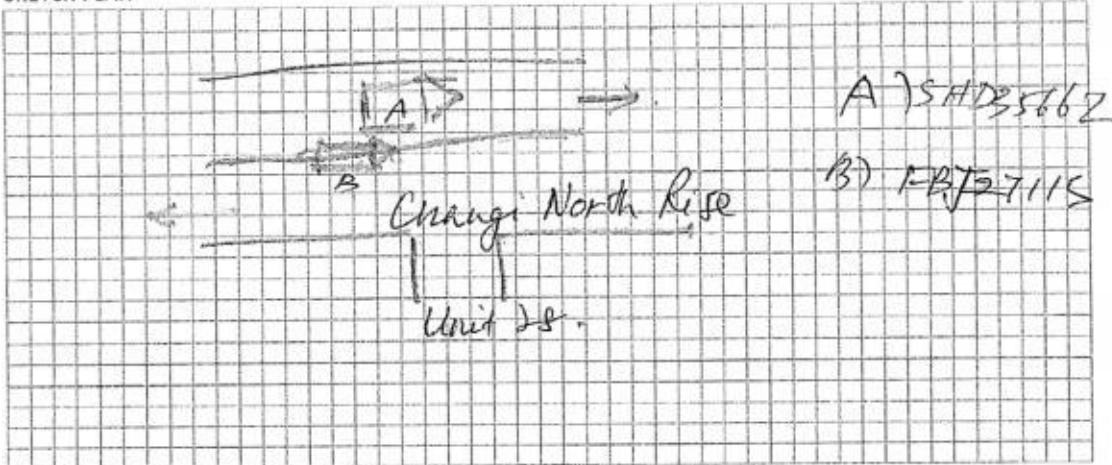
SKETCH PLAN

DESCRIBE CIRCUMSTANCES OF THE ACCIDENT

Refer Police Report - T/20180821/2006
