VEHICLE DAMAGE INSPECTION REPORT

CS/CTI18016110/KCD3E2

SKH4807R

CHEVROLET CRUZE, 1.6 (A) 13/12/2012 (Man. Year: 2012) Engine No:

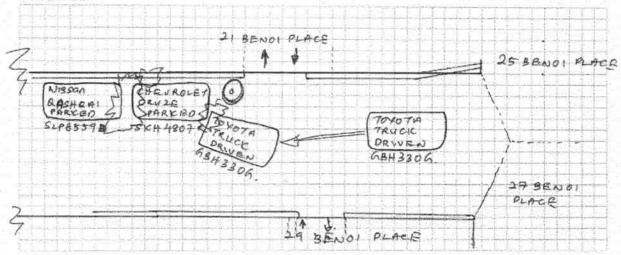
SKETCH PLAN

I had perved my remole SICH 4807R along 21 Benoi Place. my vehide is locked and parked in a stationary position. I nad then entered 29 Benoi Place. At approximately 17:25 to 17:45, I heard a loud crashing sound and was informed to go out to investigate what had happened. I went out to find rehiole GBH 3309 driven by mr. Ramoni A/L vadively had to my vehicle. My vehicle SKH 480 7 R (Cheviolet Cruze) that was stationary parked with no occupants whed moved approximately 3-4 meters bookwads, coming into contact with the side of the road curb and also in contact with a Nissan Rash Rai of vehicle plate SLE8539D perced stationary behind my vehicle- MY. Romani A/L Vadivelu is on employee of sin Hong Hwa Pte Hd that was driving vehicle 69H 3306. Fumployees of Sin Hong Hua Pte. Ltd. come out to investigate including the operations manager mr. michael oon, mr. Romani admitted to knocking my vehicle SKH4807R inter citing his own reasons mr. michael on confosed to his employees mistake and requested me to claim the damages to his valuele/ company's insurance. I have videographic evidence of the site when the had arrived on site as well.
