## 1. Policy Particulars :- (THIRD PARTY CLAIM)

**- PRE-REPAIR INSPECTION - ACCIDENT INVOLVING OUR INSURE...**

**RE: PROPERTY DAMAGE CLAIM**  
**CLAIMANT : DING FENG CAPITAL PTE LTD**  
**ACCIDENT INVOLVING GBB 4335Z & SLJ 1289H ALONG BUANGKOK**  
**GREEN ROAD ON 3 SEPTEMBER 2018**  
**PRE-REPAIR SURVEY NOTICE**

### VEHICLE DAMAGE INSPECTION REPORT

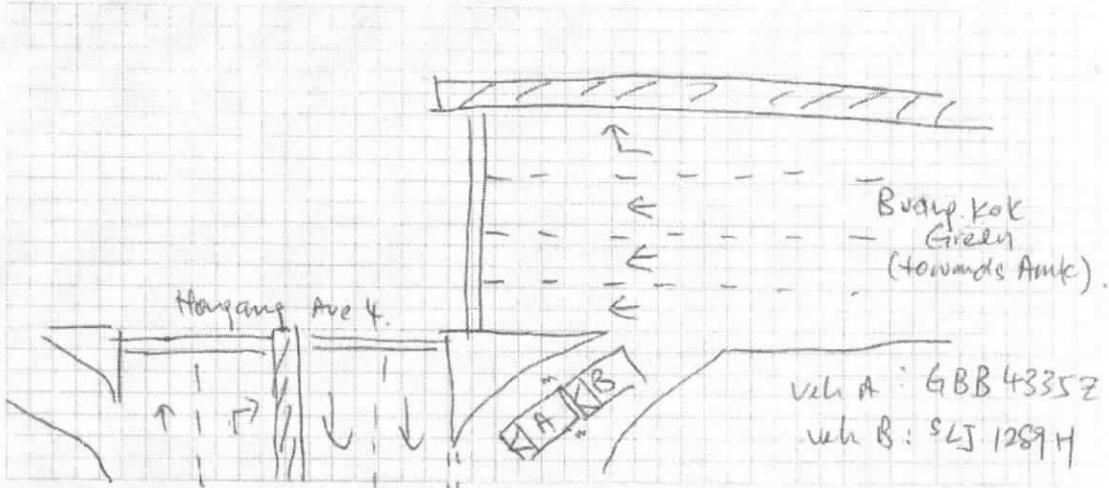
SKETCH PLAN

Type Of Accident COLLISION - HEAD TO REAR  
 Weather Conditions CLEAR  
 Road Surface DRY

I was driving along Buangkok Green Rd towards Hougang Ave 4. Somewhere on the single lane slip road to Hougang Ave 4, I slowed down and stopped to give way to traffic along the main road when I suddenly felt an impact from the rear portion of my vehicle. After the accident, I alighted to see that Vehicle B had collided into the rear portion of my vehicle. Hence I was involved in an accident of 2 vehicles.

Veh A GBB 4335 Z  
Veh B SLJ 1289 H
