VEHICLE DAMAGE INSPECTION REPORT

Our File No: CC3/TMI18017377/K1RD3E2

Reg No: SHB4287H

Make & Model: HYUNDAI I40, 1.7 D CRDi (A)

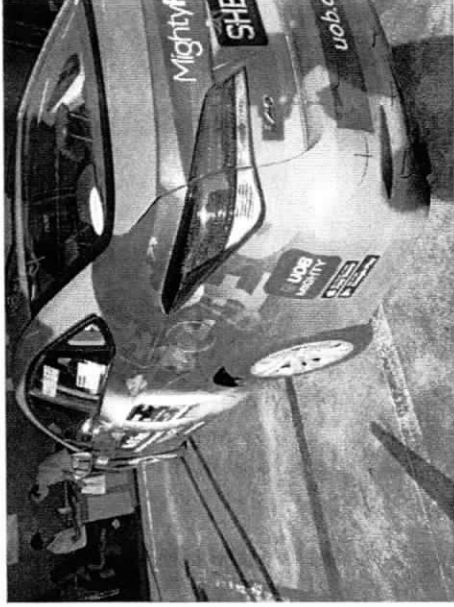
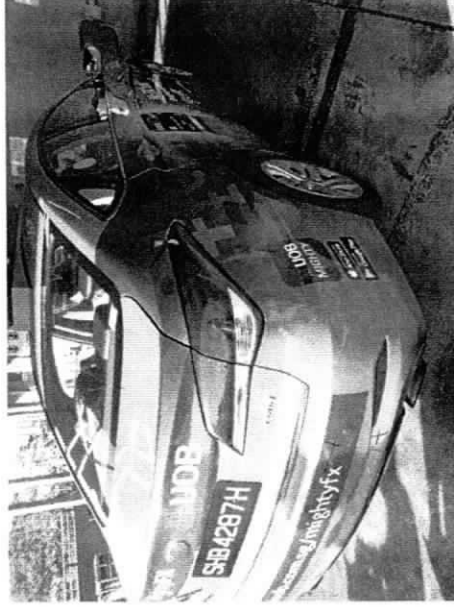
Rear

The U/C / Chassis frame / Body Structure affected due to collision.

No.	Qty	Part No.	Particulars	Condition	Repairer's	Amount
1	1		*REAR BUMPER	Deformed	553.00 FL	*553.00 FL
2	1		*REAR BUMPER REINFORCEMENT	Serviceable	428.40 FL	*- FL
3	1		*REAR BUMPER REINFORCEMENT BRACKET LH	Serviceable	80.30 FL	*- FL
4	1		*REAR BUMPER REINFORCEMENT BRACKET RH	Serviceable	80.30 FL	*- FL
5	10		*REAR BUMPER CLIPS	Necessary	22.00 FL	*22.00 FL
6	1		*REAR BUMPER SIDE BRACKET LH	Serviceable	35.60 FL	*- FL
7	1		*REAR BUMPER SIDE BRACKET RH	Serviceable	35.60 FL	*- FL
8	1		*REAR BUMPER SPONGE	Serviceable	103.50 FL	*- FL
9	1		*REAR BUMPER UNDER COVER	Cut	228.00 FL	*228.00 FL
10	1		*REAR BUMPER REFLECTOR LH (CRACKED)	Old Damage	30.60 FL	*- FL
11	1		*REAR BUMPER ADVERTISEMENT LOGO	Necessary	50.00 F	*50.00 FS
12	1		*REAR BUMPER REVERSE SENSOR	Shorted	135.70 F	*135.70 FS
13	1		*REAR BUMPER ADVERTISEMENT LOGO LH	Necessary	100.00 F	*100.00 FS
14	1		*REAR BUMPER ADVERTISEMENT LOGO RH	Necessary	100.00 F	*100.00 FS
