ASSIGNMENT

SINGAPORE ACCIDENT STATEMENT

1. Policy Particulars :- THIRD PARTY CLAIM

ADJUSTMENT ON REPAIR COST FOR VEHICLE NO. SHB 1010J

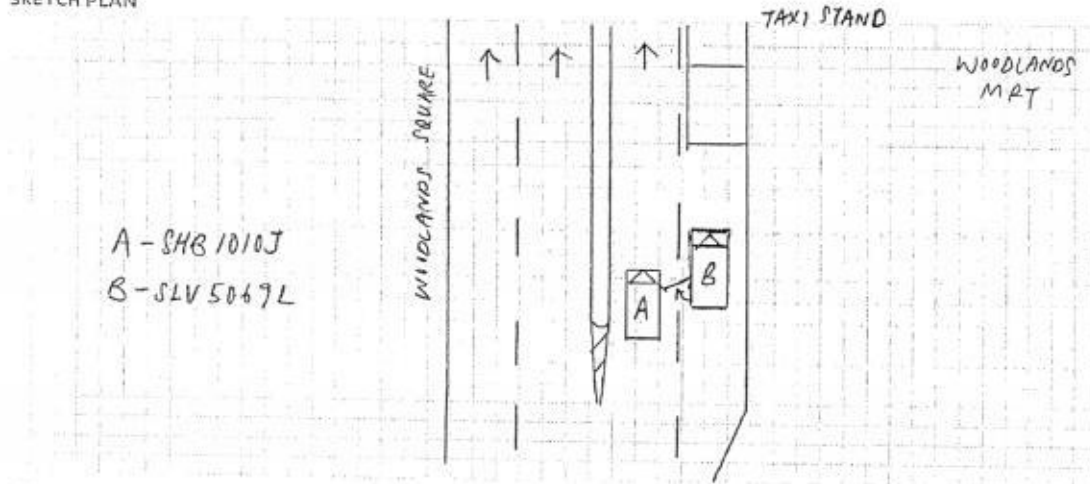
SKETCH PLAN

I WAS DRIVING TOWARDS WOODLANDS MRT TAXI STAND AT THE LEFT LANE WHEN THE VEHICLE SLV5069L STOPPING AT THE RIGHT LANE SUDDENLY OPENED THE REAR LEFT PASSENGER DOOR AND HIT ONTO THE RIGHT SIDE MIRROR OF MY TAXI.

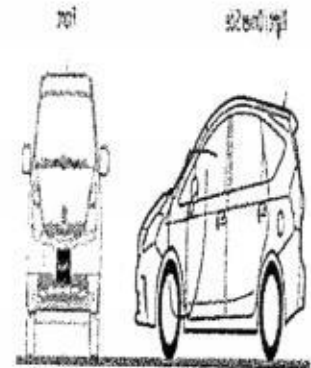
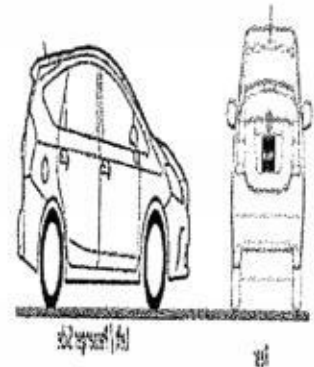
THE VEHICLE SUSTAINED DAMAGES AT THE O/S MIRROR. DAMAGES SEE DETAILS.
--

Qty	Description of Parts	Condition	Estimate By Workshop (\$)	Our Adjusted (\$)
REPLACEMENT OF PARTS				
1	COVER, OUTER MIRROR, RH (DISC 25%)	SCRATCHED	107.40	80.55
1	MIRROR GLASS RH (DISC 25%)	CRACKED	212.80	159.60
1	STICKER DECAL SMRT (DOOR) (SN)	NECESSARY	60.00	60.00
1	MIRROR ASSY, RH	SERVICEABLE	1,307.10	-
1	MIRROR LAMP RH	SERVICEABLE	65.30	-
1	DOOR BELT FRT/RH	SERVICEABLE	69.20	-
1	DOOR FRT/RH	TO REPAIR SEE LABOUR	894.40	-
			2,716.20	300.15
LABOUR				
PANEL BEATING & BODYWORK. INCLUSIVE OF THE REPAIR OF DOOR FRT/RH.			338.00	200.00
SPRAY PAINT.			558.00	250.00
TO CHECK WIRING AND SYSTEM FUNCTION.			80.00	20.00
TO REMOVE AND REFIX WING MIRROR.			120.00	30.00
TO WASH AND VACUUM.			60.00	-
			1,156.00	500.00
GRAND TOTAL			3,872.20	800.15
RECOMMENDED COST OF LUMP SUM REPAIRS (TO ITS PRE-ACCIDENT CONDITION) (CONFIRMED)				650.00

Quotation from ARC	Adjusted by Surveyor, if applicable
Total Labour Cost	\$338.00	\$200.00
Total Spray Cost	\$558.00	\$250.00
Total Spare Part Cost	\$1,649.55	\$300.15
Total Other Cost	\$260.00	(\$100.15)
TOTAL COST	\$2,805.55	\$650.00 (L/S)
Lump Sum Total	\$2,800.00	\$0.00
Number of Repair Days	4.0	2.0
Prepared / Adjusted By	Tuck Foo Kok	Naz (LKK) / NTUC
ARC / Surveyor Sign Off Date		
Signature	 	 
Remarks	BEFORE PAINT PHOTO AND AFTER PAINT PHOTO, FOR CHECK ITEM AND REPLACE ITEM. PLEASE CALL SURVEYOR
