REF: CS/TU/8009214/RISBT

**ACCIDENT INVOLVING VEHICLES NOS. SKV 9813R AND PA 9596T ALONG  
TAMPINES CENTRAL 4 ON 17<sup>th</sup> MAY 2018 AT ABOUT 1930 HOURS**

## VEHICLE DAMAGE INSPECTION REPORT

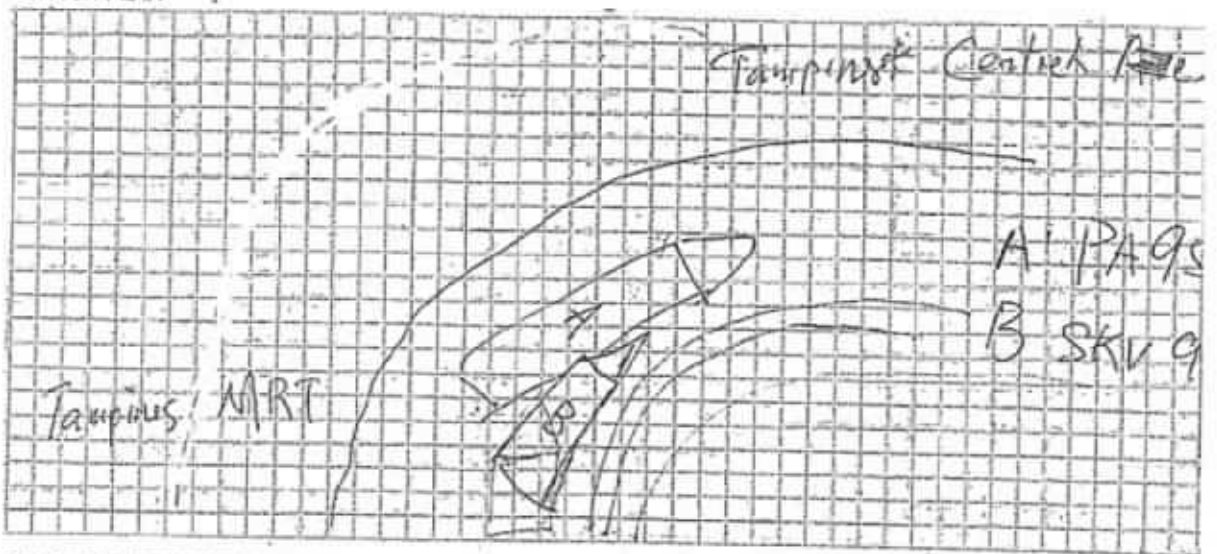
SKETCH PLAN

Driving my bus veh No. PA95967  
 Turning to Tampines Central A  
 While turning right, I signalled right  
 and Veh SKV 9813R hit my Right back side  
 of my bus.
