Affiliated to Federation Internationale Des Experts En Automobile				
AIG ASIA PACIFIC INSURANCE PTE LTD		Ref : CS3/AIG18017504/Acd3		
78 SHENTON WAY #08-16 CHARTIS BUILDING SINGAPORE 079120		Date : 26-09-2018

- PRE-REPAIR INSPECTION - ACCIDENT INVOLVING OUR INSURE...

NOTICE TO INSURER TO CONDUCT PRE-REPAIR
CLAIMANT: CAR (S) PTE LTD
TRAFFIC ACCIDENT ON 22 SEPTEMBER 2018 AT 09:30 HRS ALONG JUNCTION OF TPE
EXIT TO LOYANG AVENUE INVOLVING VEHICLES NO. GBC1462D & GR7700P

VEHICLE DAMAGE INSPECTION REPORT

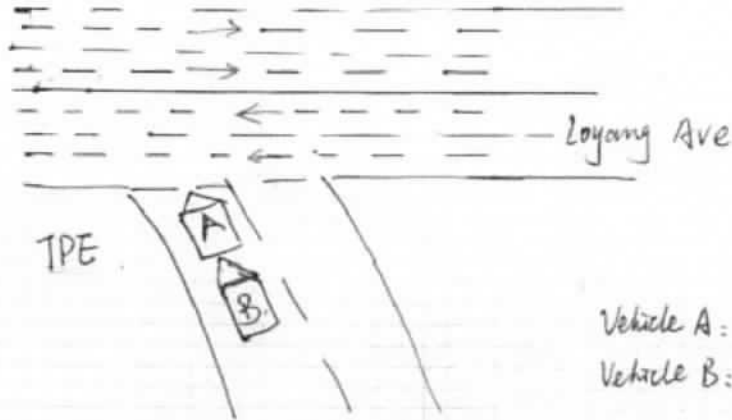
SKETCH PLAN

Vehicle A: GBC1462D

Vehicle B: GR 7J00 R

On 22/09/2018 around 9:30 am. I was driving my vehicle GRCH46D from TPE exit to Logang Ave. I was driving slowly and stopped to waiting for the vehicle cross in front. Suddenly, I feeling an impact from my rear portion. I get off my vehicle and found that Vehicle B GR 7700R was collided on my rear portion. There is no injury in this accident.

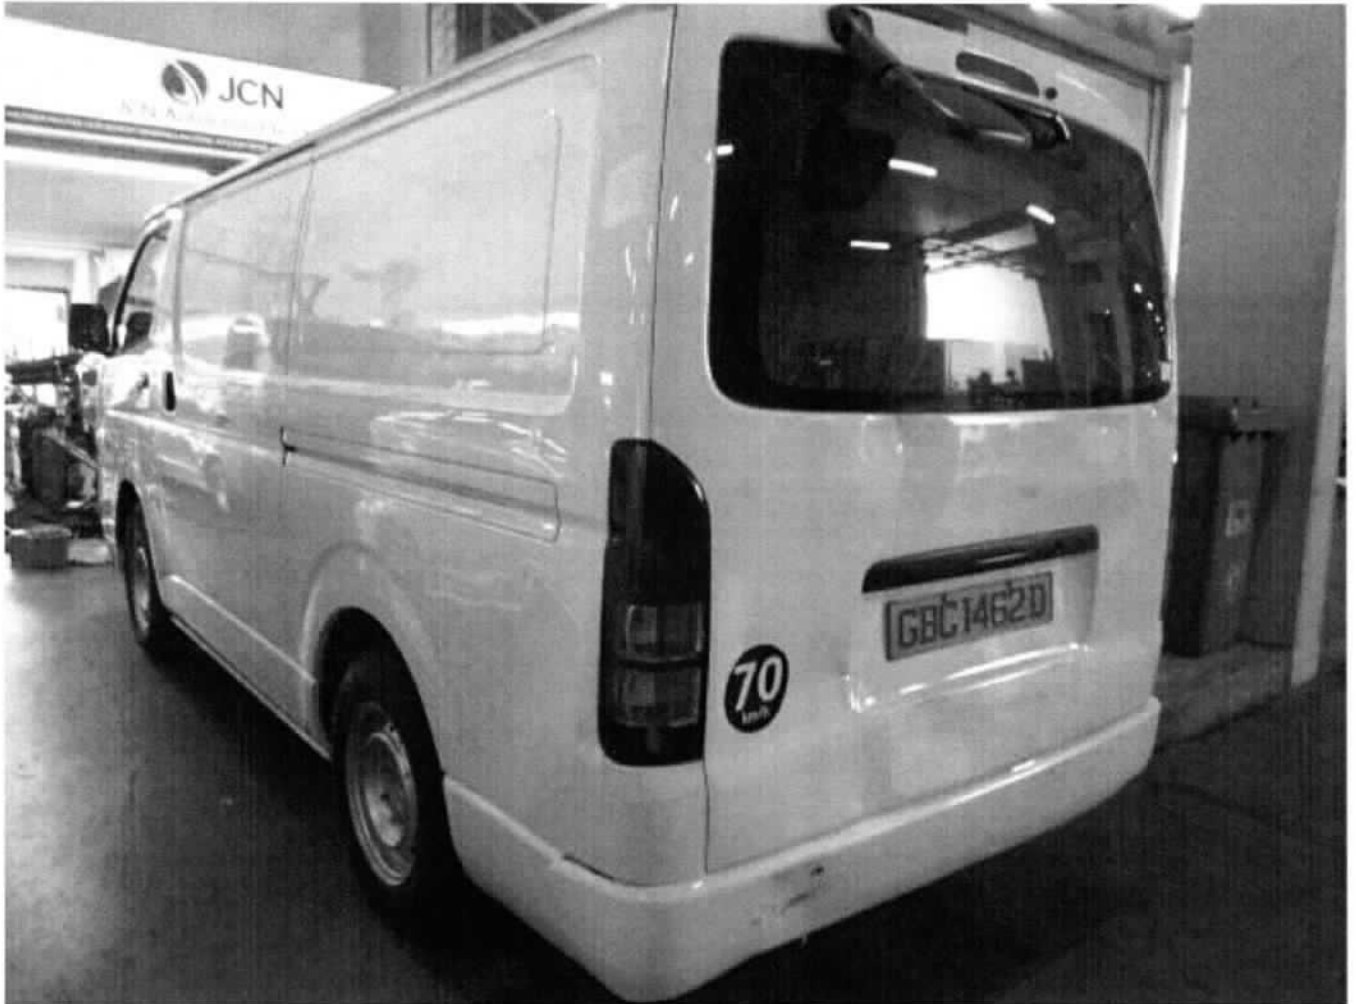
Accident Photo

The U/C / Chassis frame / Body Structure affected due to collision.

No.	Qty	Part No.	Particulars	Condition	Repairer's	Amount
1	1		*REAR BUMPER	Cut	0.00 F	*- F
2	2		*REAR BUMPER BRACKET	Bent	0.00 F	*- F
3	2		*REAR BUMPER SIDE RETAINER	Broken	0.00 F	*- F
4	1		*REVERSE SENSOR	Missing	0.00 F	*- F
5	1		*REAR END PANEL	Dented	0.00 F	*- F
6	1		*REAR LH TAILLAMP	Broken	0.00 F	*- F
7	1		*REAR RH TAILLAMP	Scratched	0.00 F	*- F
8	1		*TAILGATE	Dented	0.00 F	*- F
9	1		*TAILGATE GARNISH	Cracked	0.00 F	*- F
10	1		*TAILGATE GLASS MOULDING	Necessary	0.00 F	*- F
11	1		*TAILGATE GLASS SEALANT	Necessary	0.00 F	*- F
12	1		*TAILGATE LOCK	Bent	0.00 F	*- F
13	1		*TAILGATE RUBBER	Cut	0.00 F	*- F
14	1		*TAILGATE DAMPER	Not Necessary	0.00 F	*- F
15	1		*SPARE TYRE BRACKET	Bent	0.00 F	*- F
16	1		*SIDE STEP PANEL STOPPER	Dented	0.00 F	*- F
17	1		*REAR BODY PANEL LH	Repair	0.00 F	*- F
18	1		*STICKER (70KM/H)	Necessary	0.00 F	*- F
19	1		*TAILLAMP LOWER GARNISH	Dented	0.00 F	*- F
20	1		*REAR FLOOR PANEL STEP PANEL	Distorted	0.00 F	*- F
