DIRECT SURVEY INSPECTION ON WORKSHOP - COMFORTDELGRO ENGINEERING

PTE LTD, DOA: 26/09/2018, SHC 7136K (TP VEHICLE), SLC 4786G (OI VEHICLE)

ADJUSTMENT ON REPAIR COST FOR VEHICLE NO. SHC 7136K

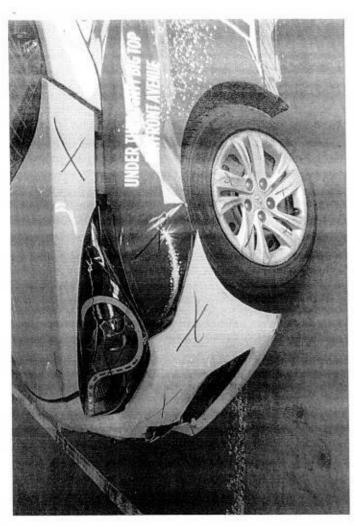
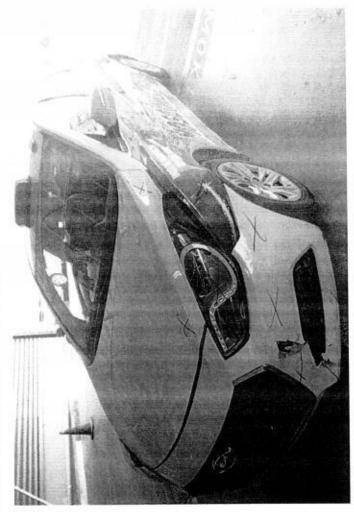
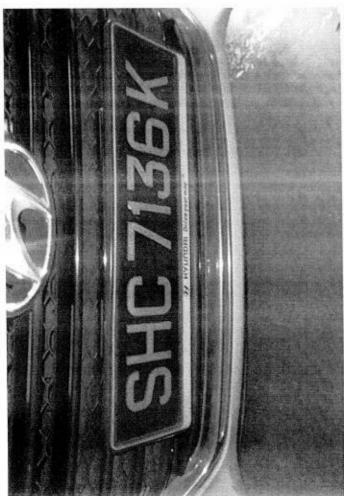
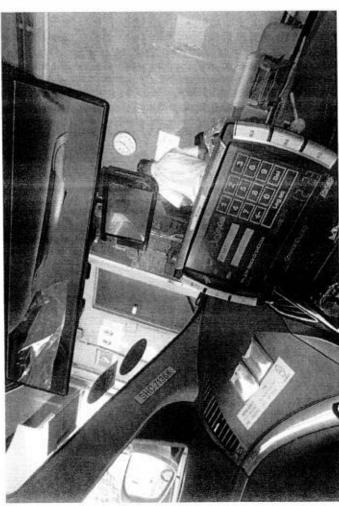
1513		Affiliated to Federation Interna	ationale Des Experts En Autom	nobile
CON	MFORTDELGRO E	NGINEERING PTE LTD	Ref : CS/QW180175	41/K1qbs2
59 L	OYANG DRIVESII	NGAPORE 508969	Date: 04-10-2018 Code: QW007	
		Policy Particula	rs :- THIRD PARTY CLAI	M
	Insured Veh.	SLC 4786G	Veh. Inspected	SHC 7136K
	Policy No.		Coverage (\$)	0.00
	Claim No.		Excess (\$)	0.00
	Assign From		Assign Date	26/09/2018
		Vehicle Pa	rticulars & Condition	M. Bartistan and St. St.
	Make & Model	HYUNDAI 140	c.c	1685
	Engine No.	HIDDEN	Year of Reg.	2015
	Chassis No.	KMHLB41UMGU080730	Colour	YELLOW
	Odometer	488540	Steering	IN ORDER
	Brakes	IN ORDER	Modification	STANDARD ALLOY RIM
	General	FAIR		
		Cond	ditions of Tyres	
		Size	Make	Balance
	R/H Front Tyre	205/60R16	CAMPEON	7 mm
	L/H Front Tyre	205/60R16	CAMPEON	7 mm
	R/H Rear Tyre	205/60R16	CAMPEON	7 mm
	L/H Rear Tyre	205/60R16	CAMPEON	7 mm
			otion of Damages	
	THE VEHICLE SU DAMAGES SEE D	STAINED DAMAGES AT THE N ETAILS.	I/S FRONT PORTION.

Qty	Description of Parts	Condition	Estimate By Workshop (\$)	Our Adjusted (\$)
	REPLACEMENT OF PARTS			
2	BONNET HINGE (LH/RH) @ \$41.00	BENT	82.00	82.00
1	RADIATOR GRILLE	CRACKED	1,110.10	1,110.10
1	RADIATOR GRILLE H EMBLEM	NOT NECESSARY	39.50	
1	FRONT BUMPER COVER	DEFORMED	1,052.20	1,052.20
1	FRONT BUMPER SPONGE	TORN	99.20	99.20
1	FRONT BUMPER REINFORCEMENT	SERVICEABLE	402.10	,
1	FRONT BUMPER GRILLE (LH)	SERVICEABLE	41.60	
1	FRONT BUMPER BRACKET TOP (LH)	CRACKED	22.40	22.40
1	FRONT BUMPER BRACKET (LH)	CRACKED	24.60	24.60
1	HEADLAMP (LH)	CRACKED	1,388.00	1,388.00
1	FRONT FENDER (LH)	DENTED	566.30	566.30
1	FRONT FENDER SHIELD (LH)	SERVICEABLE	175.90	
1	FRONT FENDER RETAINER	SERVICEABLE	24.60	
1	FRT WHEEL HUB CAP, LH	SERVICEABLE	107.10	
	LESS 20% DISCOUNT		-1,027.12	-868.96
			4,108.48	3,475.84
	SPECIAL NETT ITEMS			
1	FRONT FENDER ADVERTISEMENT LOGO (LH) (SN)	NECESSARY	100.00	100.00
	VI (1400) W		100.00	100.00

LABOUR			
	PANEL BEATING.		440.00	300.00
	SPRAY PAINTING CHARGE.		440.00	400.00
	WIRING.		30.00	20.00
	TUFF KOTE.		50.00	20.00
	FRT WHEEL ALIGNMENT.	NOT NECESSARY	80.00
