01 October 2018

**Road Traffic Accident On 10 April 2015 At About
1800Hrs Along Bedok North Avenue 3 Towards Upper
Changi Road, Involving Motor Cars SFW 6562M And SJD
201Y**

**Requested By
AIG Asia Pacific Insurance Pte Ltd
78 Shenton Way #08-16
Singapore 079120**

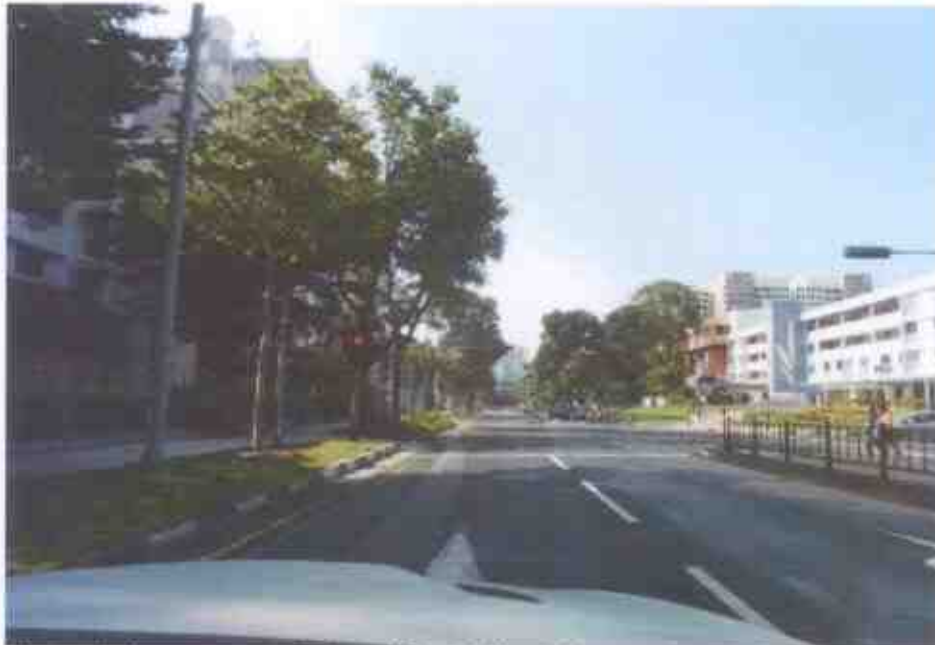
Photo 1 shows a general view of Bedok North Avenue 3 towards Upper Changi Road. This was in the same travelling direction and same travelling lane taken by the Suzuki prior to the accident. The carpark driveway where the Honda had approached was relatively unnoticeable as I was approaching the signalized T-junction located before the Accident Junction.

25. During my visit to the Accident Location, I had driven along the same route and the same travelling lane that was taken by the Suzuki. It was observed that the carpark driveway was rather unnoticeable when I was approaching the T-junction, that was located before the Accident Location. The carpark driveway was not conspicuous as it appears to have blended into the surrounding landscape. The carpark driveway becomes noticeable nearer to or at the stop line of the T-junction. Based on this observation, it would be reasonable to expect that at or just before the T-junction and the roadway thereafter, the Suzuki driver was able to see the Honda as the Honda was approaching the end of the carpark driveway, coming out onto the main roadway of Bedok North Avenue 3. See photo 1 – 5 below.

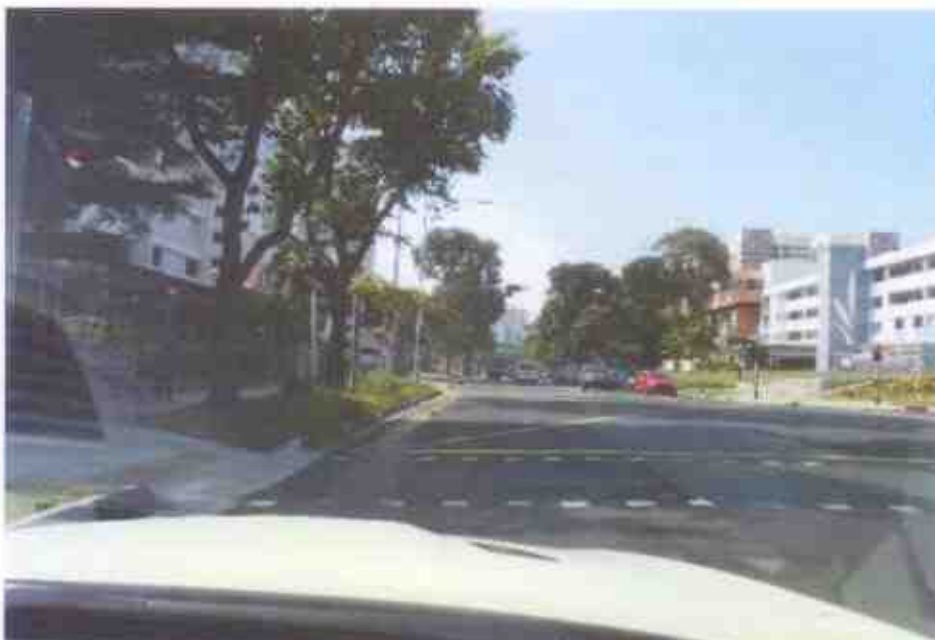
Photo 2 shows a general view of Bedok North Avenue 3 towards Upper Changi Road. This was in the same travelling direction and same travelling lane taken by the Suzuki prior to the accident. The carpark driveway where the Honda had approached becomes noticeable nearer to or at the stop line of the T-junction located before the Accident Junction.

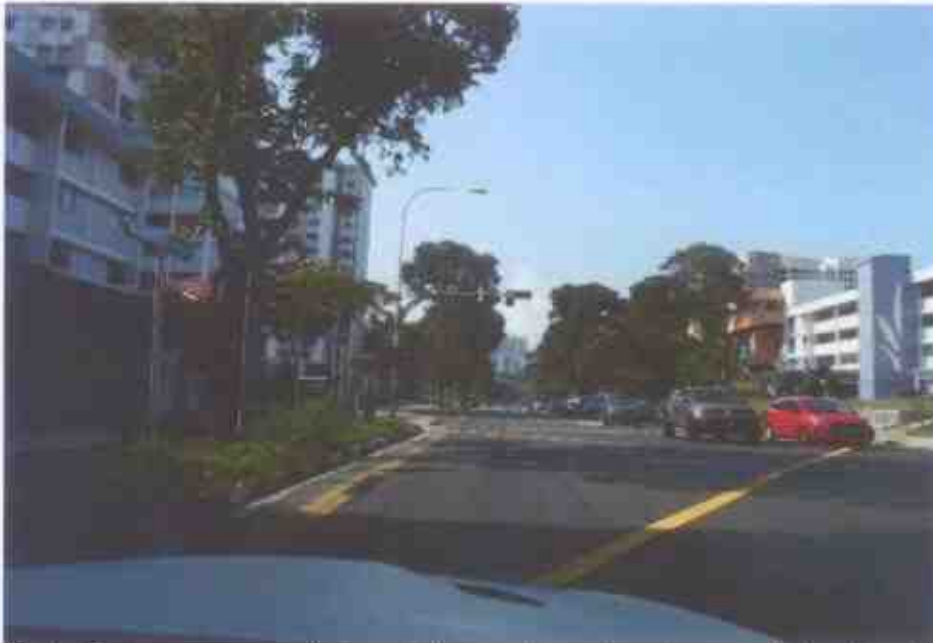
Photo 3 shows a general view of the roadway when I was entering into the signalized T-junction. The carpark driveway was clearly visible towards the front left of me. Basing on my observations, I would expect that at or just before the T-junction and the roadway thereafter, the Suzuki driver was able to see the Honda as the Honda was approaching the end of the carpark driveway, coming out onto the main roadway of Bedok North Avenue 3.

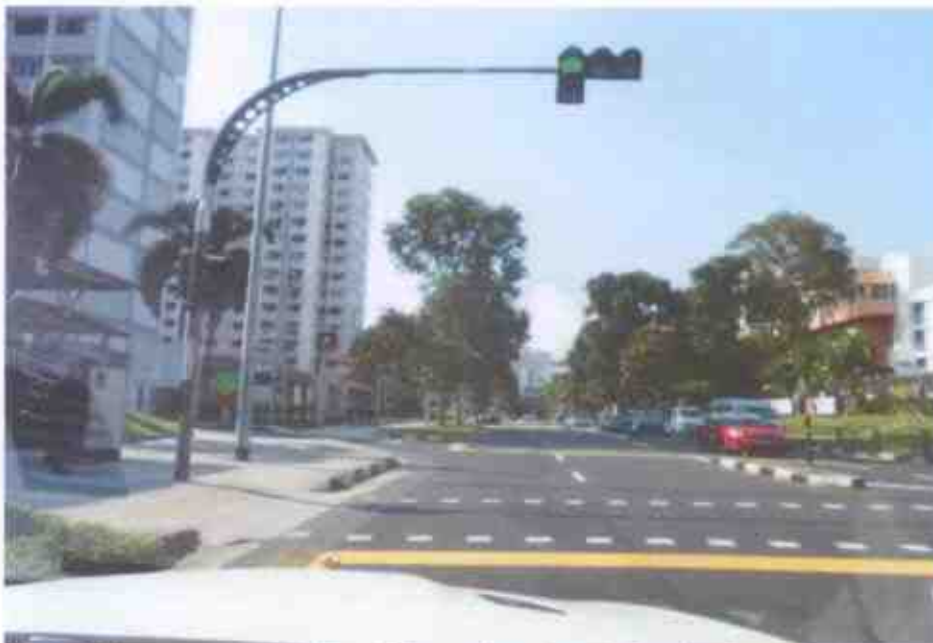
Photo 4 shows a general view of the roadway just before the Accident Location. Basing on my observations, I would expect that at or just before the T-junction and the roadway thereafter, the Suzuki driver was able to see the Honda as the Honda was approaching the end of the carpark driveway, coming out onto the main roadway of Bedok North Avenue 3.

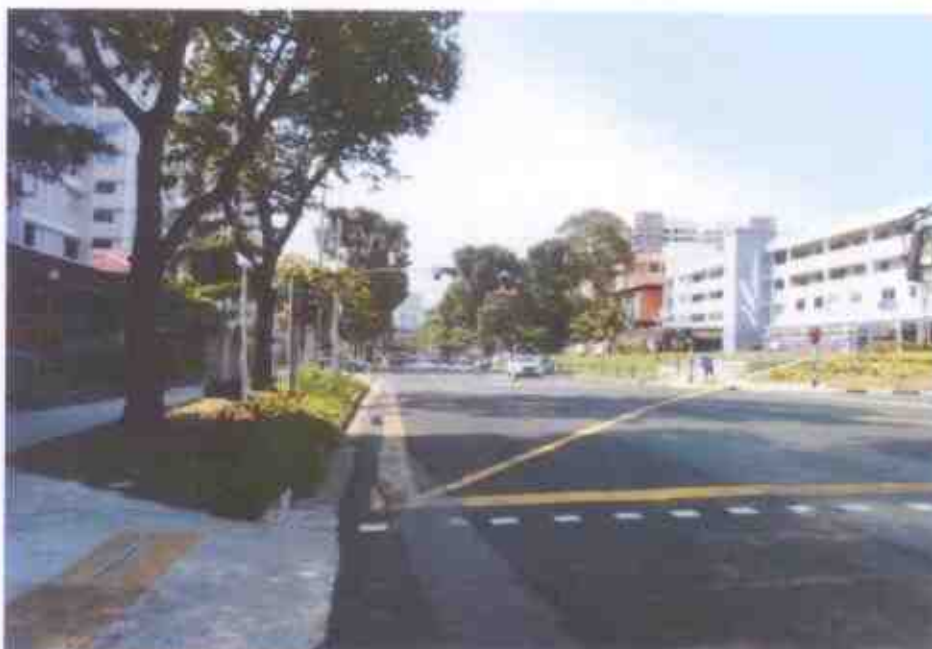
Photo 5 shows a general view of the roadway at the stop line of the T-junction before the Accident Location. A grey coloured motor car can be seen at or near the stop line of the carpark exit where the Honda had approached from. Photograph taken while standing near the road kerb.

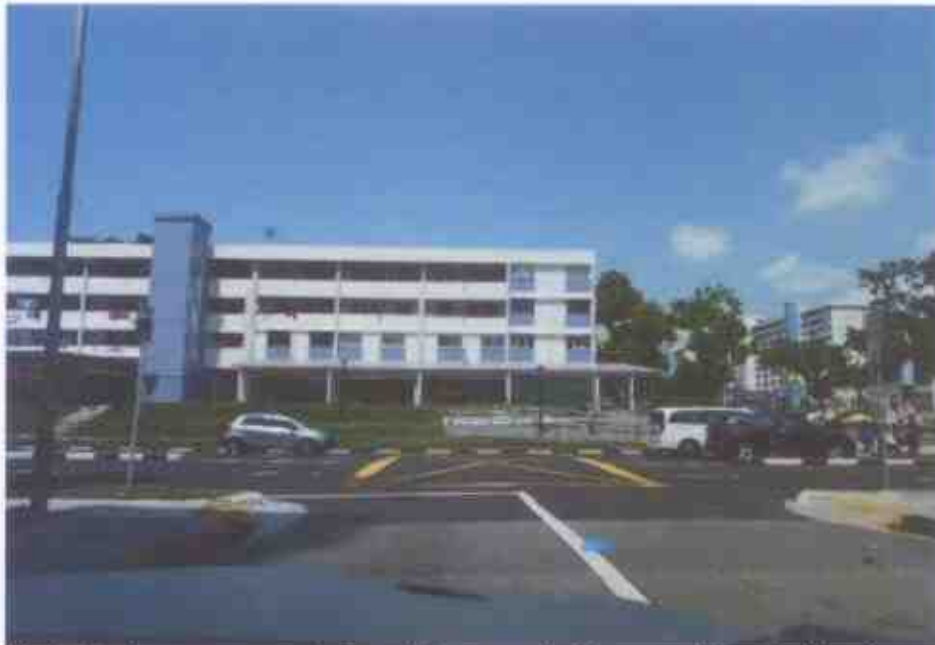
Photo 6 shows a general view of the carpark driveway which the Honda was travelling on prior to the accident. At this location, the roadway and vehicular traffic that was approaching from my right (Suzuki's approach direction) was obstructed.

26. When driving along the carpark exit, it was observed that the roadway and vehicular traffic that was approaching from my right (Suzuki's approach direction) was obstructed. This was about 10m before the stop line, and at this location, it would not have been possible for the driver of the Suzuki and the driver of the Honda to see each other as the obstruction was caused by a large fixed landscape.
27. Nearing the stop line at the carpark driveway, I was able to see the roadway of Bedok North Avenue 3 up to the stop line at the T-junction. Vehicular traffic approaching from my right was visible at this point and onwards. From this observation, I would expect the driver of the Honda to be able to see the Suzuki approaching from the right, along the extreme left lane of Bedok North Avenue 3 when the Honda was near or at the stop line of the carpark driveway. See photo 6 - 9 below.

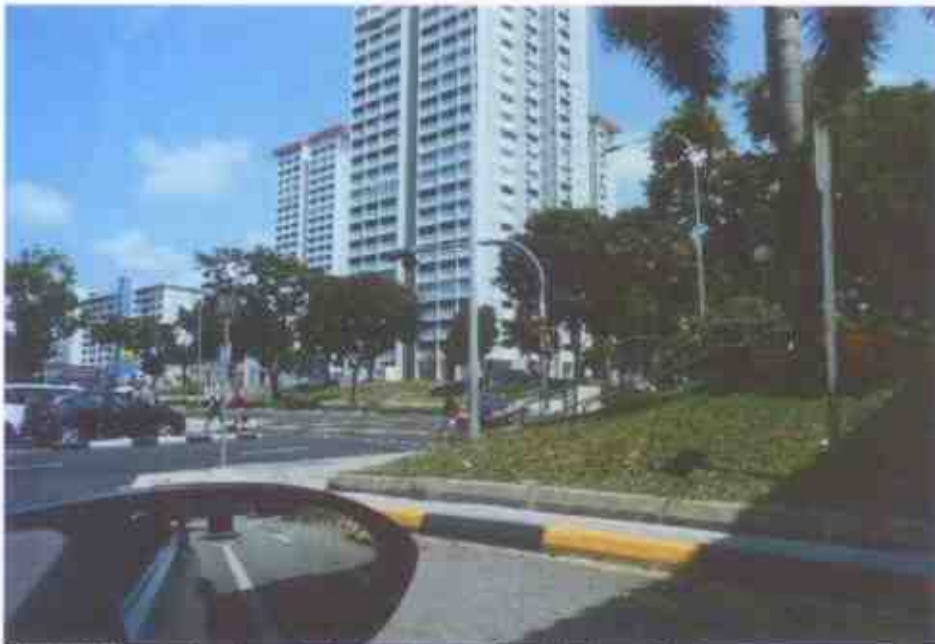
Photo 7 shows the view of the roadway and vehicular traffic that was approaching from my right (Suzuki's approach direction). I was not able to see the roadway on the right due to obstruction caused by a large fixed landscape. This was approximately 10m before the stop line at the carpark exit. Similarly, the driver of the Suzuki would have not been able to see the Honda at this location due to the same fixed landscape.

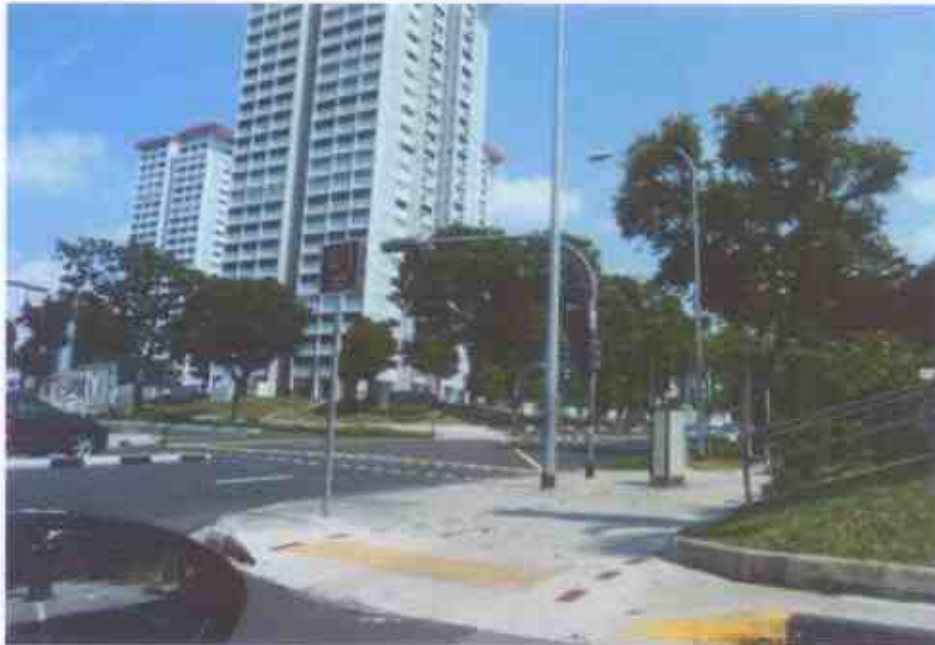
Photo 8 shows the view of the roadway and vehicular traffic that was approaching from my right (Suzuki's approach direction) as I was near the stop line at the carpark exit. I was able to see the roadway of Bedok North Avenue 3 up to the stop line at the T-junction.

41. The discussion on the line of sight in the KAR Report, in particular for the Honda driver, contradicts the actual line of sight available to the Honda driver, especially when site-survey photo 2 shown in page 47 of the KAR Report had showed no view obstruction at the stop line of the carpark driveway. My observations during my visit to the Accident Location also did not suggest that the Honda driver would have difficulty seeing the Suzuki approaching from his right when the Honda was near or at the stop line of the carpark driveway. Refer to photographs 8 and 9 above.

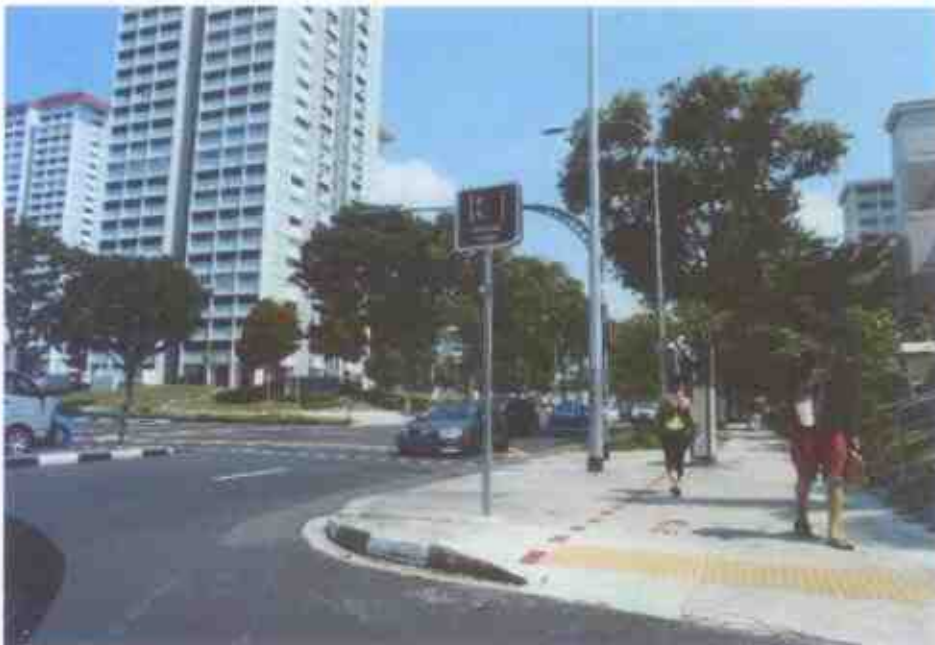
Photo 9 shows the view of the roadway and vehicular traffic that was approaching from my right (Suzuki's approach direction) as I was at the stop line at the carpark exit. I was able to see the roadway of Bedok North Avenue 3 up to the stop line at the T-junction. From this observation, I would expect the driver of the Honda to be able to see the Suzuki approaching from the right, along the extreme left lane of Bedok North Avenue 3 when the Honda was near or at the stop line of the carpark driveway.

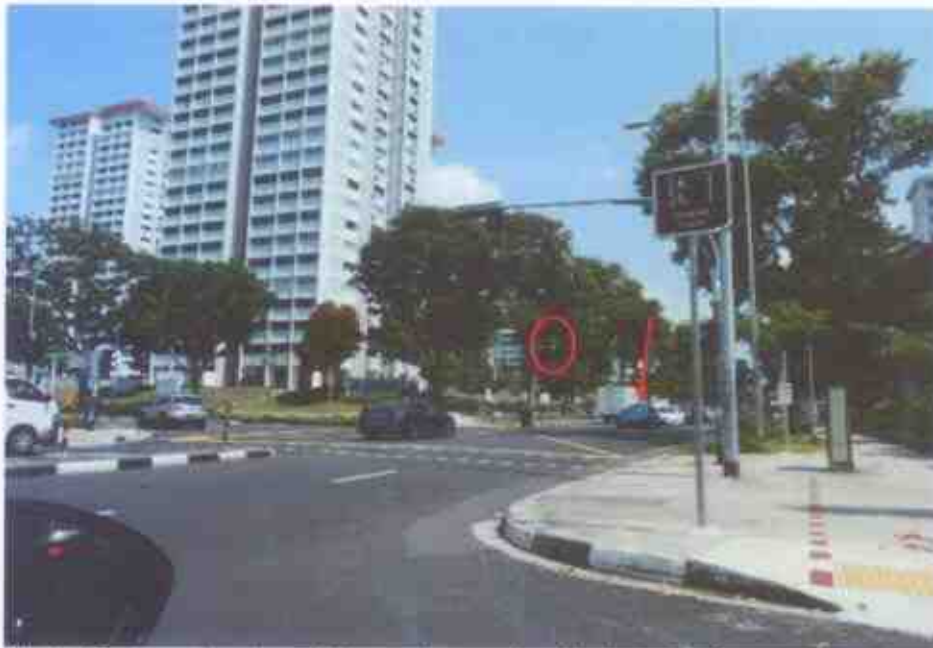
Photo 10 shows the view of the roadway and vehicular traffic from the stop line at the carpark exit. The stopped vehicle at the T-junction that was mentioned by the Honda driver could have been a vehicle that was waiting to turn right at the T-junction, similar to the arrowed vehicle in this photograph. At this point, the traffic light was showing green (circled) in both directions of Bedok North Avenue 3.

32. Although the statement was generally written without any further details of which lane was the vehicle stopped and/or colour of traffic light signal at the T-junction, it may have been possible that the "stopped vehicle" mentioned by the Honda driver was in fact a vehicle that was waiting to turn right at the T-junction and not a vehicle that had stopped due to red traffic light signal. See photo 10 below.

33. I note that there was no clarification made with the Honda driver regarding this "stopped vehicle" in the KAR Report despite the driver's presence during their visit to the Accident Location. Neither was there any discussion or comment in the KAR Report on whether the Suzuki had beaten the red light given the "stopped vehicle" comment by the Honda driver. Since there was no discussion regarding this aspect, it would appear to me that the colour of the traffic light signal at the T-junction was not a factor leading to the accident.
