To Inspect Vehicle No:

GW 1883H

Make: TOYOTA HILUX 3.0 AUTO C.C. 2,982

VEHICLE DAMAGE INSPECTION REPORT

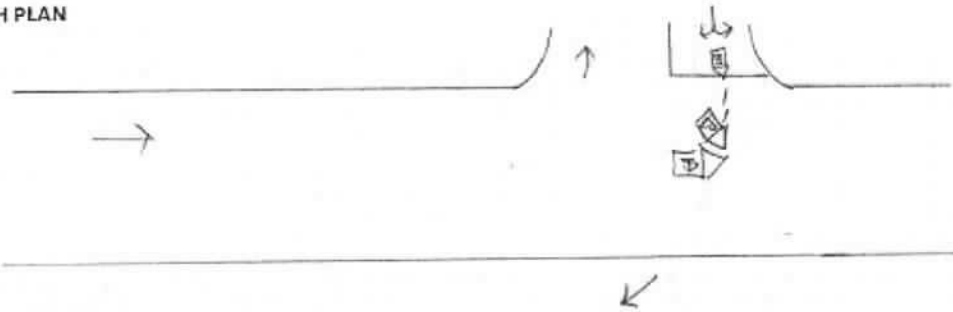
SKETCH PLAN

A) G10 1883 H

B) PA 8922

At mentioned details, I was driving along Teek Wye Ave
 & going straight when suddenly vehicle B turn out from
 slip road & hit onto my vehicle's front part.

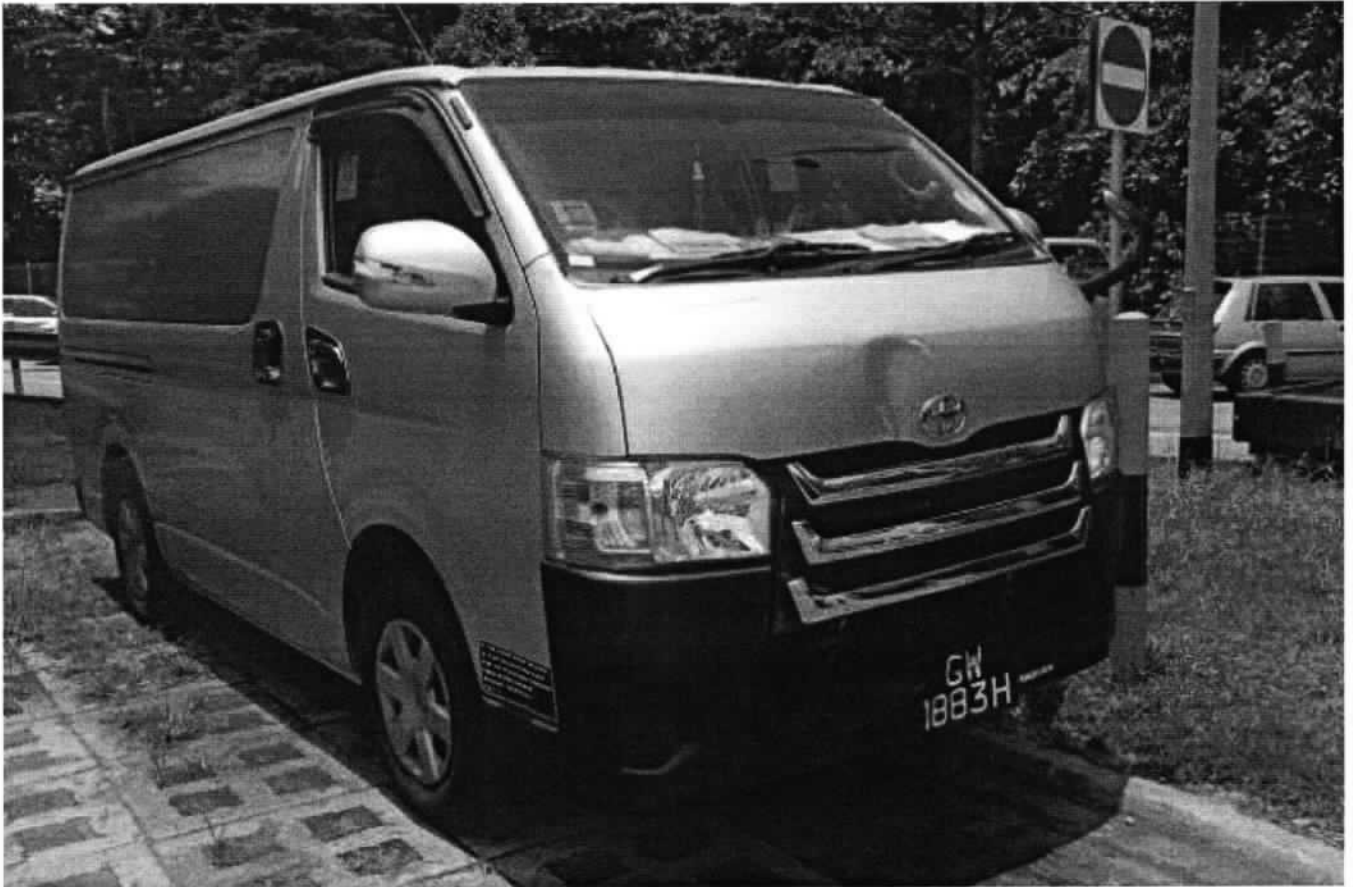
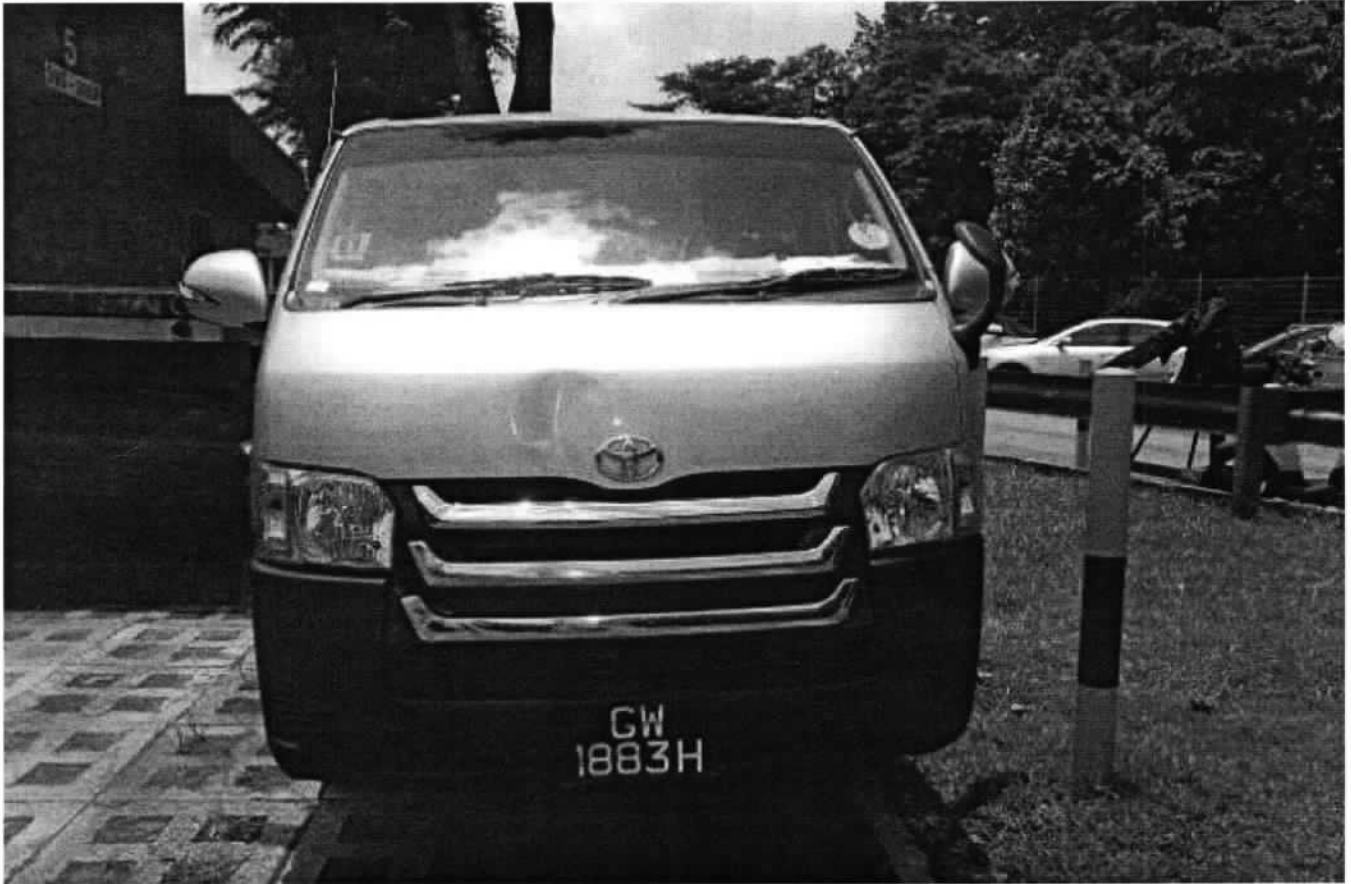
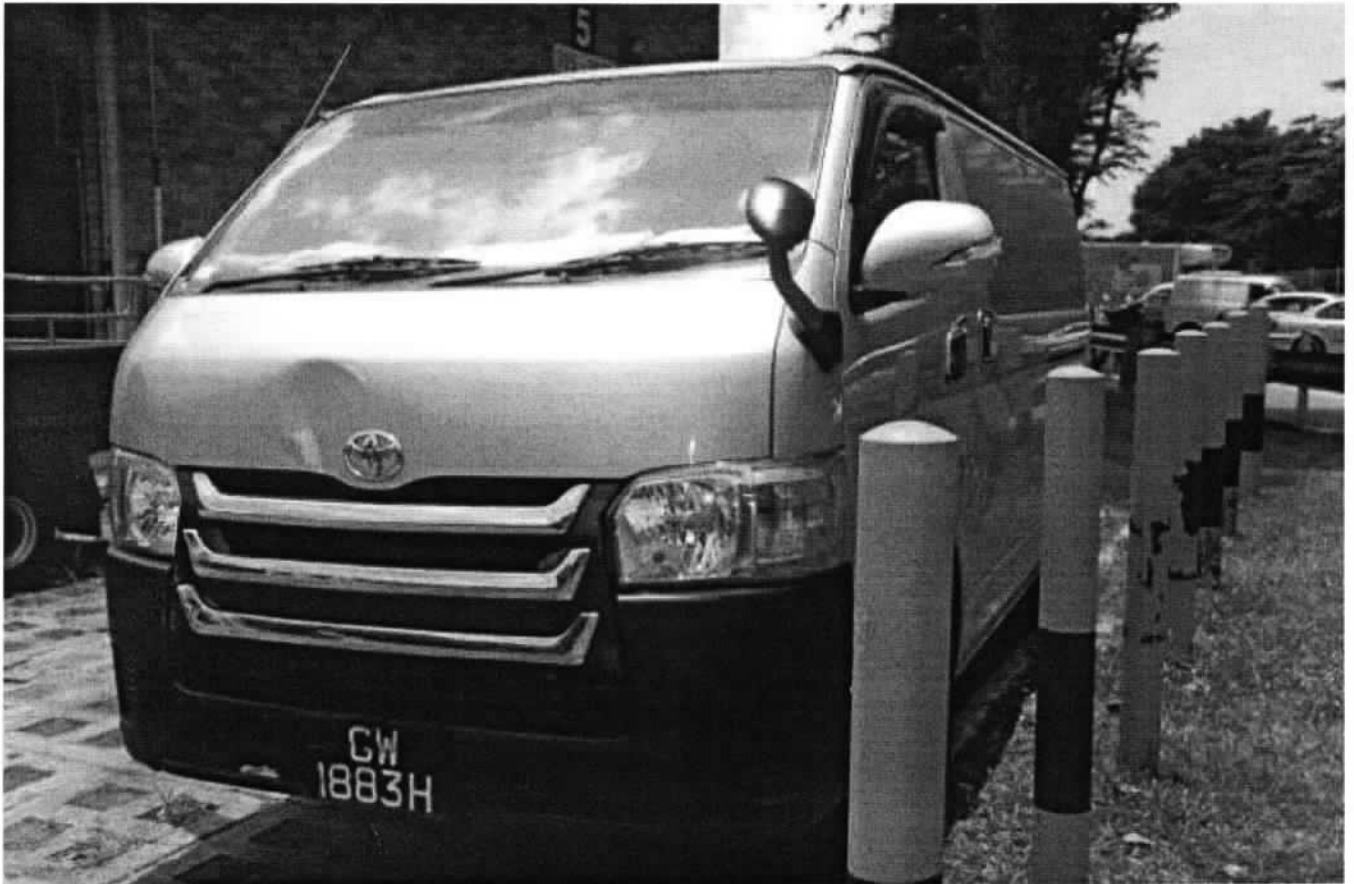
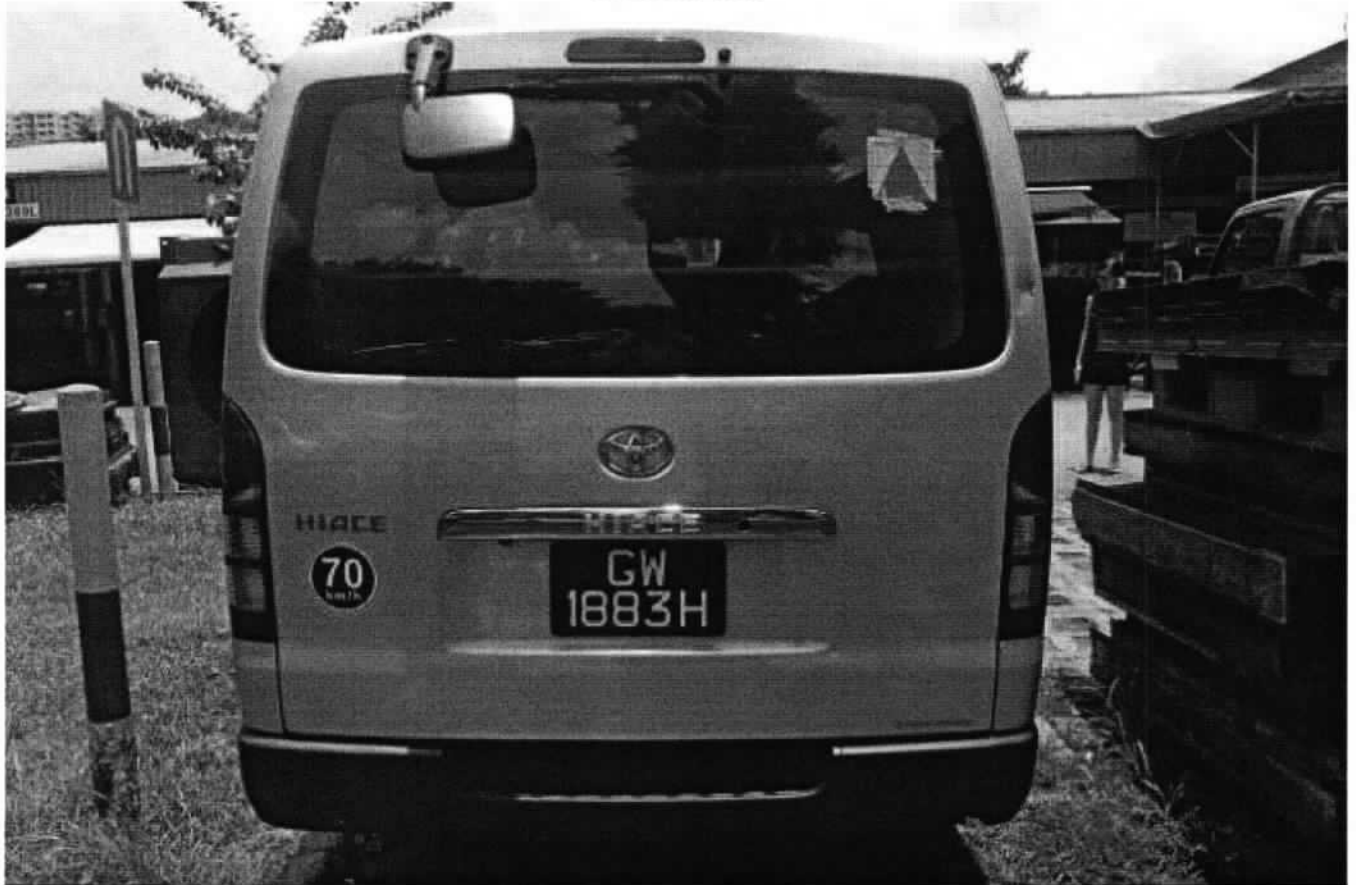
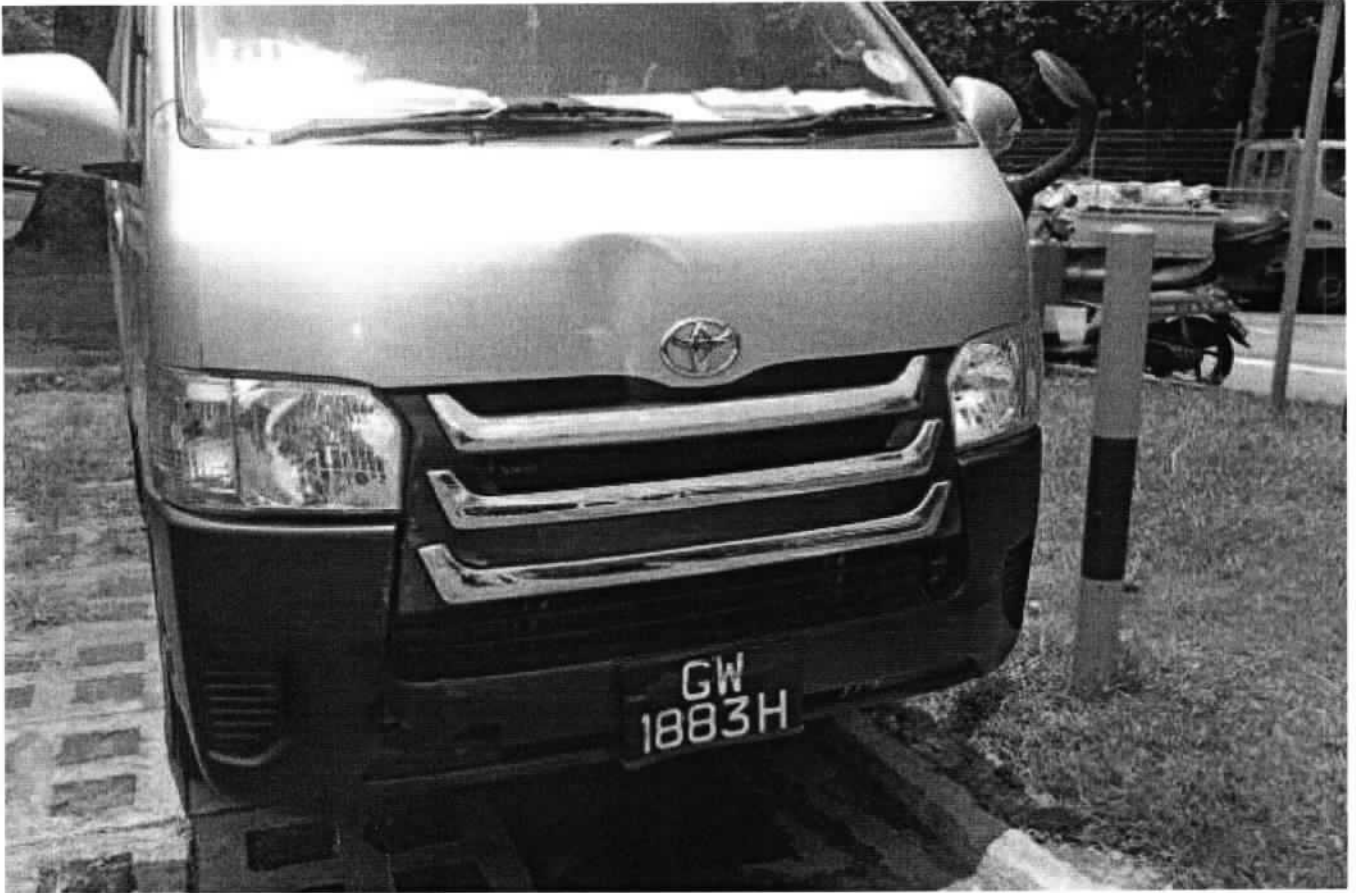
Accident Photo

The U/C / Chassis frame / Body Structure affected due to collision.

No.	Qty	Part No.	Particulars	Condition	Repairer's	Amount
1	1		*FRONT BUMPER	Cracked	535.00 FL	*400.00 FL
2	1		*FRONT BUMPER UPPER CHROME GRILLE	Deformed	795.00 FL	*700.00 FL
3	1		*SET FRONT BUMPER UPPER CHROME GRILLE FASTENERS	Necessary	38.00 FL	*38.00 FL
4	1		*FRONT BUMPER LOWER GRILLE	Serviceable	265.00 FL	*- FL
5	1		*SET FRONT BUMPER LOWER GRILLE FASTENERS	Not Necessary	38.00 FL	*- FL
6	1		*FRONT BUMPER RH SIDE RETAINER	Distorted	170.00 FL	*170.00 FL
7	1		*FRONT BUMPER REINFORCEMENT	Bent	425.00 FL	*425.00 FL
8	2		*FRONT RH & LH HEADLAMP	O/S Scratched / N/S Cracked	1,530.00 FL	*1,530.00 FL
9	2		*FRONT HEADLAMP BRACKET	Cracked	110.00 FL	*110.00 FL
10	2		*SET FRONT HEADLAMP FASTENERS	Cracked	50.00 FL	*50.00 FL
11	1		*FRONT PANEL	Dented	895.00 FL	*895.00 FL
12	1		*SET FRONT PANEL FASTENERS	Necessary	38.00 FL	*38.00 FL
13	1		*FRONT PANEL INNER LOCK	Bent	125.00 FL	*125.00 FL
14	1		*FRONT BONNET TOYOTA EMBLEM LOGO	Necessary	58.00 FL	*58.00 FL

15	1		*FRONT SUPPORT PANEL MOUNTING	Bent	695.00 FL	*695.00 FL
16	1		*RADIATOR ASSY	Bent	1,250.00 FL	*1,100.00 FL
17	1		*AIR CONDENSOR ASSY	Bent	1,020.00 FL	*1,020.00 FL
18	1		*AIR CLEANER BOX ASSY	Not Necessary	650.00 FL	*- FL
19	1		*AIR CLEANER BLOWER SENSOR	Not Necessary	255.00 FL	*- FL
20	1		*AIR CLEANER INLET	Not Necessary	255.00 FL	*- FL
21	1		*FRONT BRAKE PUMP	Not Necessary	840.00 FL	*- FL
22	1		*FRONT WIPER MOTOR	Not Necessary	770.00 FL	*- FL
23	1		*WIPER GARNISH	Not Necessary	395.00 FL	*- FL
24	1		*CARPLATE W HOUSING	Dented / Cracked	60.00 FS	*35.00 FS
25	1		*WINDSCREEN SEALANT	Not Necessary	60.00 FS	*- FS

No	Particulars	Lab.Type	Repairer's	Amount
<u>Labour Items</u>				
1	TO PANEL BEAT AND RENEWAL OF ALL NECESSARY DAMAGED BODY PARTS	New	1,800.00	500.00
2	CHECK WIRING & LIGHTINGS	New	120.00	50.00
3	TO ANTI-RUST	New	150.00	50.00
4	TO REALIGN HEADLAMP FOCUS	New	35.00	30.00
5	TO REMOVE AND REINSTALL RADIATOR AND CONDENSOR	New	100.00	100.00
6	TO REMOVE AND REINSTALL FRONT WINDSCREEN	New	120.00	0.00
7	TO TOP UP COOLANT AND AIR CON GAS	New	80.00	0.00
8	TO REALIGN OR CONDUCT FRONT SUPPORT PANEL / CHASSIC ALIGNMENT	New	300.00	0.00
9	TO REMOVE & REFIX DASHBOARD COMPONENTS	New	240.00	0.00
10	TO PUTTY AND SPRAY-PAINT OF AFFECTED AREAS	New	1,200.00	500.00
Gross Labour Cost (S\$)			4,145.00	1,230.00
