Re : **THIRD PARTY CLAIM**

## VEHICLE INSPECTION REPORT

Registration No	: FBA 7543 A	Mileage	: 141625km
Make/Model	: Honda CB400	Engine No	: NC23E3100145
Type Of Body	: Motorcycle	Chassis No	: JH2NC39946M200128
Year Of Manu./Regn.	: 2006	Passenger Cap.	: 1 Passenger
Colour	: Grey	Others	: -

## VEHICLE DAMAGE INSPECTION REPORT

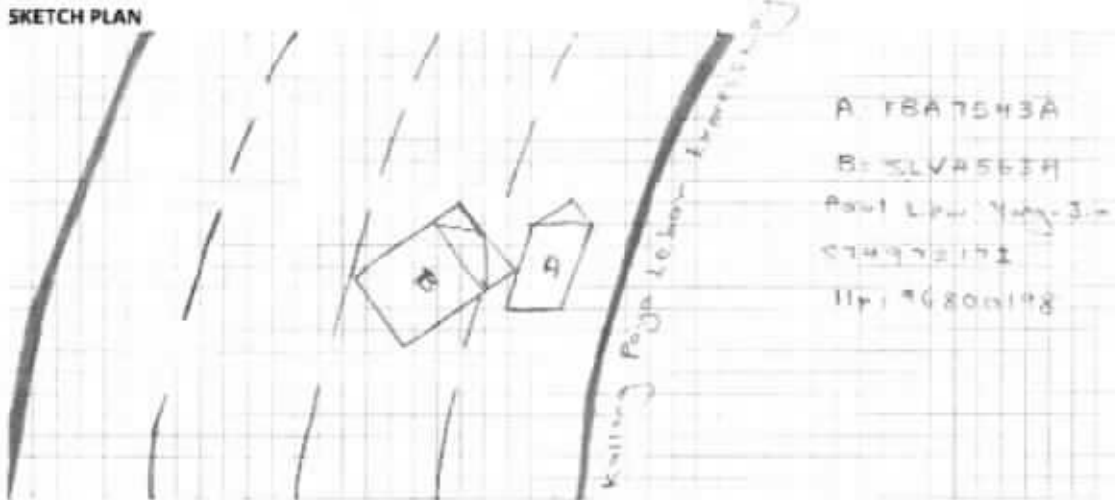
### SKETCH PLAN

Type Of Accident	COLLISION - CHANGE/CROSS LANE
Weather Conditions	SHELTERED
Road Surface	DRY

**DESCRIBE CIRCUMSTANCES OF THE ACCIDENT**

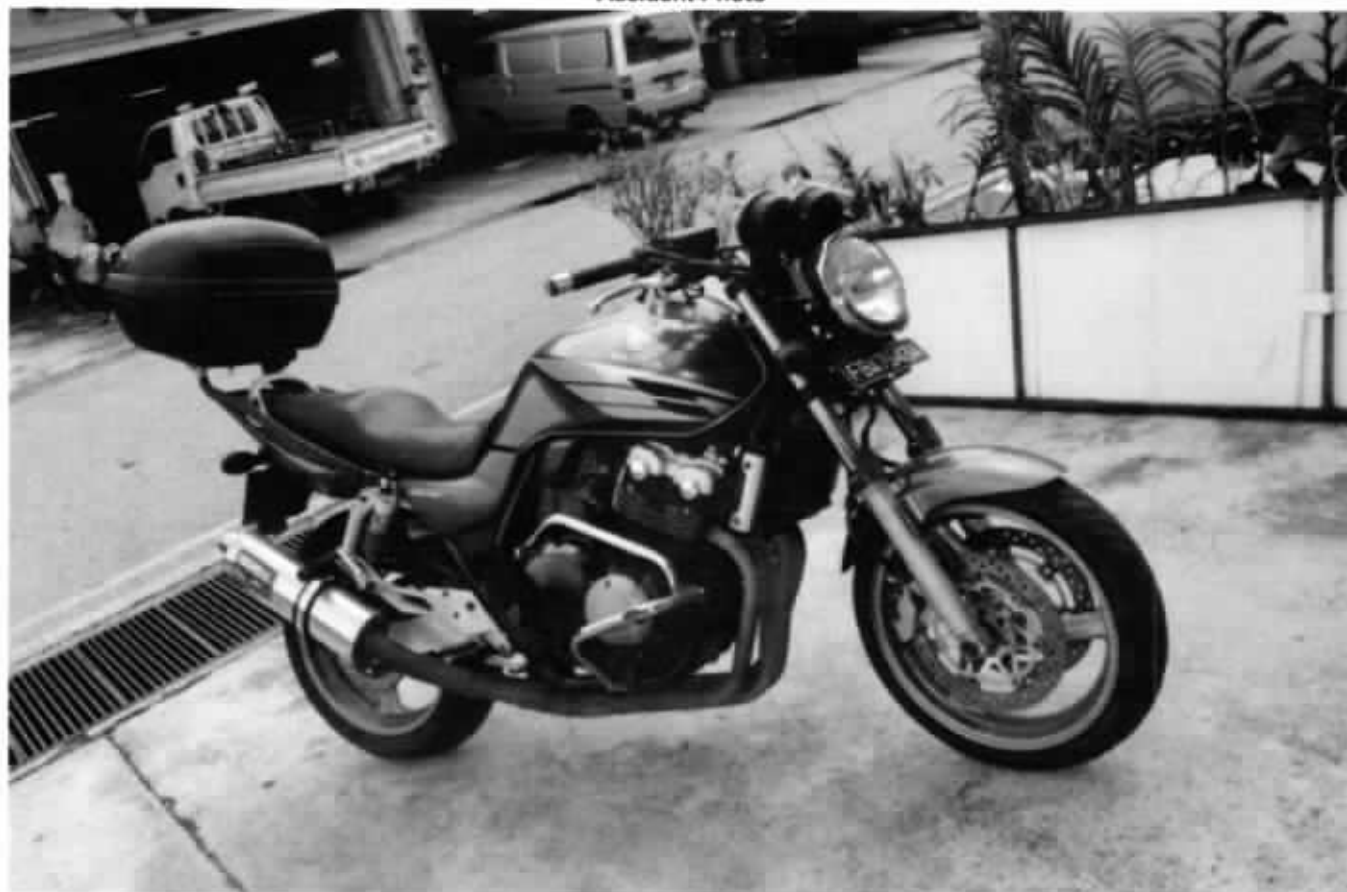
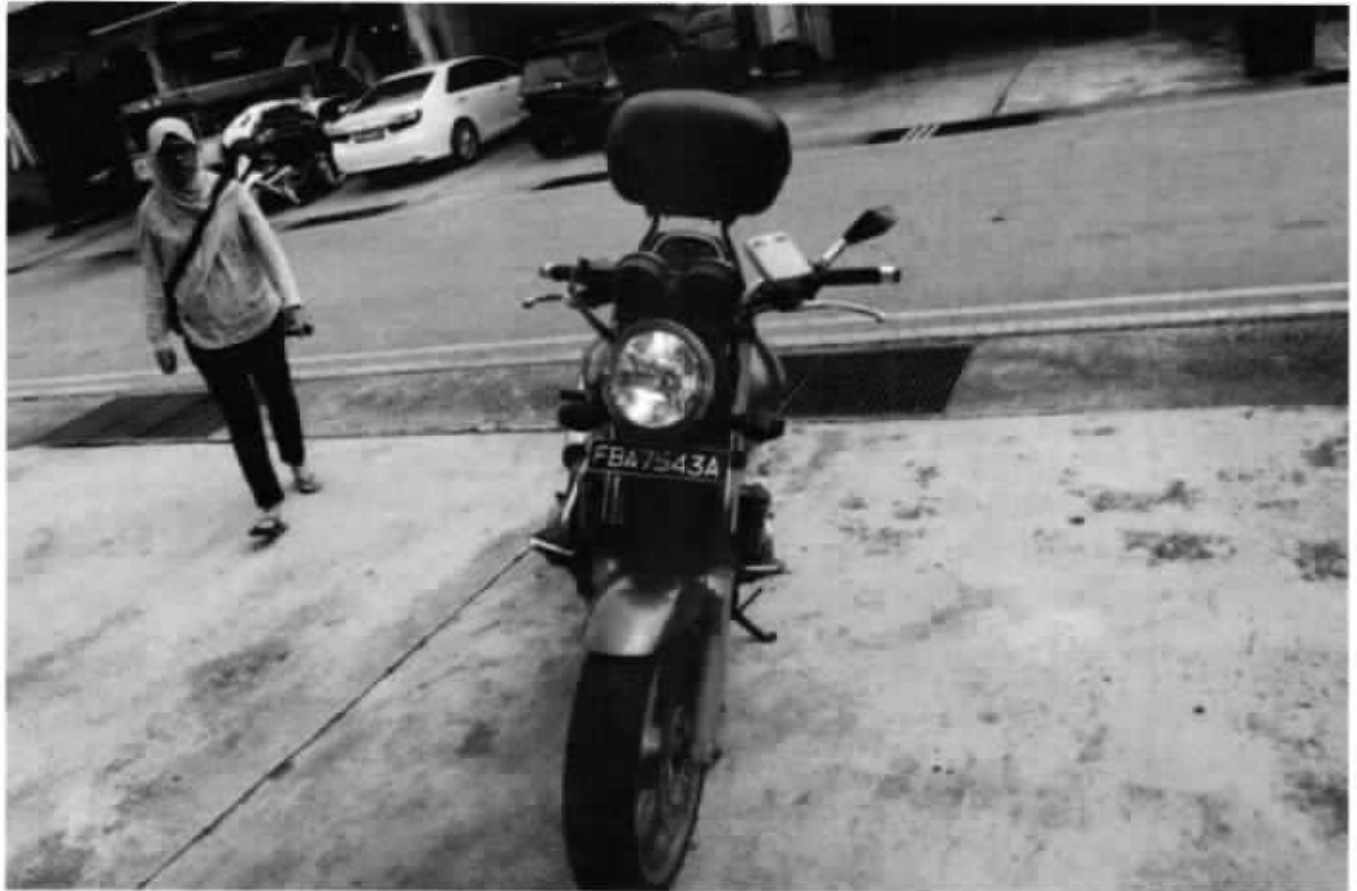
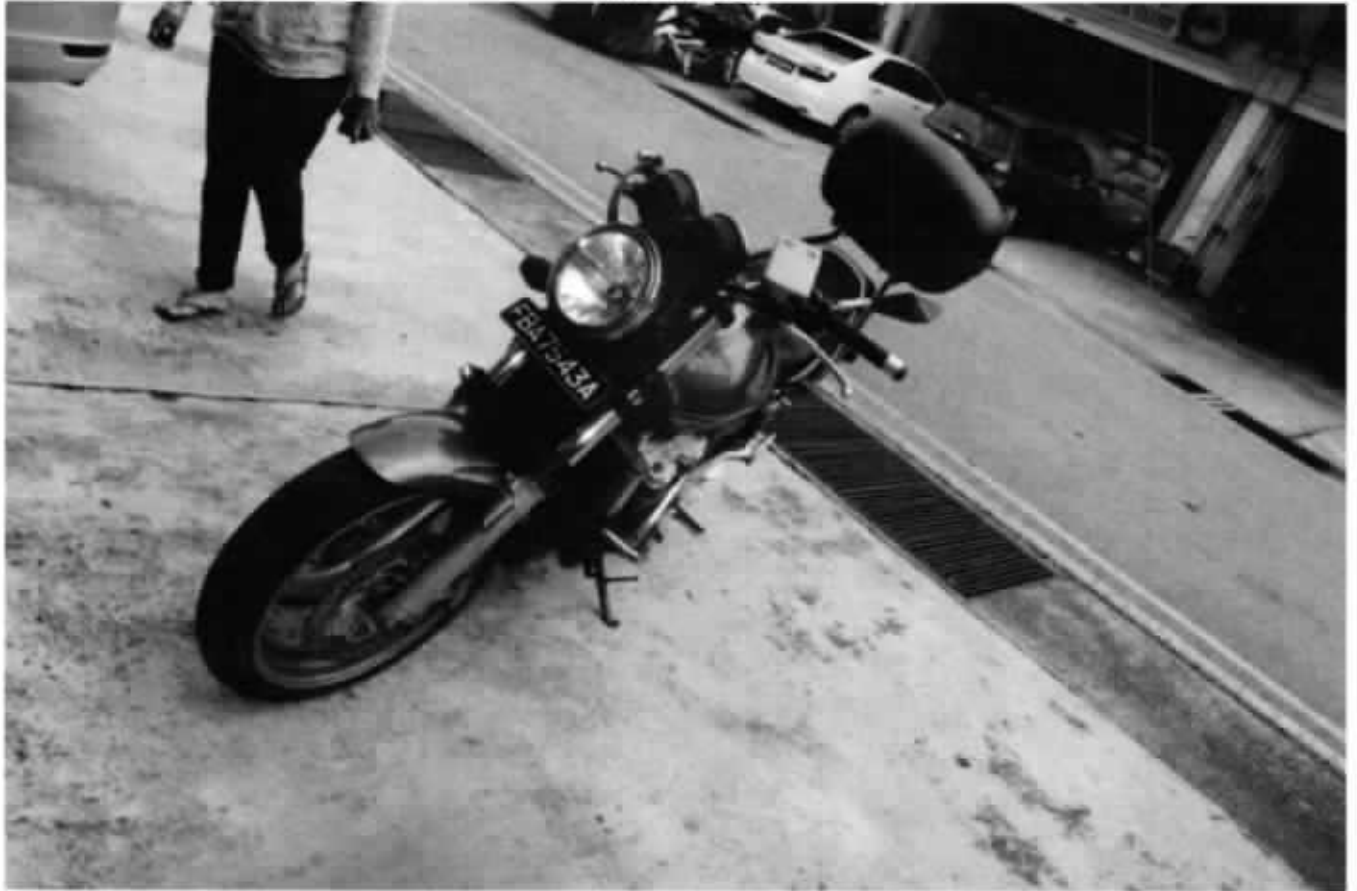
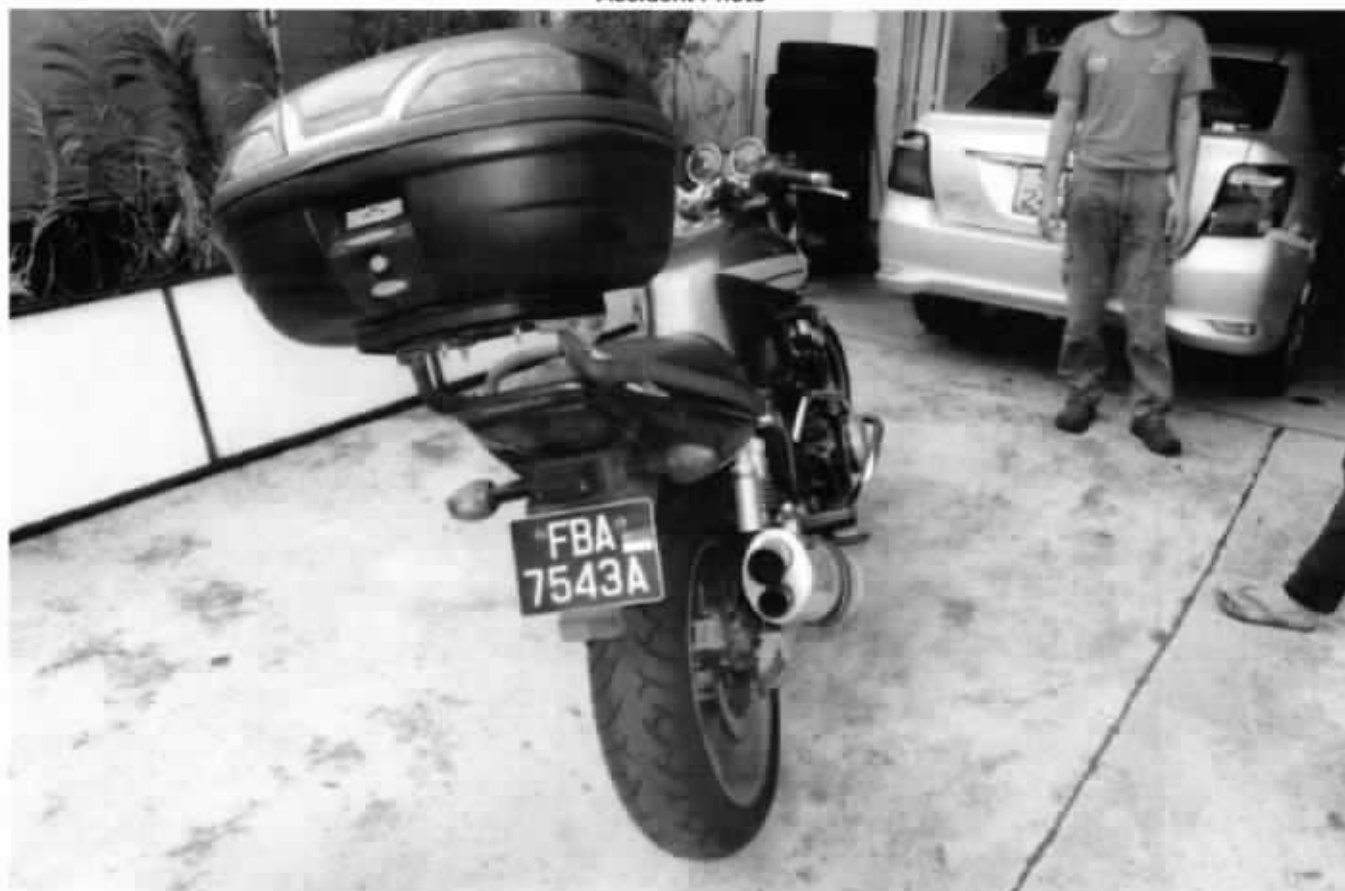
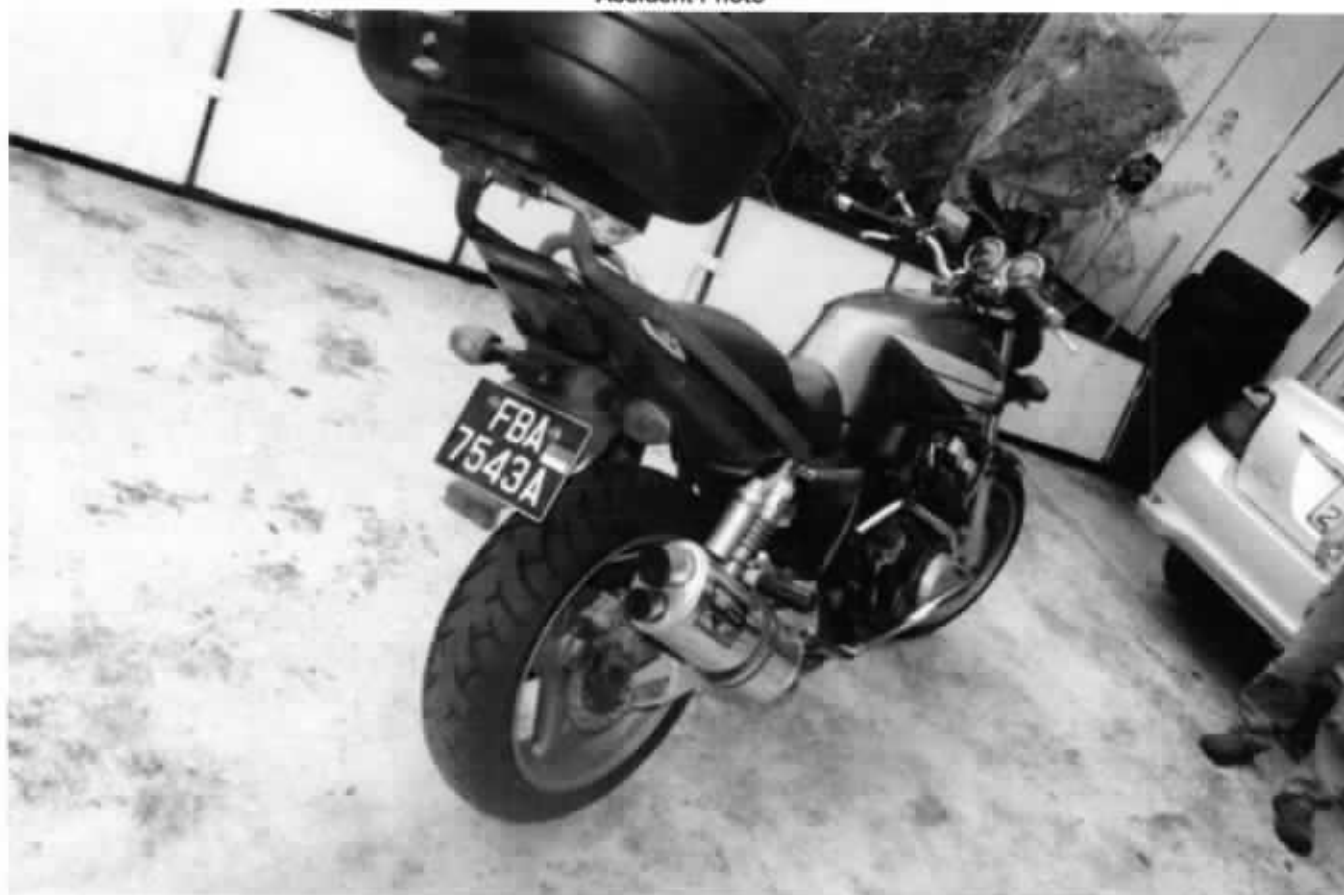
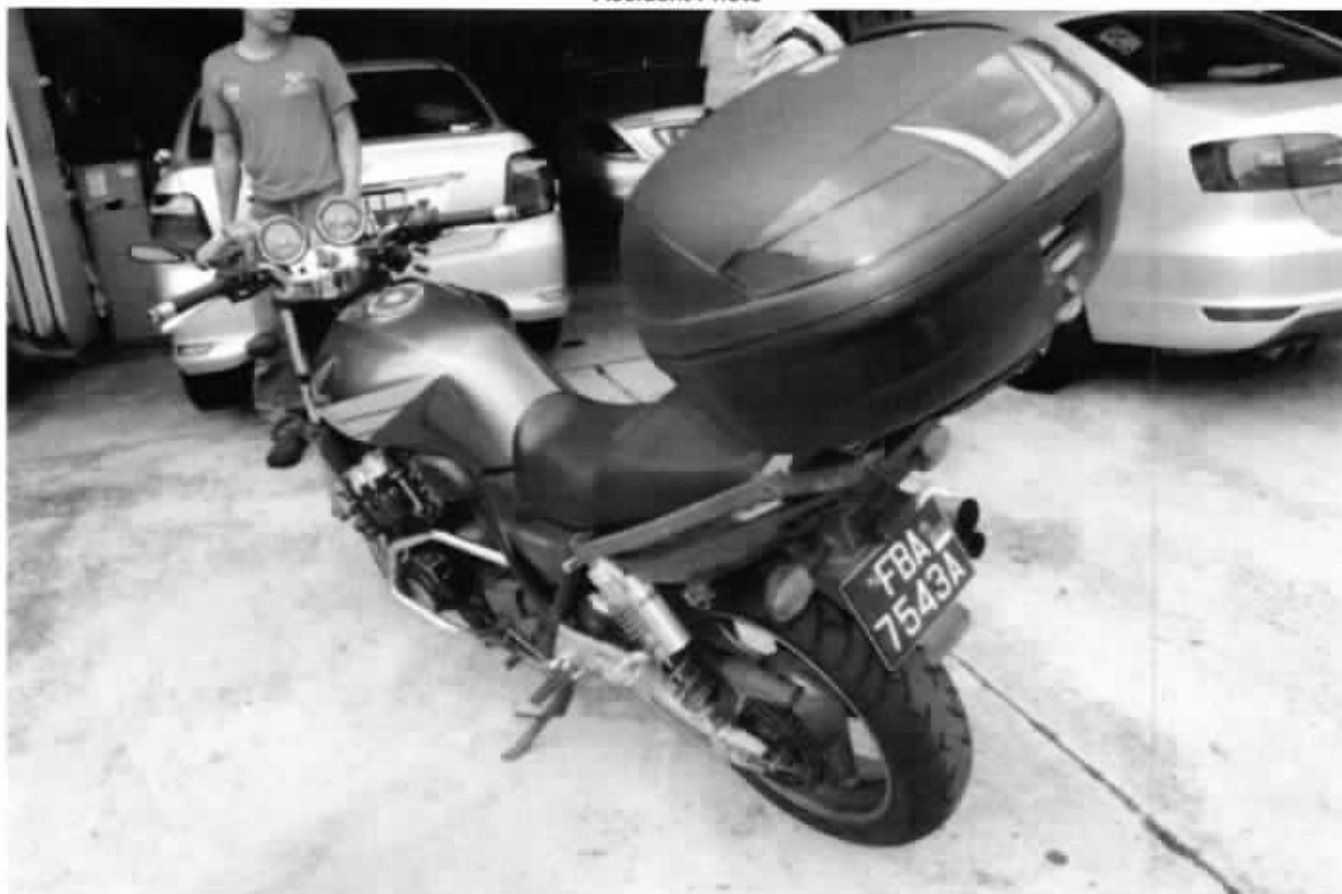
Accident Photo

The vehicle sustained an impact on the front, R/H & L/H portion.

The main body frame, handle bar, fuel tank, forks, wheel rim, exhaust muffler were dented/bent.
