1. Policy Particulars :- THIRD PARTY CLAIM				
Insured Veh.	SMA 8179G	Veh. Inspected	SHC 2312B	
Policy No.		Coverage (\$)	0.00	
Claim No.		Excess (\$)	0.00	
Assign From		Assign Date	02/10/2018

TP Claims against NTUC Income: Follow-Through Survey

THE VEHICLE SUSTAINED DAMAGES AT THE O/S FRONT PORTION. DAMAGES SEE DETAILS.

ADJUSTMENT ON REPAIR COST FOR VEHICLE NO. SHC 2312B

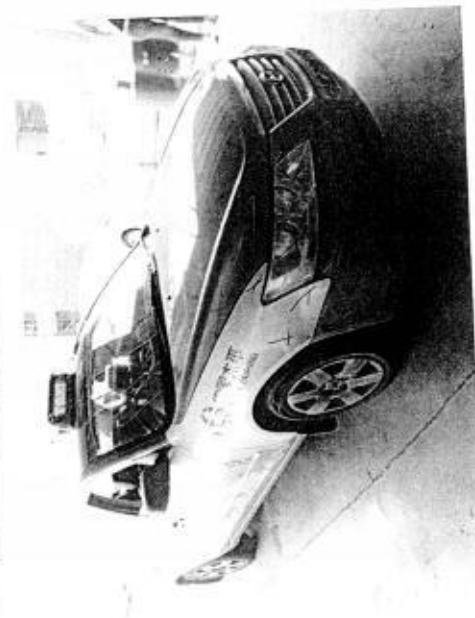
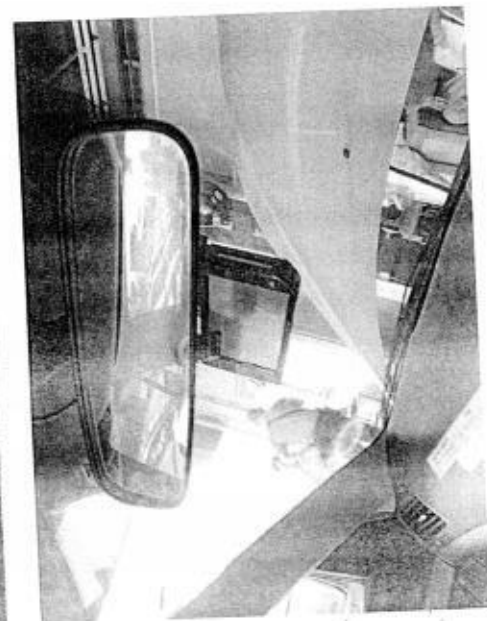
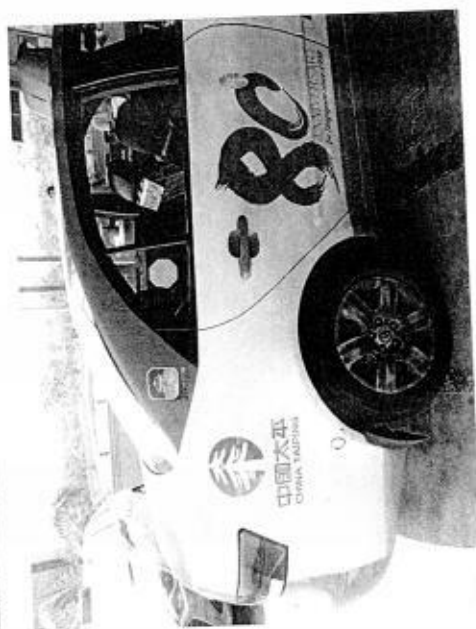
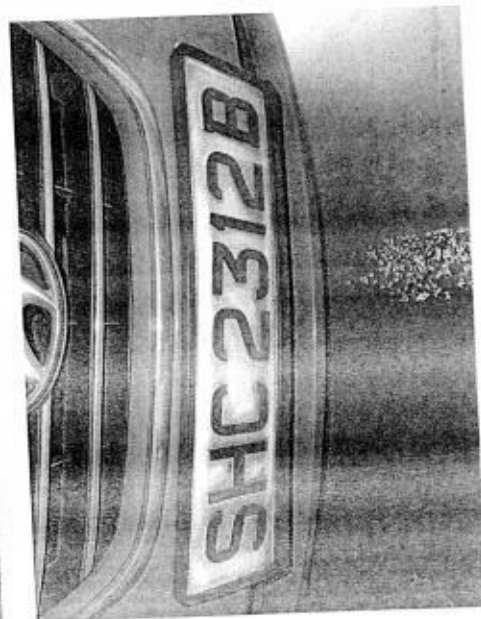
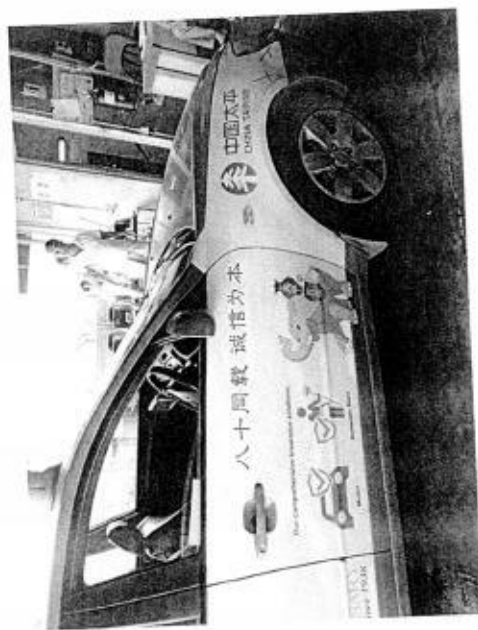
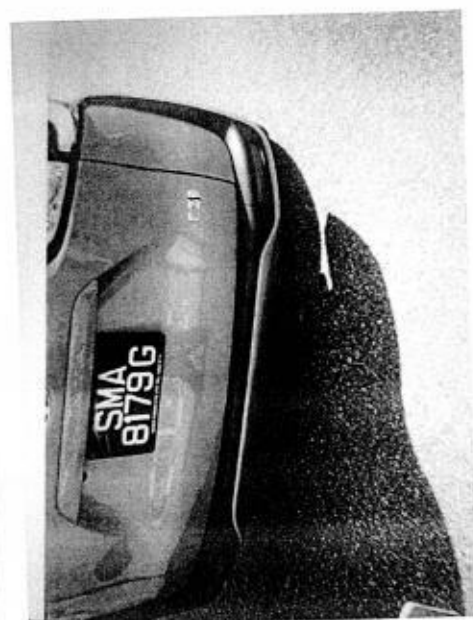
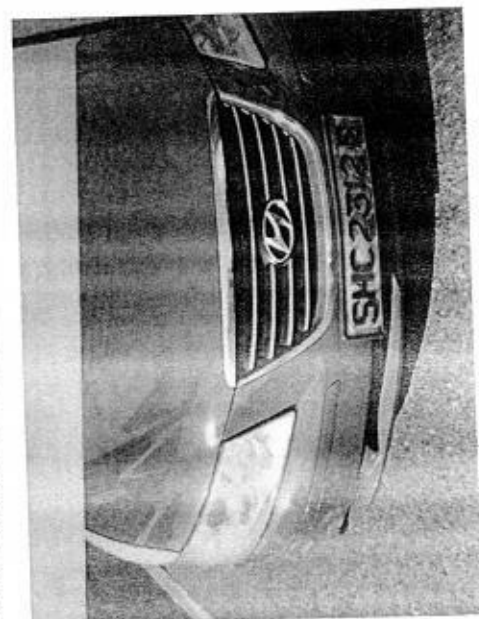
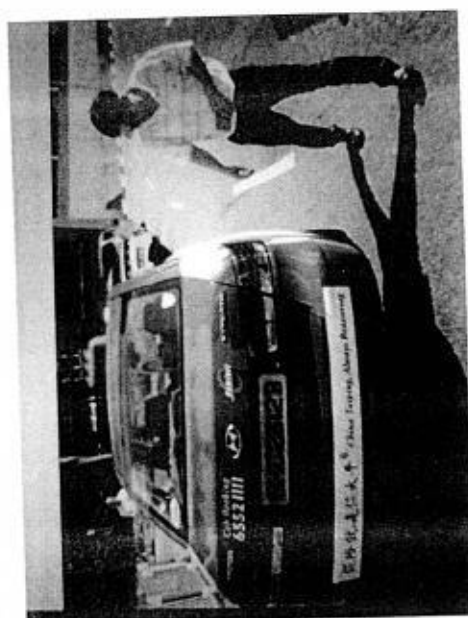
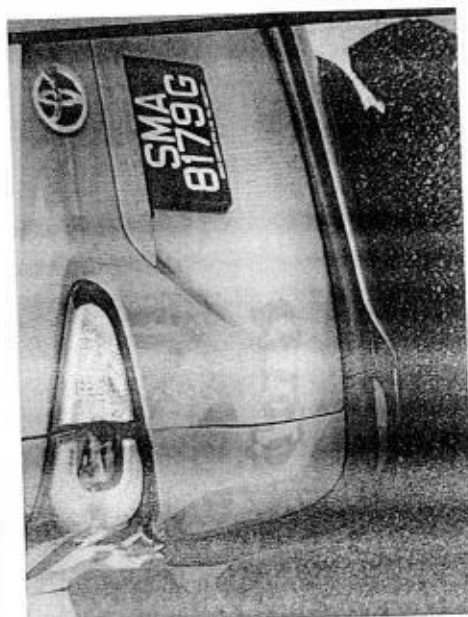
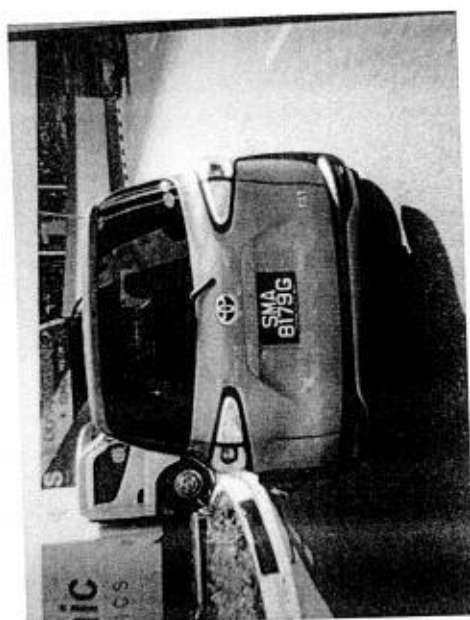
The U/C / Chassis frame / Body Structure affected due to collision.

Qty	Description of Parts	Condition	Estimate By Workshop (\$)	Our Adjusted (\$)
REPLACEMENT OF PARTS				
1	FRONT BUMPER COVER	TO REPAIR SEE LABOUR	538.80	-
1	FRONT BUMPER BRACKET TOP (RH)	SERVICEABLE	22.40	-
1	FRONT BUMPER PROTECTOR (RH)	TO REPAIR SEE LABOUR	29.20	-
1	HEADLAMP (RH)	GRAZED	797.90	797.90
1	FRONT FENDER (RH)	DENTED	593.00	593.00
1	FRONT FENDER SHIELD (RH)	SERVICEABLE	86.00	-
1	FRONT FENDER RETAINER	SERVICEABLE	9.20	-
	LESS 20% DISCOUNT		-415.30	-278.18
			1,661.20	1,112.72
SPECIAL NETT ITEMS				
1	FRONT FENDER ADVERTISEMENT LOGO (RH)(SN)	NECESSARY	100.00	100.00

100.00	100.00
LABOUR				
	PANEL BEATING.INCLUSIVE OF THE REPAIR OF FRONT BUMPER COVER AND FRONT BUMPER PROTECTOR (RH).		440.00	200.00
	SPRAY PAINTING CHARGE.		440.00	400.00
	WIRING CHARGE.		50.00	20.00
	TUFF KOTE.	NOT NECESSARY	50.00	-

980.00	620.00
	GRAND TOTAL		2,741.20	1,832.72
RECOMMENDED COST OF LUMP SUM REPAIRS (TO ITS PRE-ACCIDENT CONDITION)(CONFIRMED)				1,450.00
