NTUC INCOME INSURANCE CO-OPERATIVE LTD Ref: NS/INC18017858/K1qb				
73 BRAS BASAH ROAD #05-01 NTUC TRADE UNION HOUSESINGAPORE 189556			Date: 02-10-2018	
			Code: INC4

TP Claims against NTUC Income: Follow-Through Survey

THE VEHICLE SUSTAINED DAMAGES AT THE N/S FRONT PORTION. DAMAGES SEE DETAILS.

ADJUSTMENT ON REPAIR COST FOR VEHICLE NO. SHC 8166S

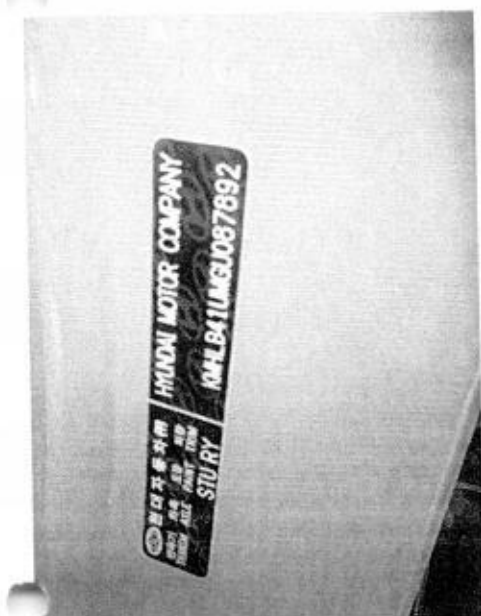
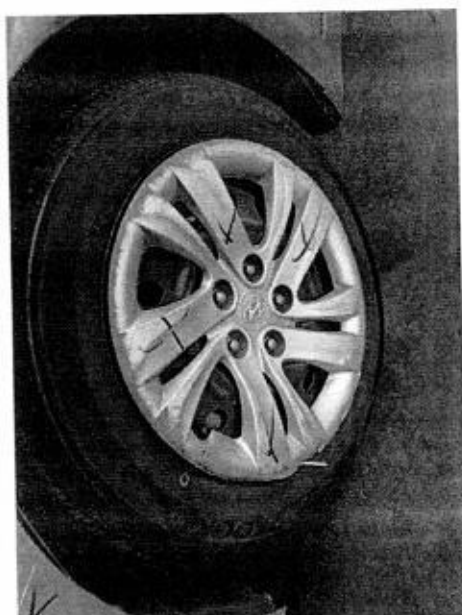
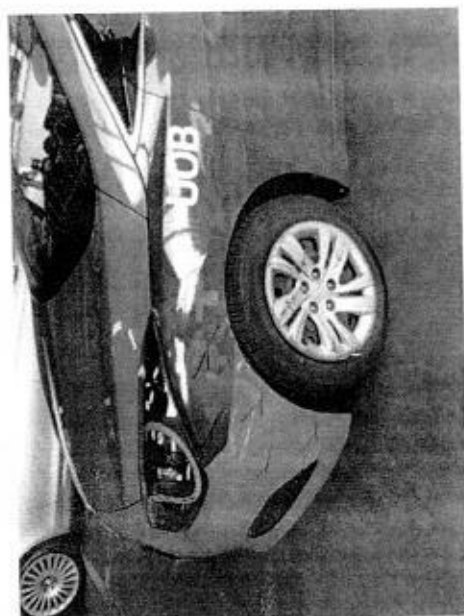
N/S Front

The U/C / Chassis frame / Body Structure affected due to collision.

Qty	Description of Parts	Condition	Estimate By Workshop (\$)	Our Adjusted (\$)
<u>REPLACEMENT OF PARTS</u>				
1	FRONT BUMPER COVER	DEFORMED	544.50	544.50
1	FRONT BUMPER BRACKET TOP (LH)	SERVICEABLE	22.40	-
1	FRONT BUMPER BRACKET (LH)	SERVICEABLE	24.60	-
1	FRONT FENDER (LH)	DENTED	566.30	566.30
1	FRONT FENDER SHIELD (LH)	SERVICEABLE	175.90	-
1	FRONT FENDER RETAINER	SERVICEABLE	24.60	-
1	FRONT WHEEL RIM (LH)	SERVICEABLE	325.30	-
1	FRONT WHEEL HUB CAP (LH)	GRAZED	107.10	107.10
	LESS 20% DISCOUNT		-358.14	-243.58
			1,432.56	974.32
<u>SPECIAL NETT ITEMS</u>				
1	FRONT NUMBER PLATE (SN)	SERVICEABLE	25.00	-
1	FRONT NO PLATE TRIM COVER (SN)	SERVICEABLE	30.00	-
1	FRONT FENDER ADVERTISEMENT LOGO (LH)(SN)	NECESSARY	100.00	100.00

155.00	100.00
<u>LABOUR</u>				
	PANEL BEATING.		440.00	300.00
	SPRAY PAINTING CHARGE.		440.00	400.00
	TUFF KOTE.		50.00	30.00
	FRONT WHEEL ALIGNMENT.	NOT NECESSARY	80.00	-
			1,010.00	730.00
GRAND TOTAL			2,597.56	1,804.32
RECOMMENDED COST OF LUMP SUM REPAIRS (TO ITS PRE-ACCIDENT CONDITION) (CONFIRMED)				1,450.00
