OD/TP Re-inspection / Evaluation

Vehicle Inspection Report

Report No: AAS/2018/152

Registration no: SKH9565E
Make/Model: BMW 316i (A)
Year of registration: 2012/16
Colour: Metallic Black

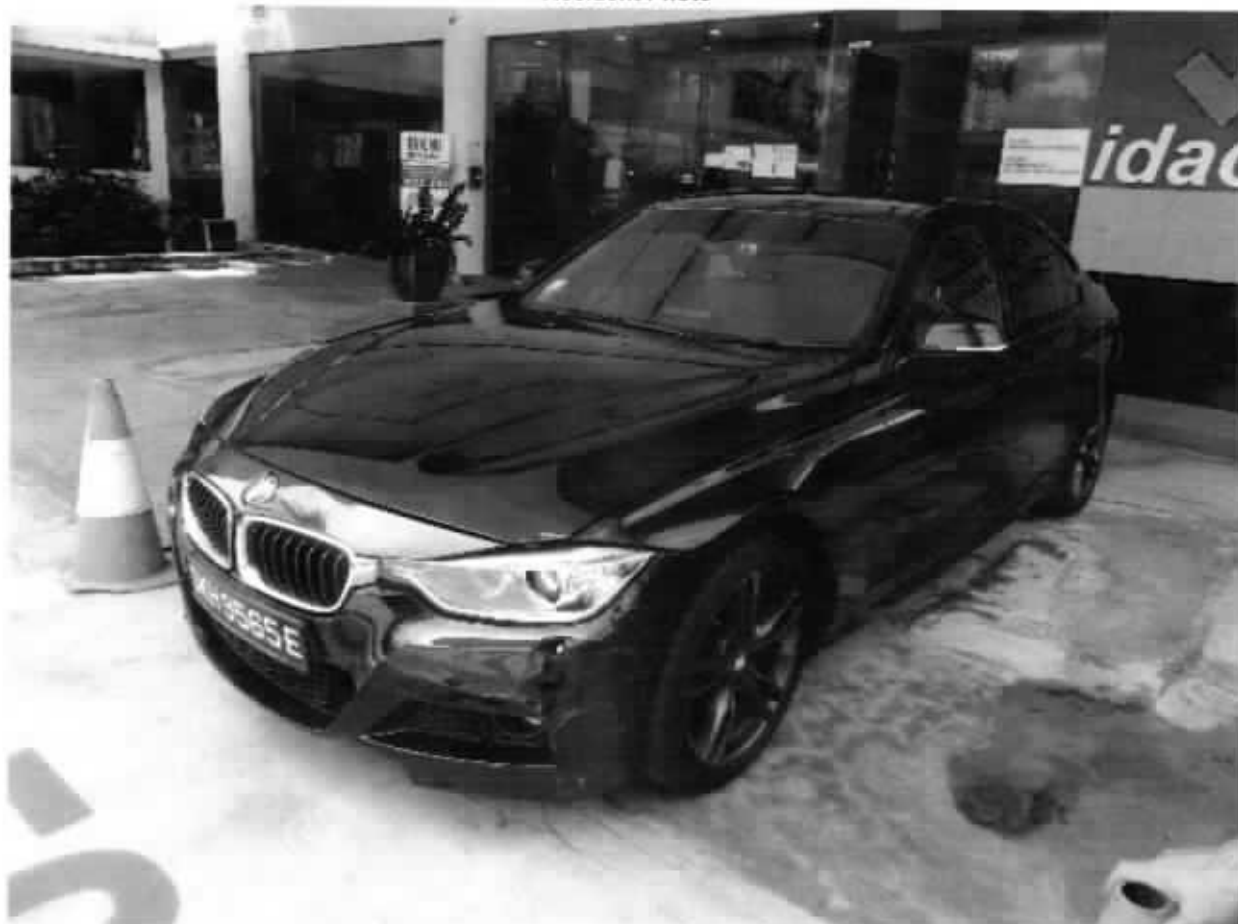
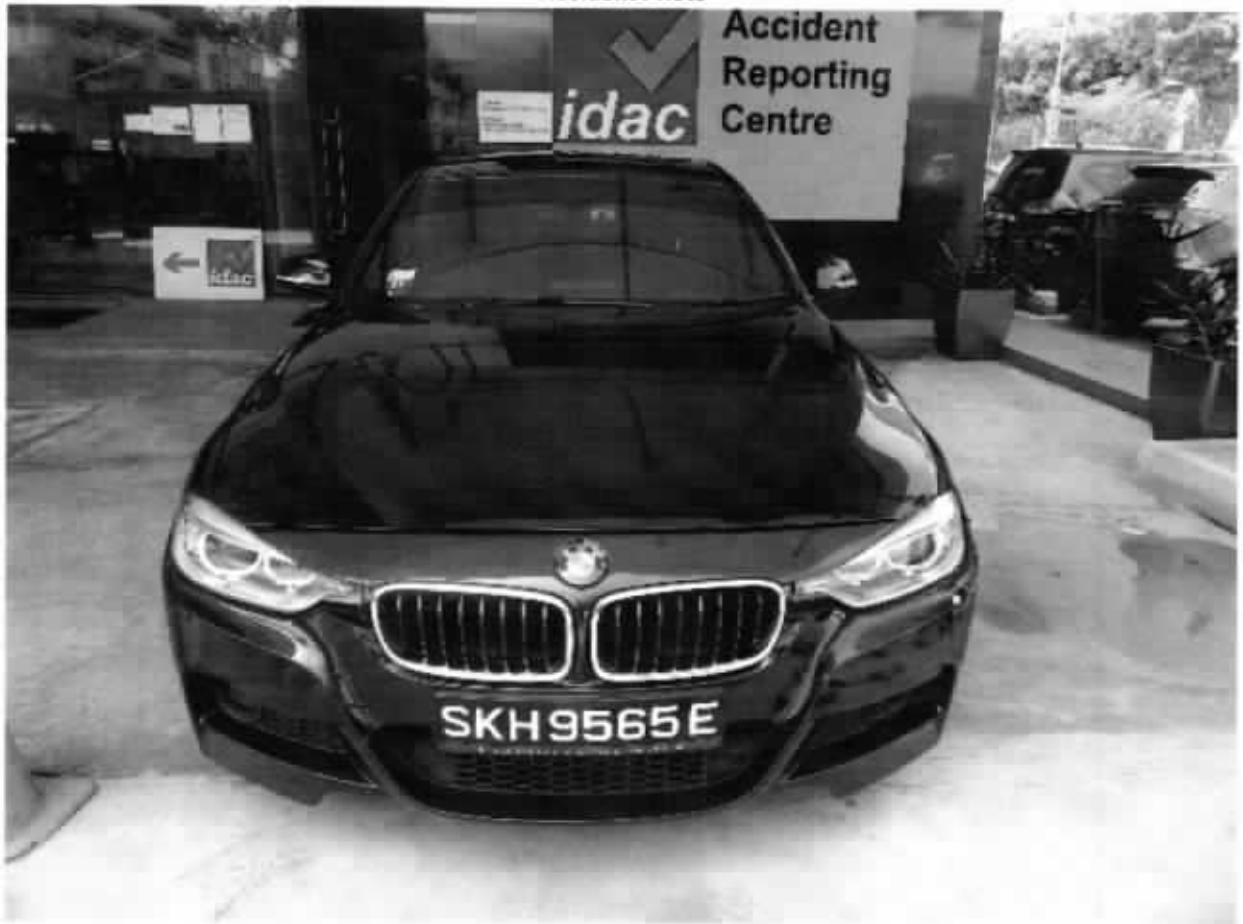
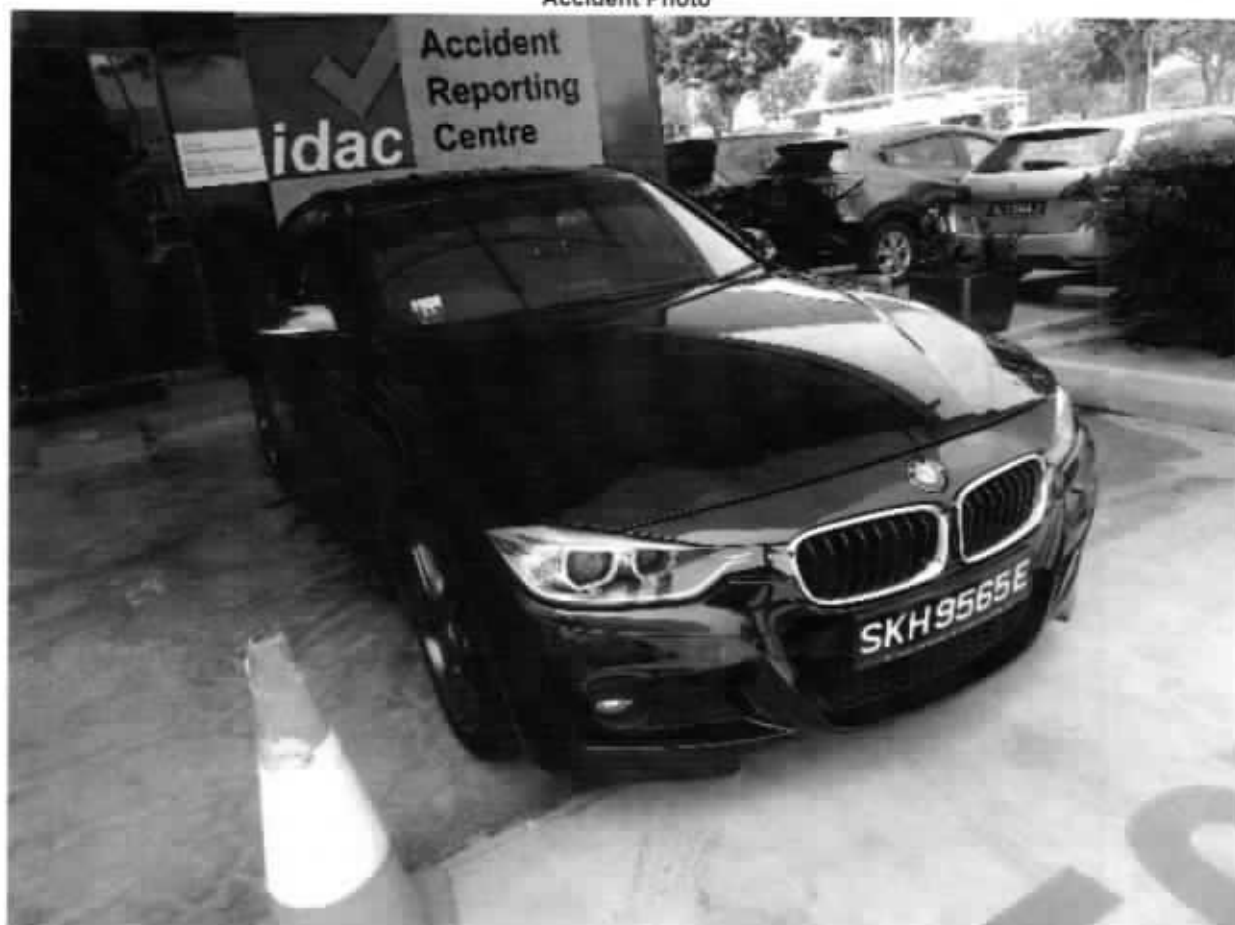
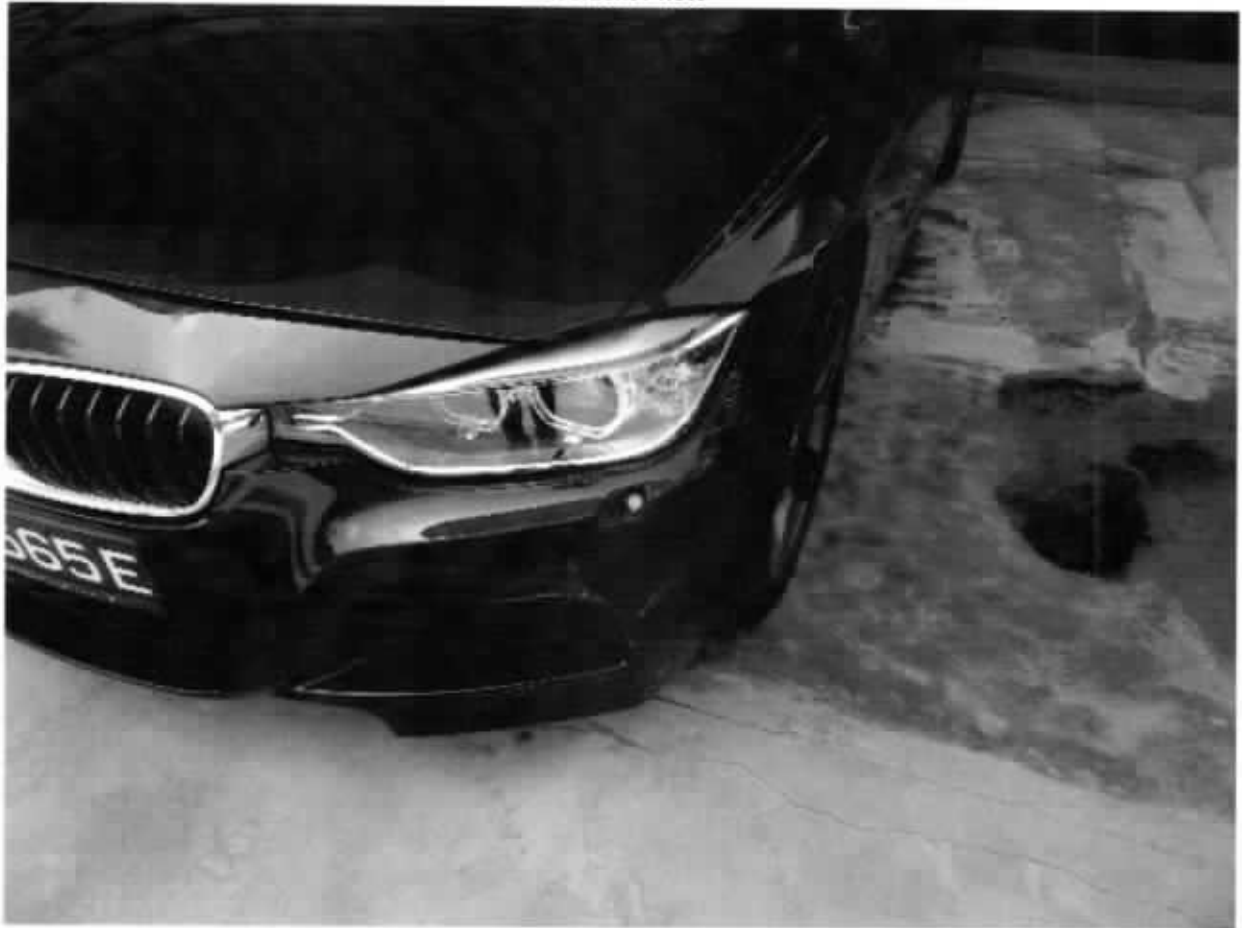
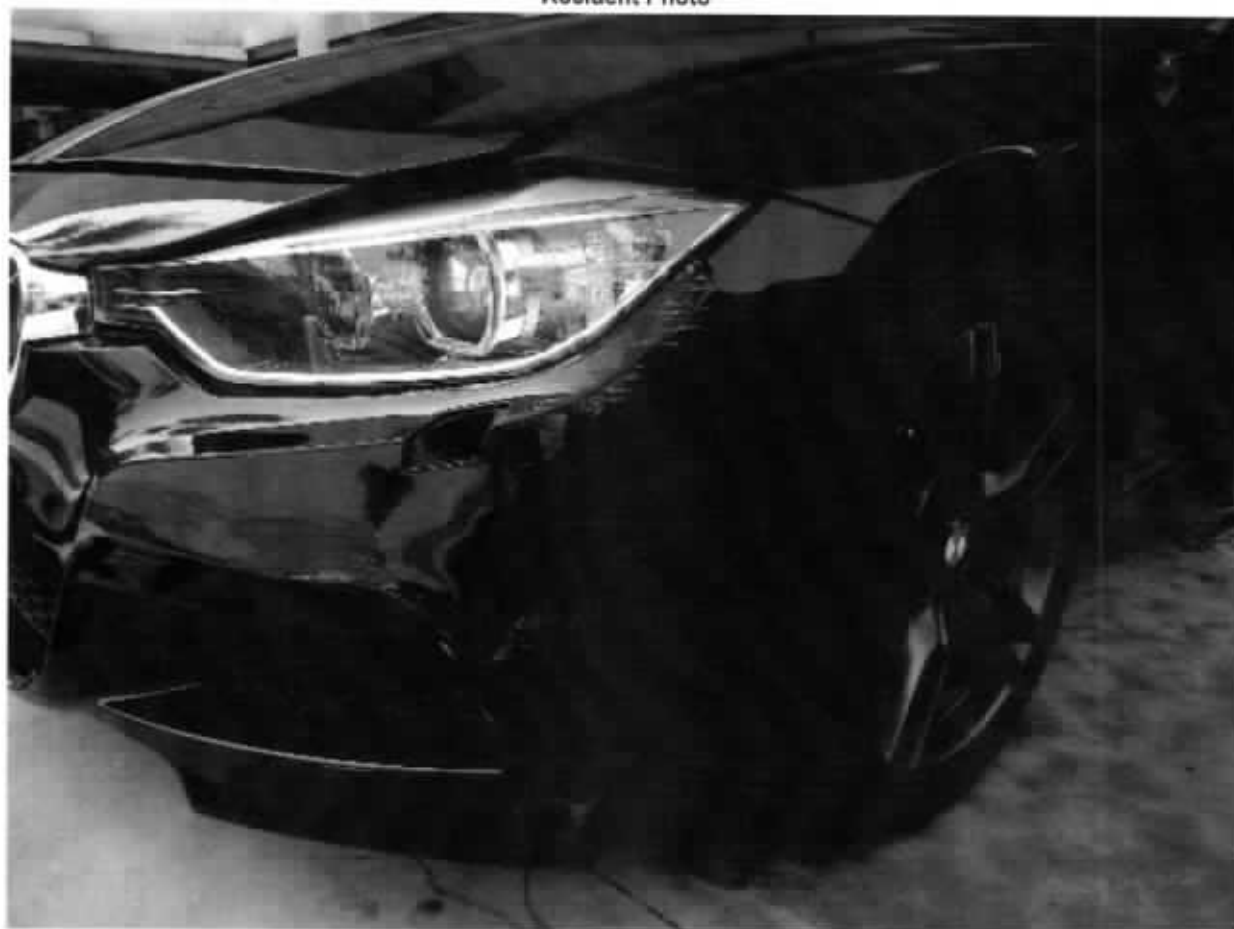
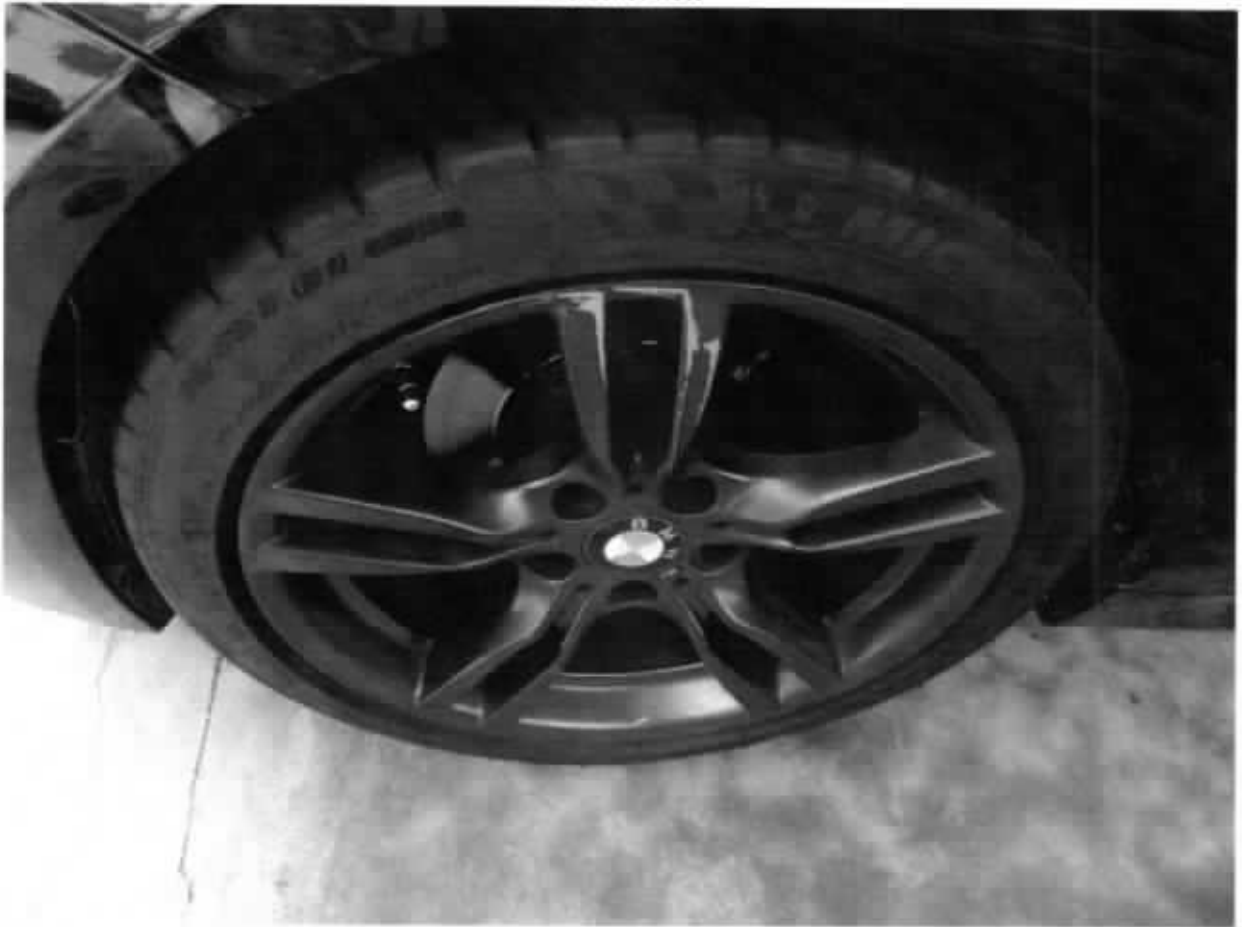
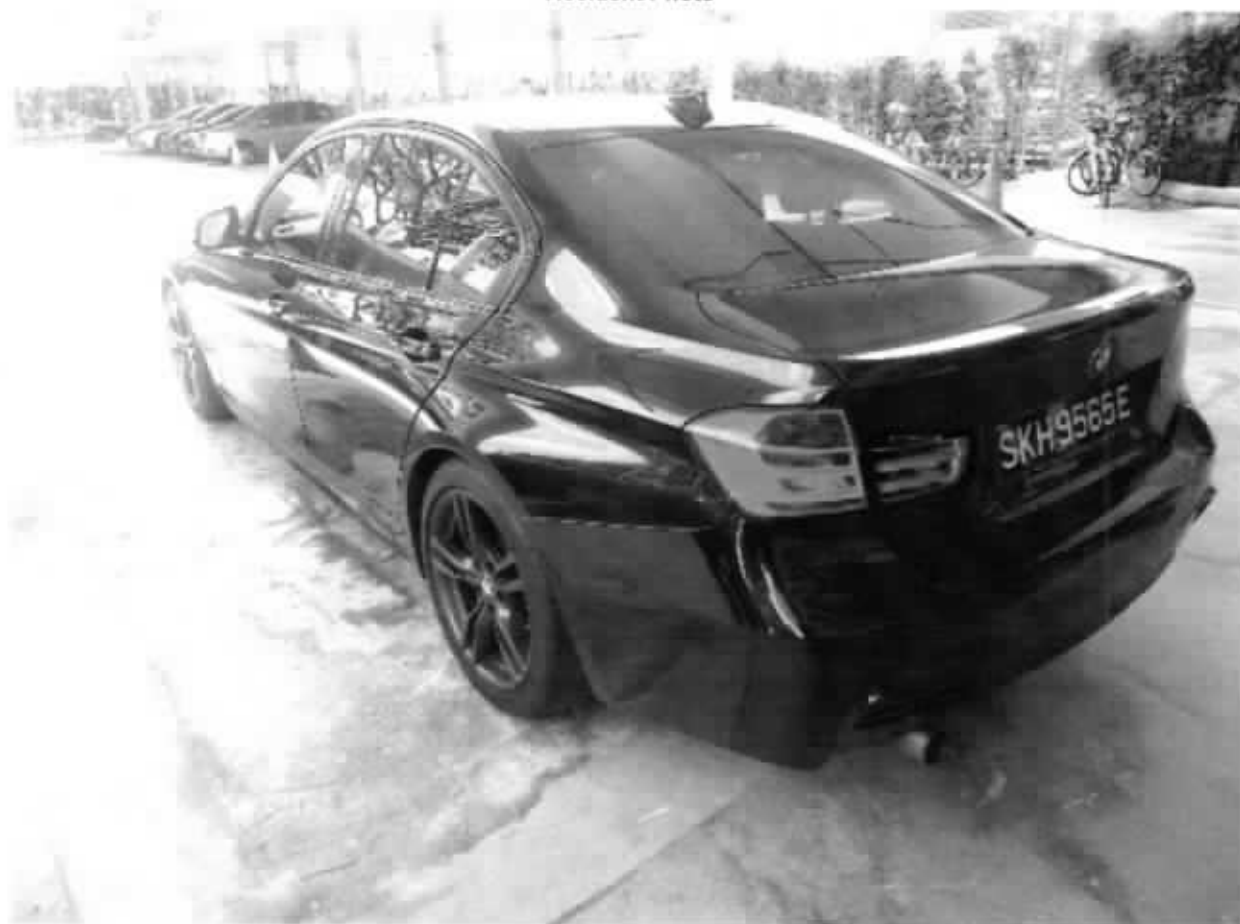
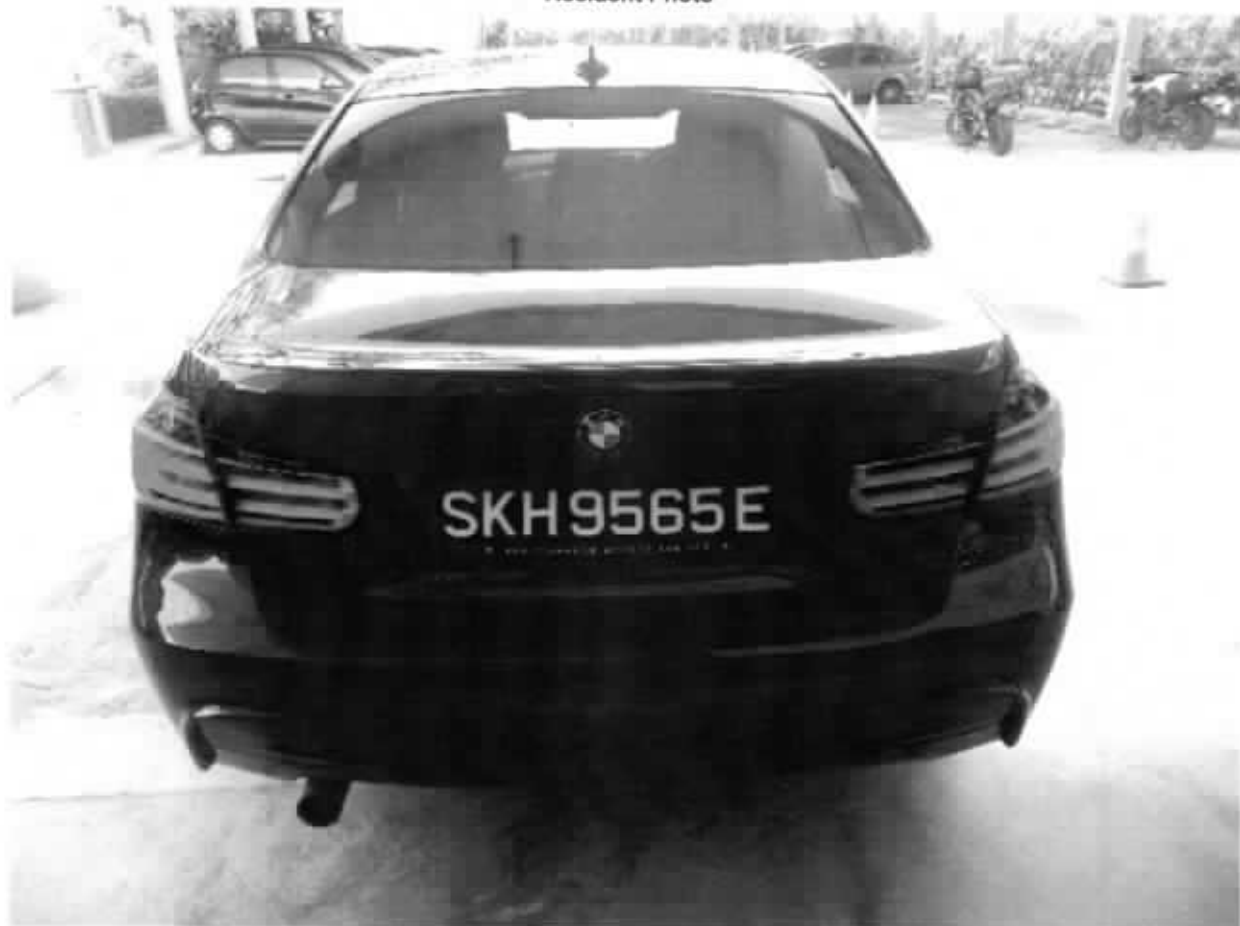
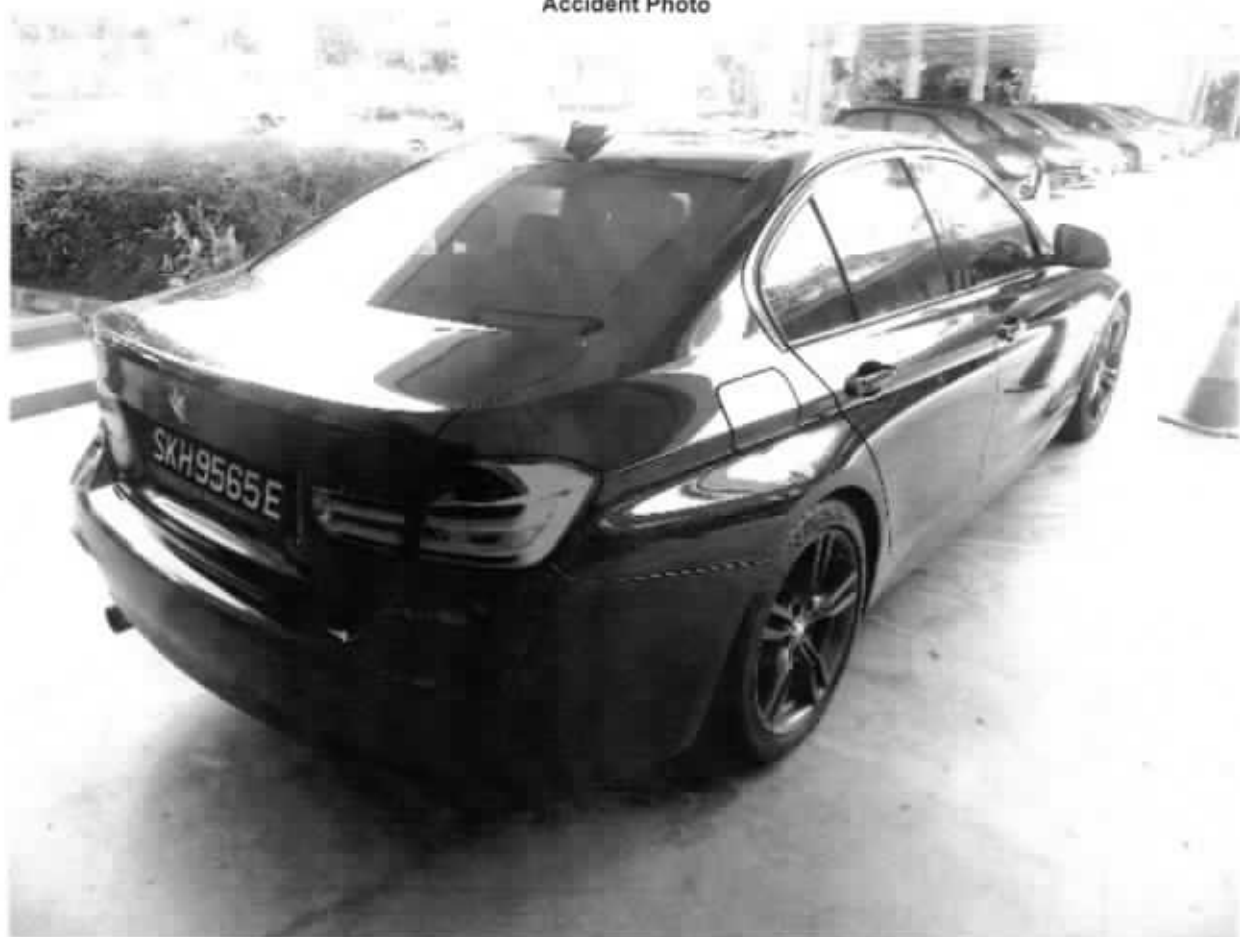
Accident Photo

Point of impact

At the LHF portion.

The bonnet, front bumper, headlamps, LHF fender, LHF road rim, LHF undercarriages, etc.

The repairer has agreed to undertake the repair at a lumpsum of SGD \$14,600.00
