Your Ref: SDZ 8008S
Our Ref : CI/TP18018087/D

05 October 2018

INSPECTION REPORT OF MOTOR CAR SDZ 8008S

**Requested By
Performance Motors Limited
303 Alexandra Road
Sime Darby Performance Centre
Singapore 159941**

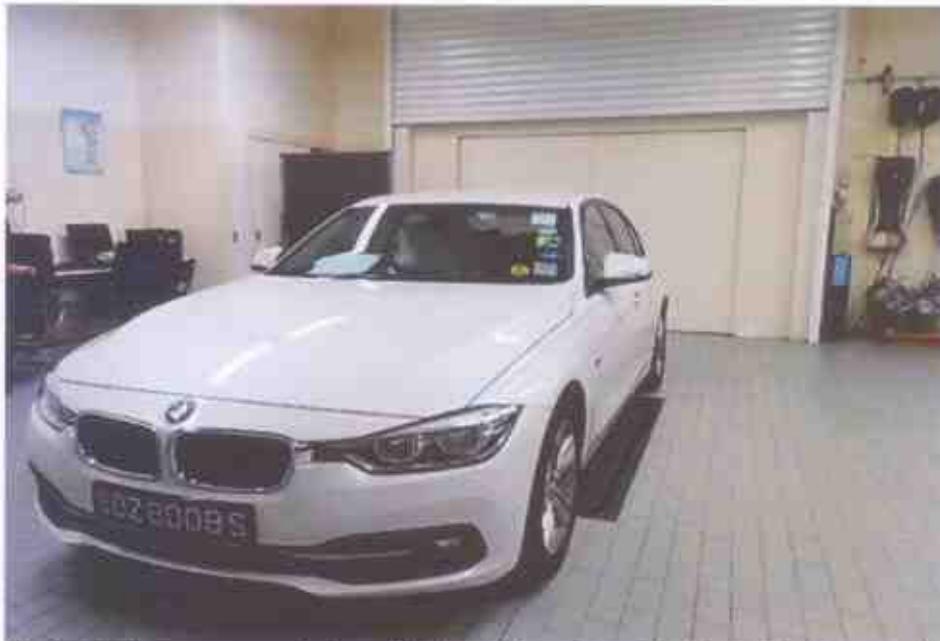
Photo 1 shows a general view of Subject Motor Car at the time of my inspection on 10 September 2016. The mileage recorded was 29,822km.

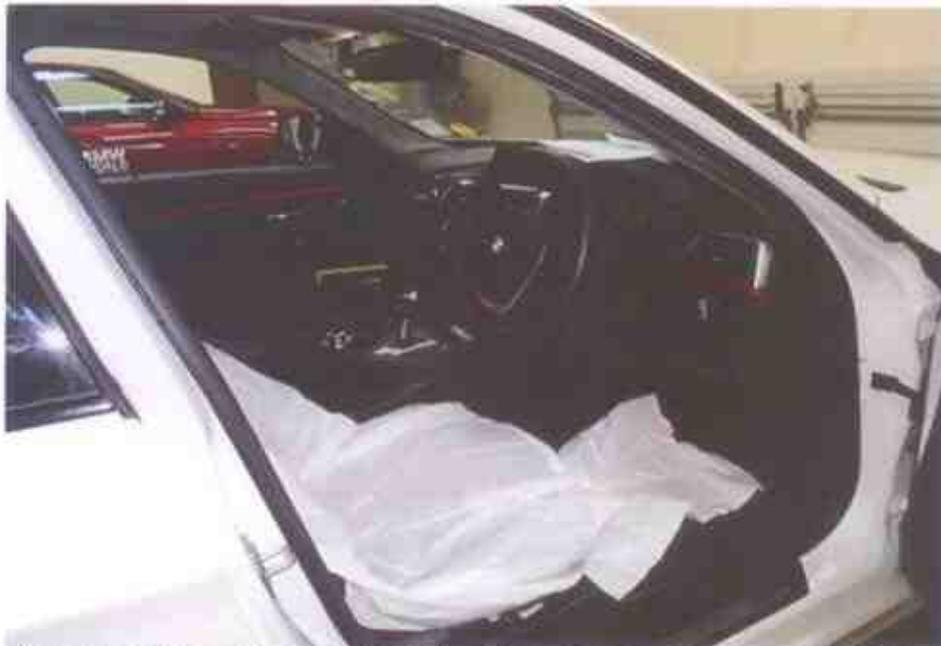
Photo 2 shows a general view of the passenger compartment of the Subject Motor Car at the time of my inspection on 10 September 2018.

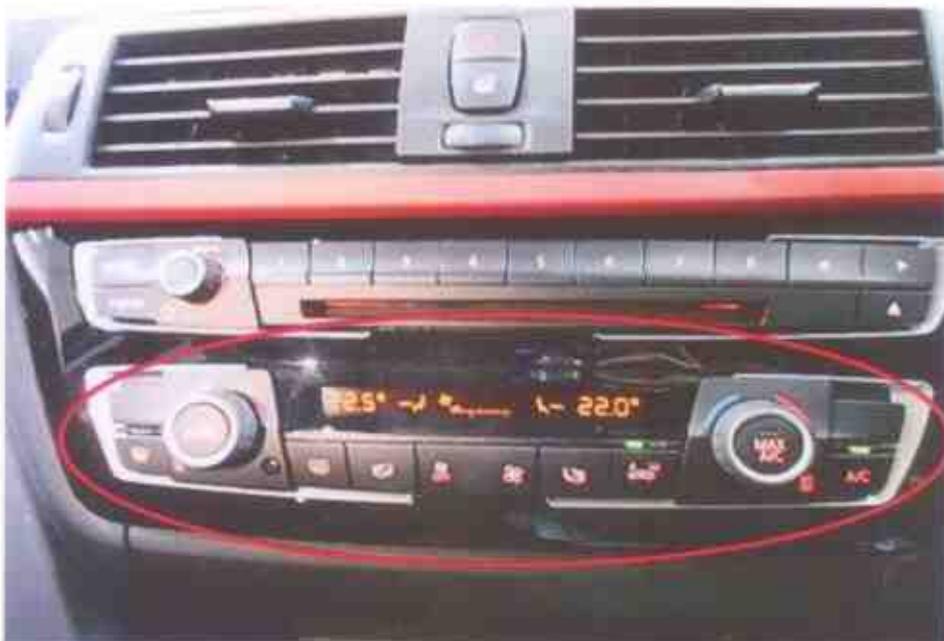
21. The blower speed was then reduced back to low speed (1 bar) and this time, I had put my ears directly at the outlet of the air conditioning vents at the centre of the dashboard panel. Some sounds akin to "water flowing through pipe" sound was faintly heard. The blower speed was then progressively increased and the "water flowing through pipe" sound was gradually covered by the air blowing sounds as the blower speed increases. See photo 1 - 3 below.

Photo 3 shows a general view of the control panel (circled) for the air conditioning system of the Subject Motor Car.

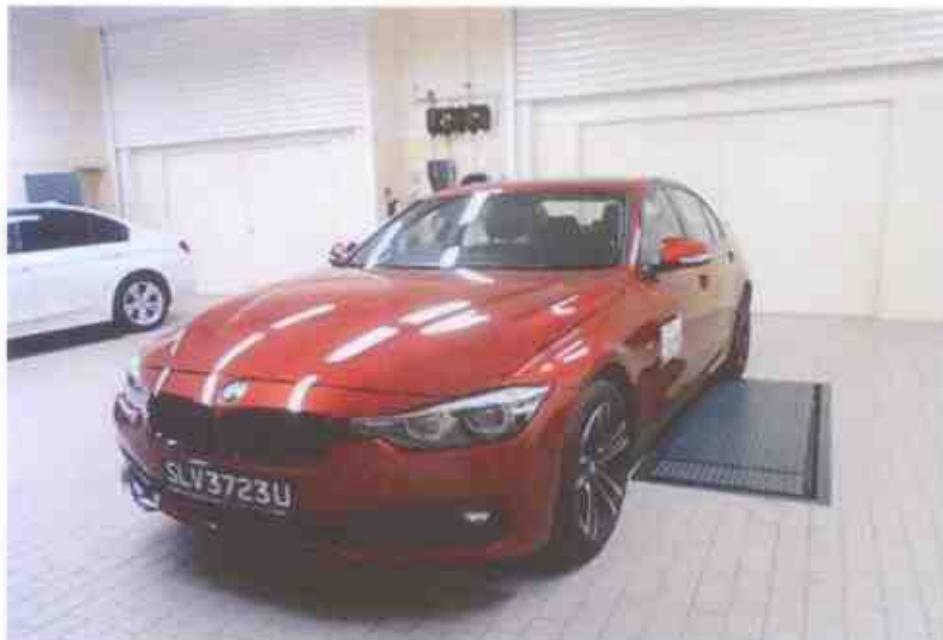
Photo 4 shows a general view of Comparison Motor Car at the time of my inspection on 10 September 2018. The mileage recorded was 3,492km.

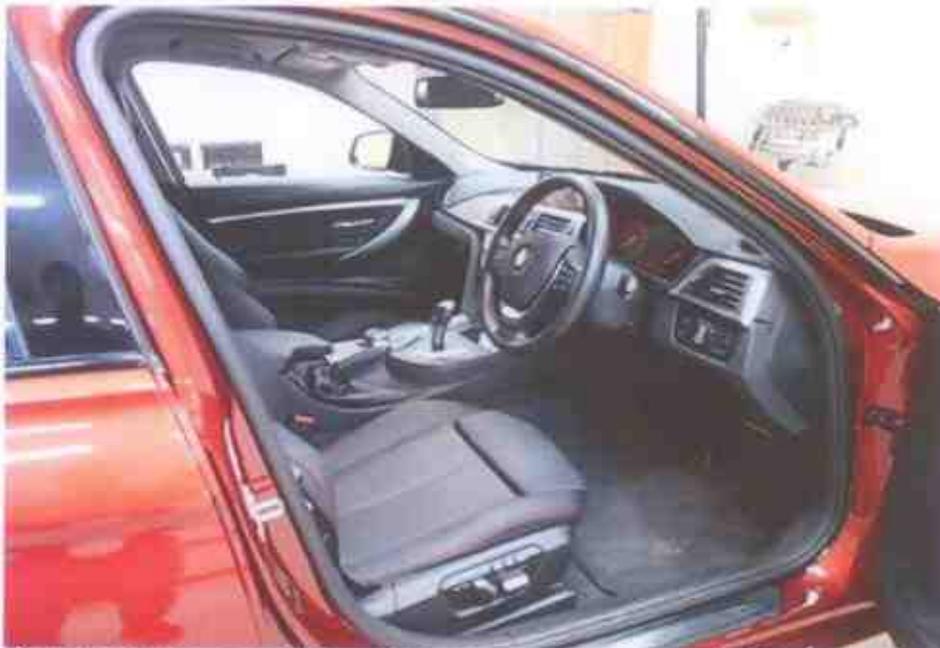
Photo 5 shows a general view of the passenger compartment of the Comparison Motor Car at the time of my inspection on 10 September 2018.

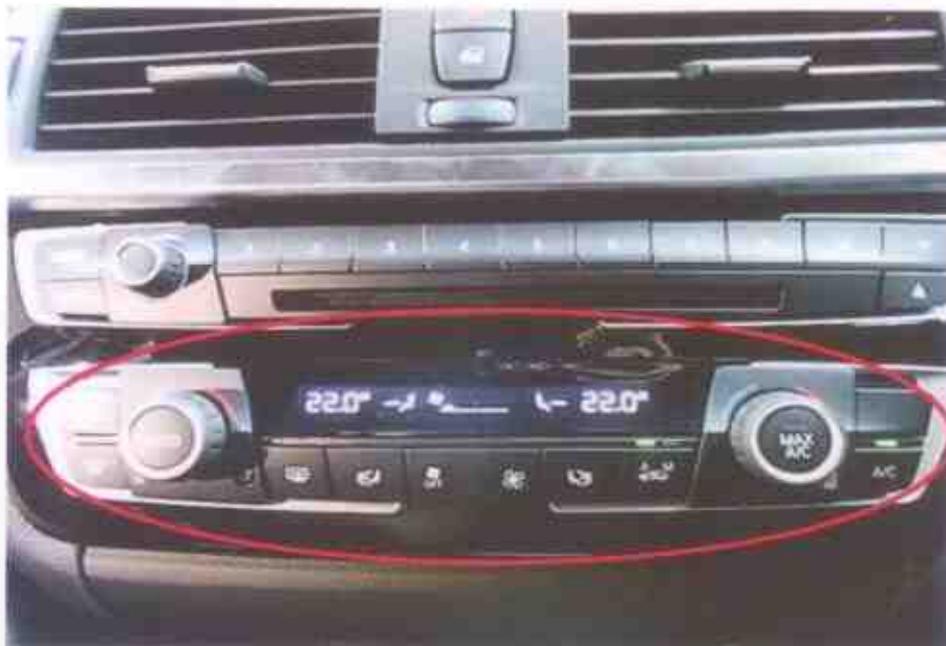
23. Whilst seating on the driver seat in a normal driving position with the engine running, I switched on the air conditioning system with the blower speed turned to low speed (1 bar). The same "water flowing through pipe" like sound was heard. The sound was more audible as compared to the Subject Motor Car. I did not need to put my ears directly at the outlet of the air conditioning vents to hear this sound.

Photo 6 shows a general view of the control panel (circled) for the air conditioning system of the Comparison Motor Car.

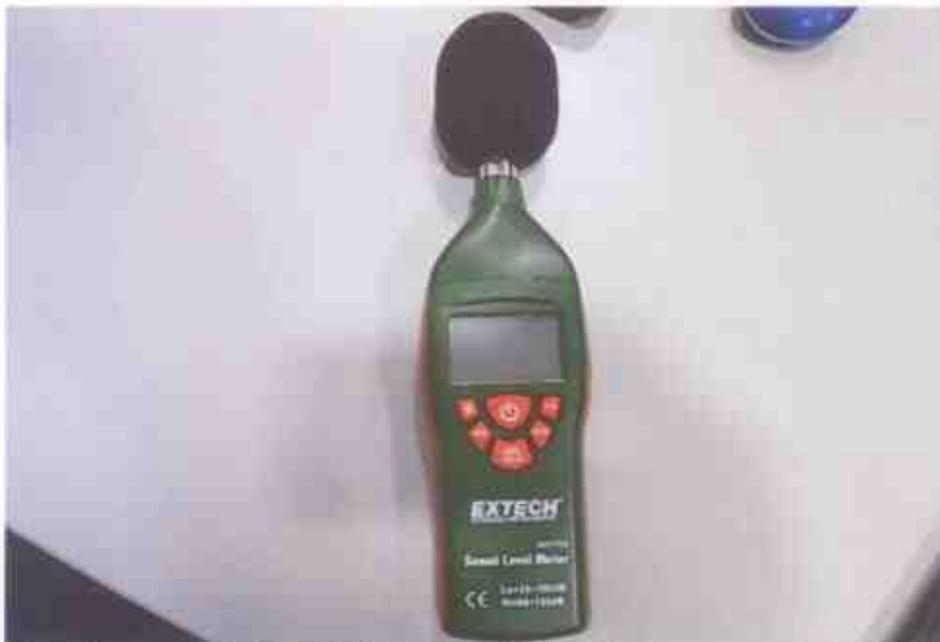
25. The equipment used to measure the sound level emitting from the air conditioning vents of the Subject Motor Car and the Comparison Motor Car as part of the Sound Measurement Tests was a Extech Sound Level Meter (herein referred to as "**Sound Recording Equipment**"), which was calibrated prior to the start of the Sound Measurement Tests. See photo 7 below.

Photo 7 shows the Extech Sound Level Meter that was used in the Sound Measurement Tests to measure the sound level emitting from the air conditioning vents of the Subject Motor Car and the Comparison Motor Car. The meter was calibrated prior to the Sound Measurement Tests.

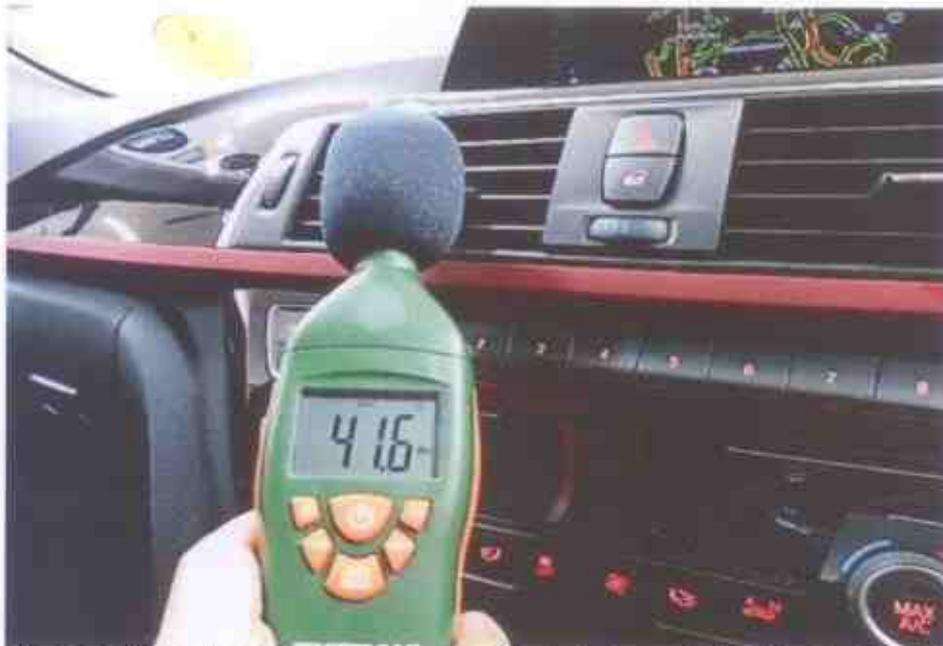
26. The Sound Measurement Tests were carried out by placing the Sound Recording Equipment directly at the outlet of the air conditioning vents at the centre of the dashboard panel of the Subject Motor Car and the Comparison Motor Car. The peak sound level was then recorded when the air conditioning system was switched on from a low speed (1 bar) to medium speed and to high speed.
27. I wish to highlight that the Sound Recording Equipment will also record other sounds from within the passenger compartment, in particular the air blowing sounds emitting from the air conditioning vents. Purely isolating the "water flowing through pipe" sound that I heard was not possible. See photo 8 & 9 below.

Photo 9 shows the Sound Measurement Tests being carried out to the Subject Motor Car using the Exttech Sound Level Meter. The Sound Measurement Tests were carried out by placing the Sound Recording Equipment directly at the outlet of the air conditioning vents at the centre of the dashboard panel of the Subject Motor Car.

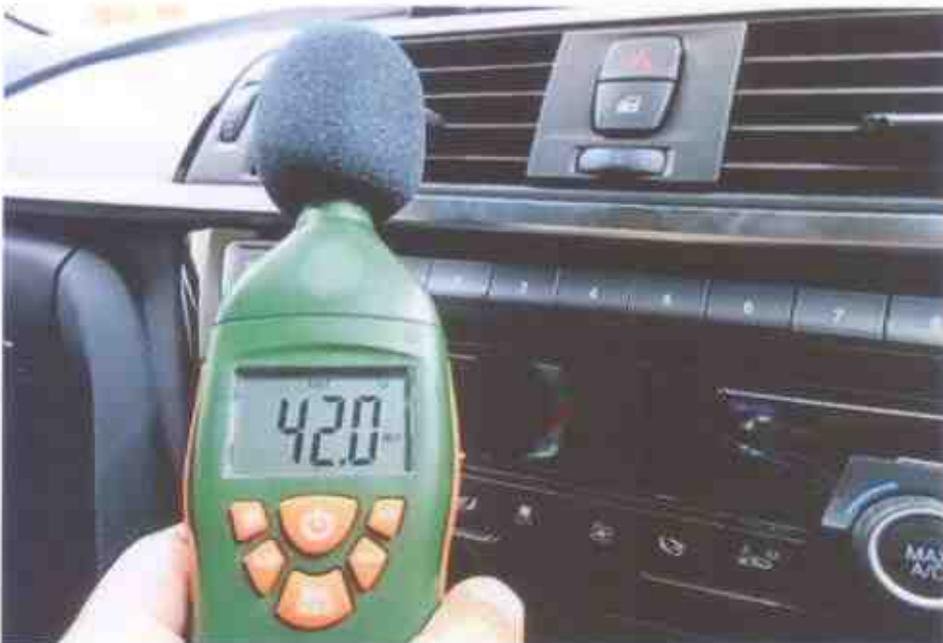
Photo 10 shows the Sound Measurement Tests being carried out to the Comparison Motor Car using the Exttech Sound Level Meter. The Sound Measurement Tests were carried out by placing the Sound Recording Equipment directly at the outlet of the air-conditioning vents at the centre of the dashboard panel of the Comparison Motor Car, a similar method to the Subject Motor Car.

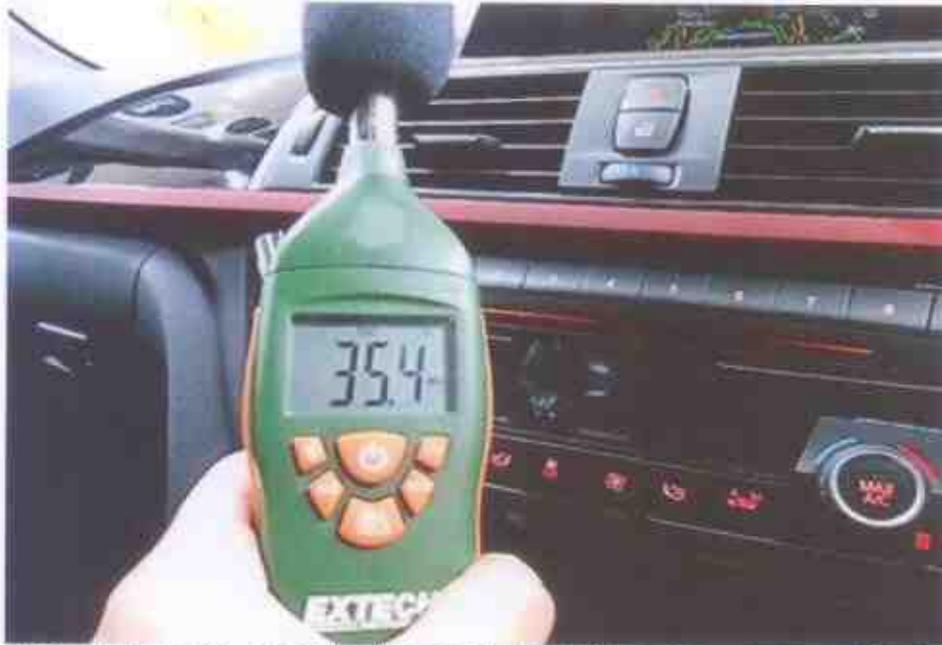
Photo 1 shows the sound level recorded when the engine and air conditioning system of the Subject Motor Car was switched off.

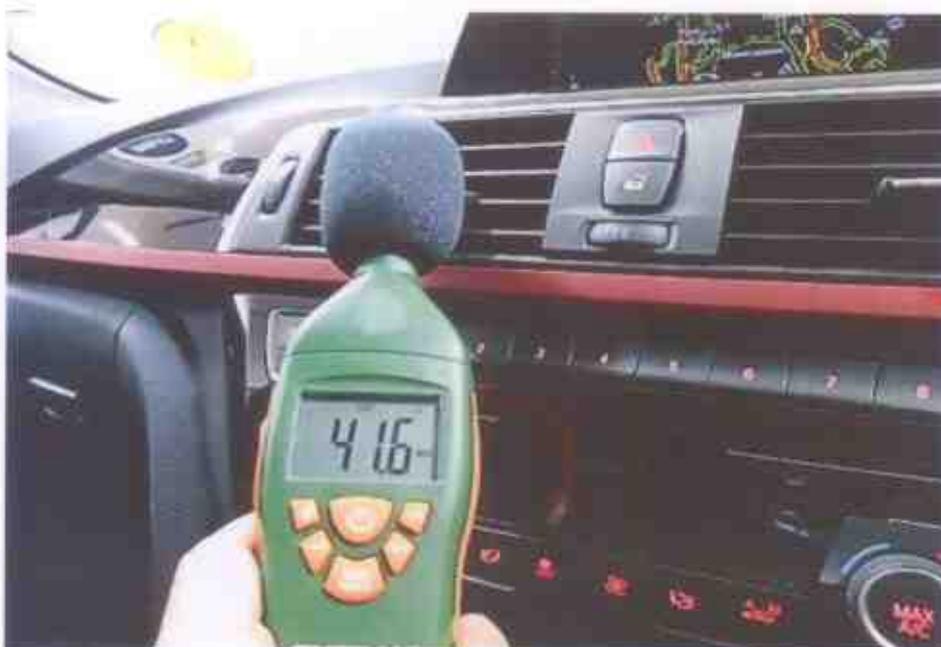
Photo 2 shows the sound level recorded when the engine of the Subject Motor Car was switched on, but air conditioning system switched off.

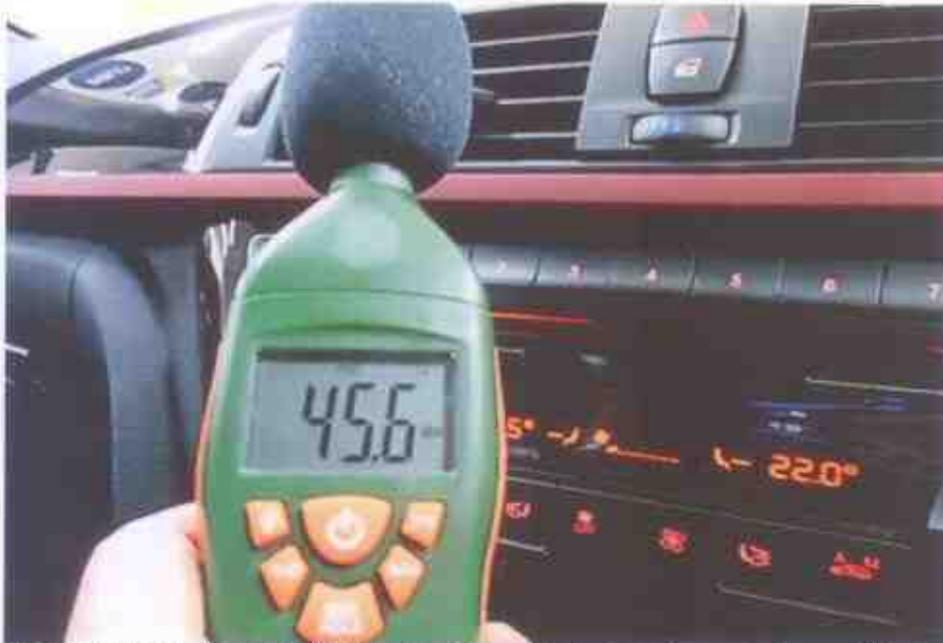
Photo 3 shows the sound level recorded when the engine and air conditioning system of the Subject Motor Car switched on with blower speed 1.

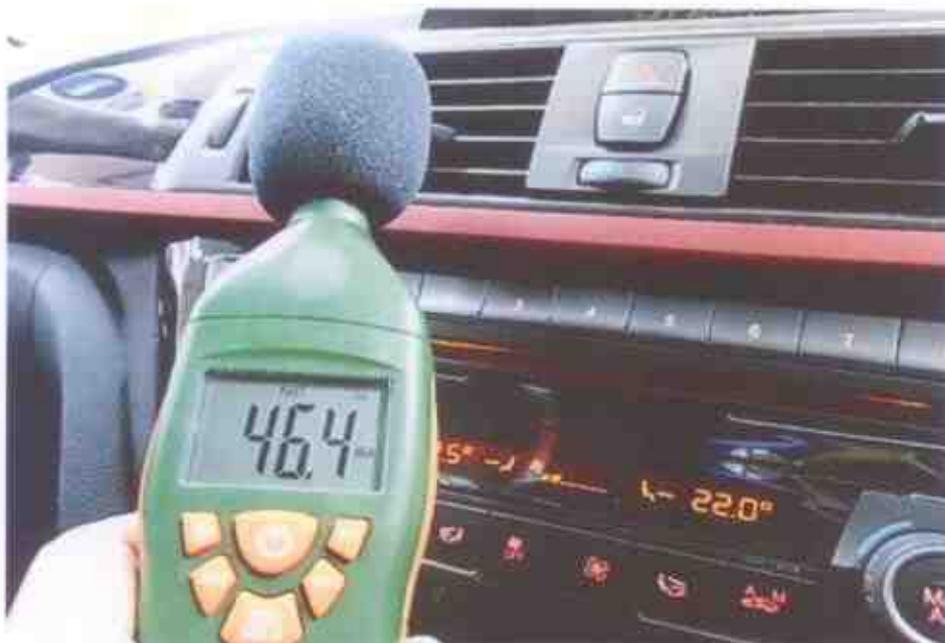
Photo 4 shows the sound level recorded when the engine and air conditioning system of the Subject Motor Car switched on with blower speed 2.

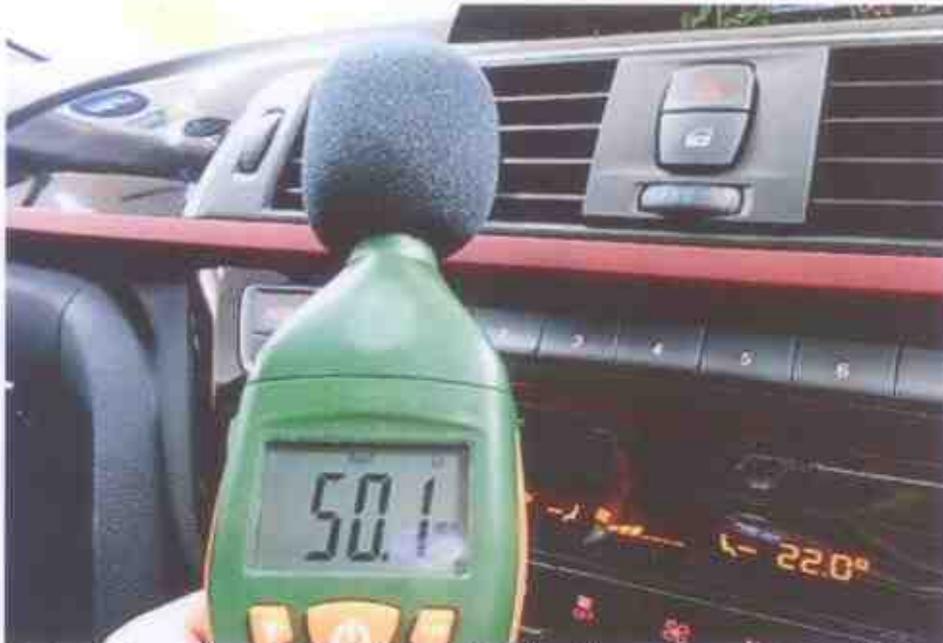
Photo 5 shows the sound level recorded when the engine and air conditioning system of the Subject Motor Car switched on with blower speed 3.

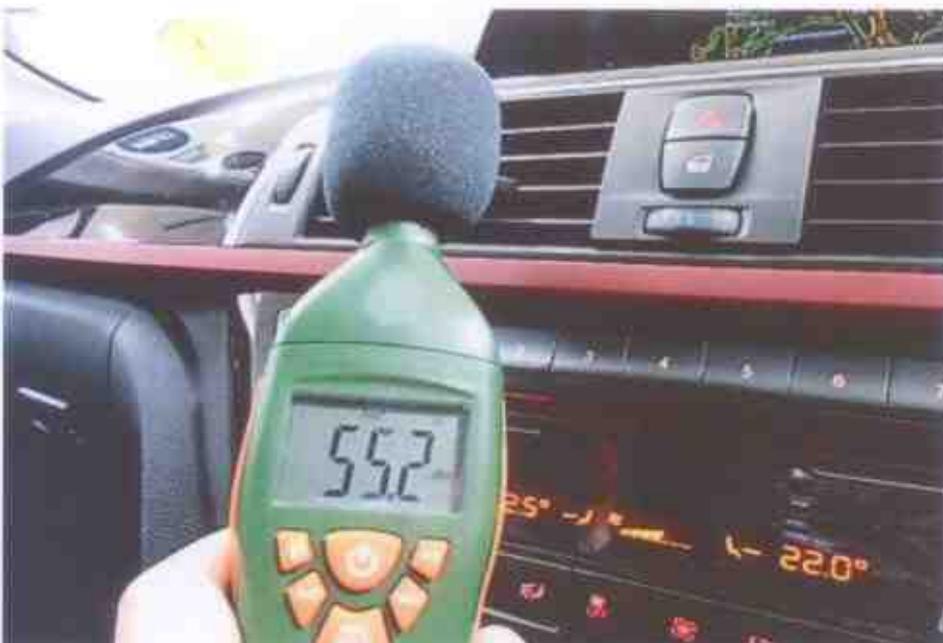
Photo 6 shows the sound level recorded when the engine and air conditioning system of the Subject Motor Car switched on with blower speed 4.

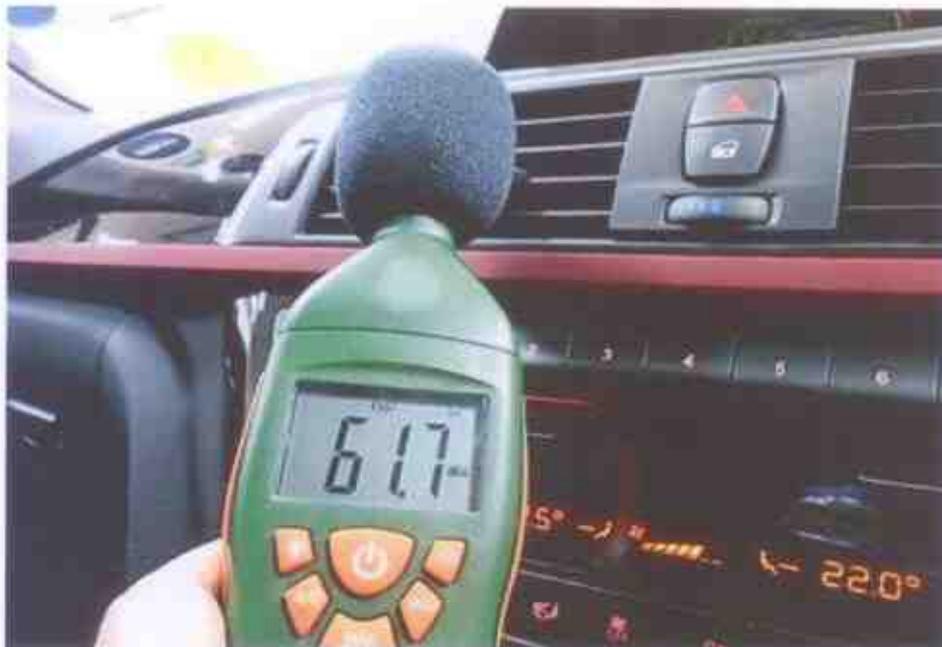
Photo 7 shows the sound level recorded when the engine and air conditioning system of the Subject Motor Car switched on with blower speed 5.

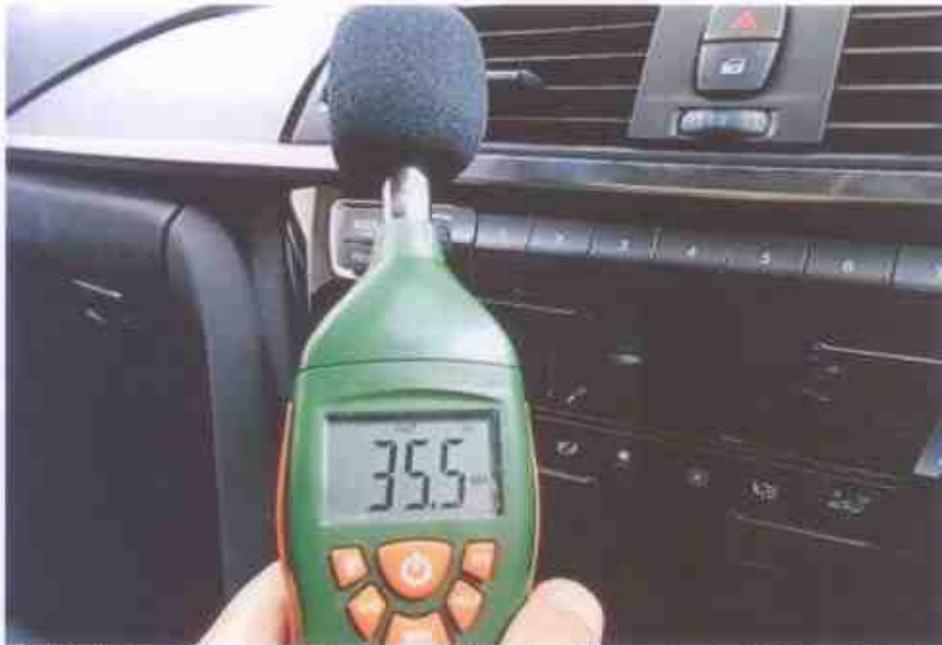
Photo 1 shows the sound level recorded when the engine and air conditioning system of the Comparison Motor Car was switched off.

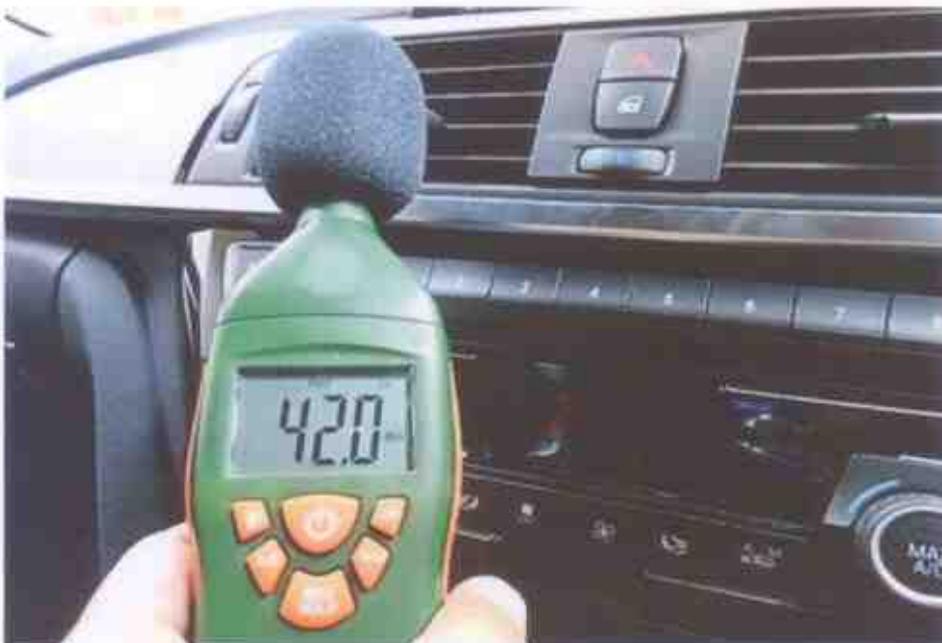
Photo 2 shows the sound level recorded when the engine of the Comparison Motor Car was switched on, but air conditioning system switched off.

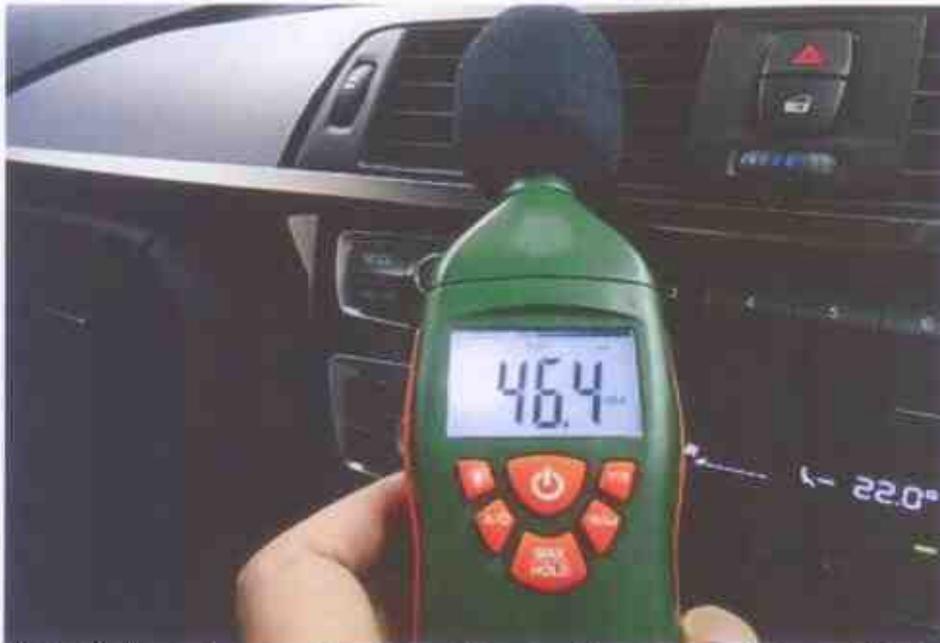
Photo 3 shows the sound level recorded when the engine and air conditioning system of the Comparison Motor Car switched on with blower speed 1.

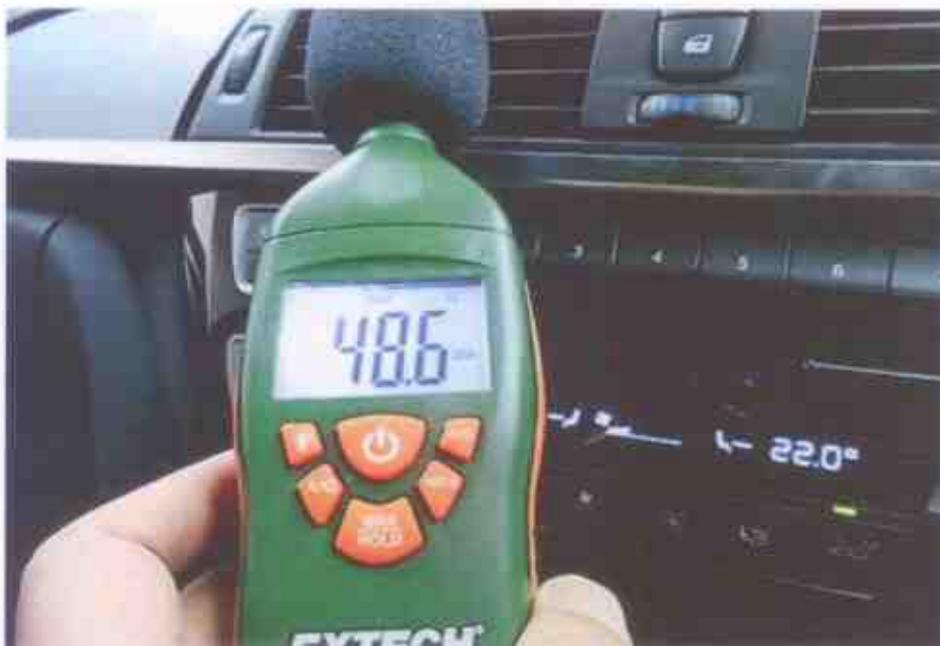
Photo 4 shows the sound level recorded when the engine and air conditioning system of the Comparison Motor Car switched on with blower speed 2.

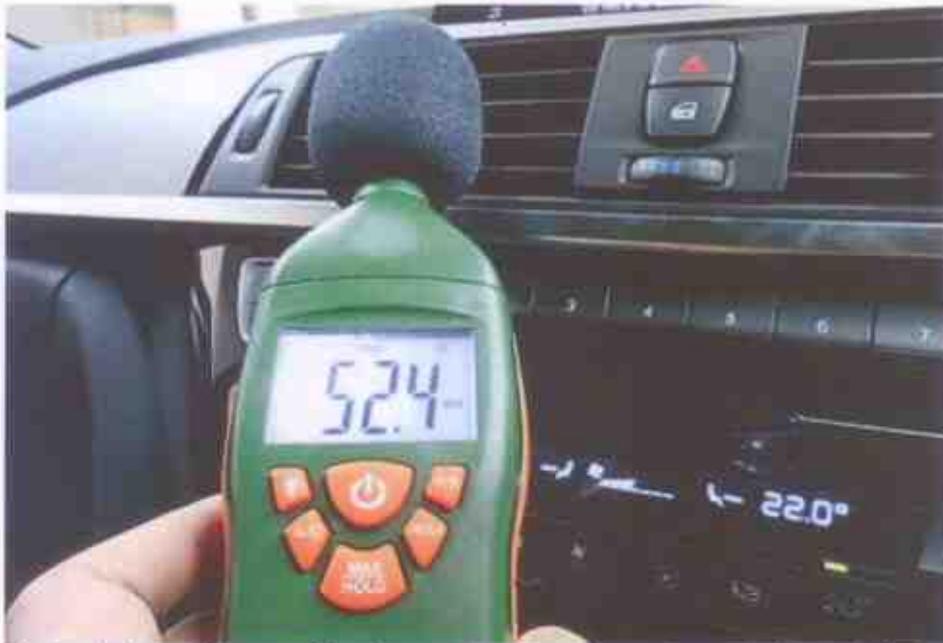
Photo 5 shows the sound level recorded when the engine and air conditioning system of the Comparison Motor Car switched on with blower speed 3.

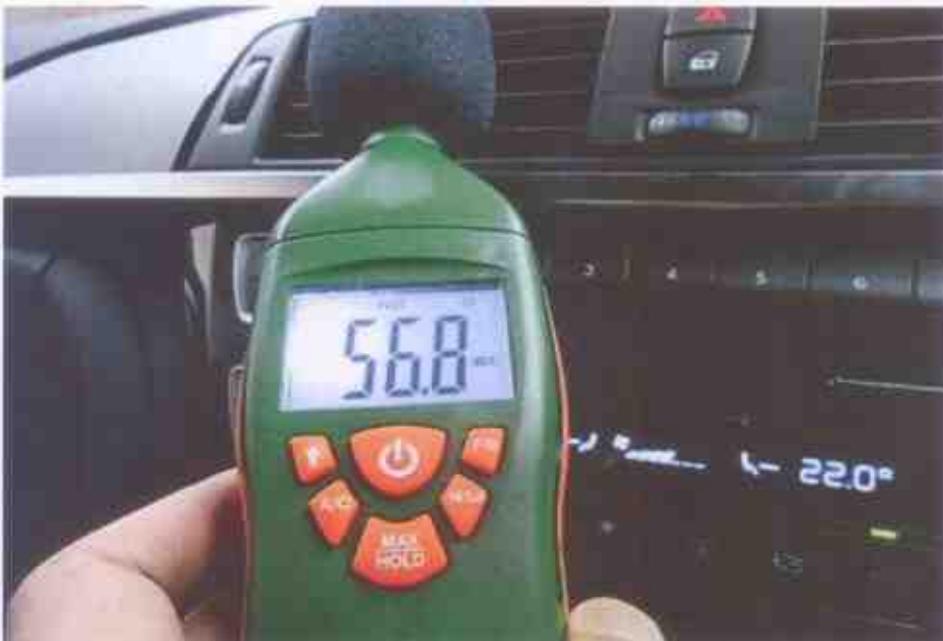
Photo 6 shows the sound level recorded when the engine and air conditioning system of the Comparison Motor Car switched on with blower speed 4.

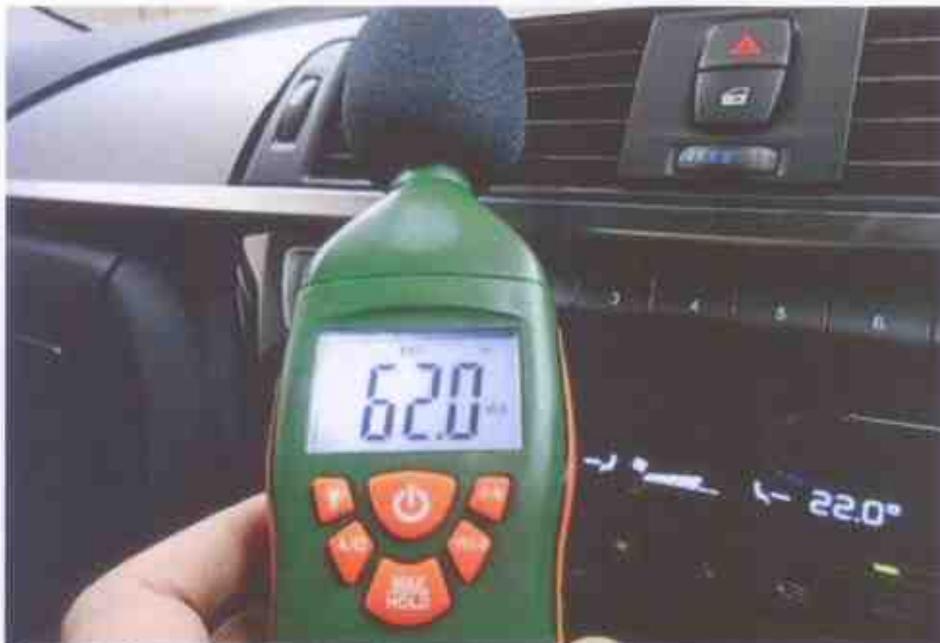
Photo 7 shows the sound level recorded when the engine and air conditioning system of the Comparison Motor Car switched on with blower speed 5.
