1. Policy Particulars :- THIRD PARTY CLAIM				
Insured Veh.	SLM 5635A	Veh. Inspected	SHA 4282B	
Policy No.	5092436279-01	Coverage (\$)	0.00	
Claim No.	MT/1014323-002	Excess (\$)	0.00	
Assign From		Assign Date	05/10/2018

4. Description of Damages				
THE VEHICLE SUSTAINED DAMAGES AT THE O/S FRONT PORTION. DAMAGES SEE DETAILS.				
5. General Information				
Accident Date	03/10/2018	Inspection Date	05/10/2018	
Survey held at	COMFORTDELGRO ENGINEERING PTE LTD 59 LOYANG DRIVE SINGAPORE 508969			
5a. Remarks				
A)THE INSPECTION WAS CONDUCTED ON A"WITHOUT PREJUDICE" BASIS. B)IN ACCORDANCE TO YOUR INSTRUCTIONS, WE HAVE NOT AUTHORISED REPAIRS.				
5b. Estimate Days of Repair				
ESTIMATED NORMAL PERIOD FOR REPAIR:		2 Working Days

ADJUSTMENT ON REPAIR COST FOR VEHICLE NO. SHA 4282B

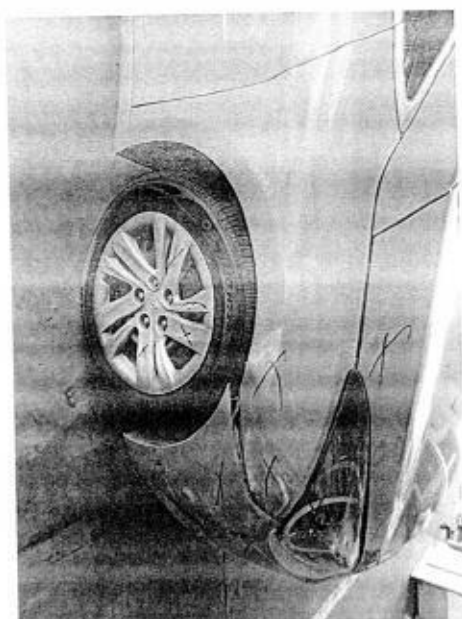
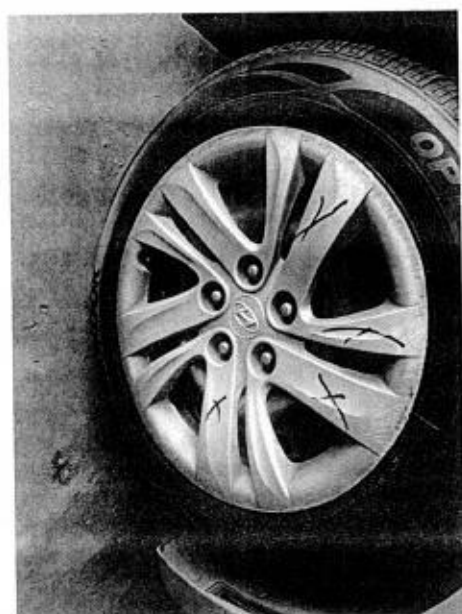
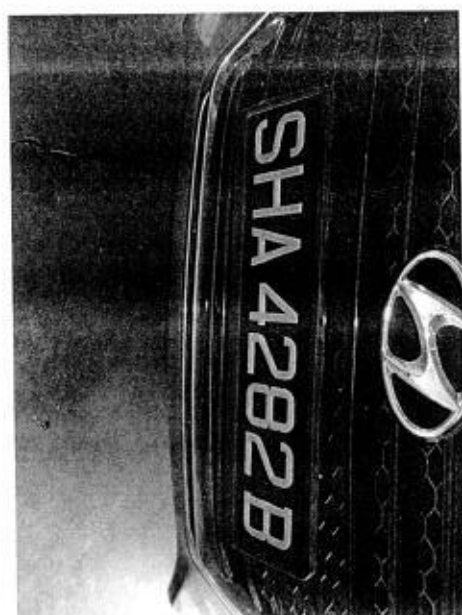
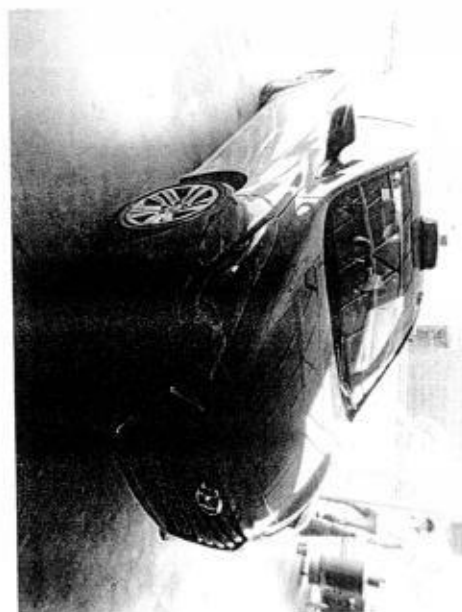
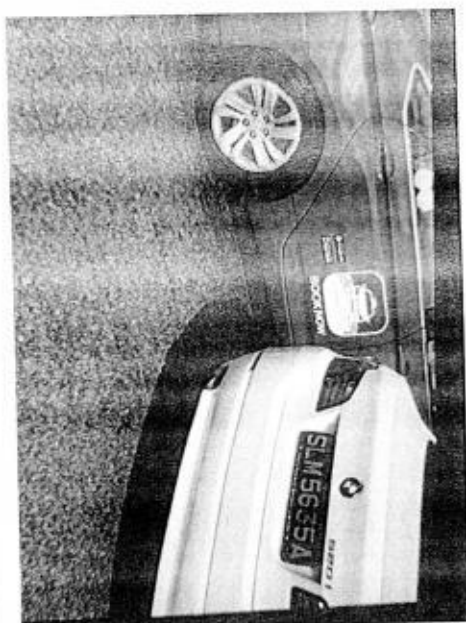
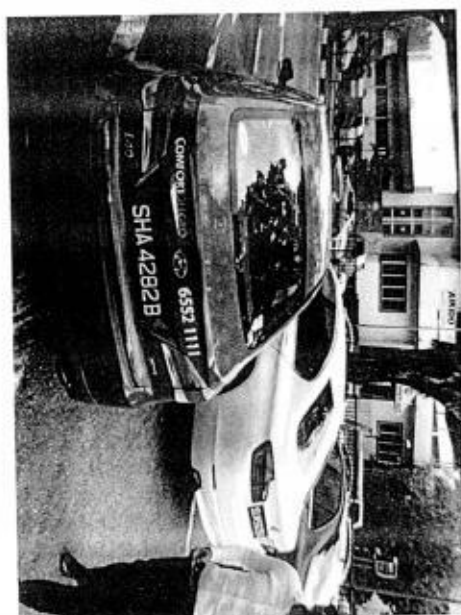
O/S Front

The U/C / Chassis frame / Body Structure affected due to collision.

Qty	Description of Parts	Condition	Estimate By Workshop (\$)	Our Adjusted (\$)
REPLACEMENT OF PARTS				
1	FRONT BUMPER COVER	CRACKED	544.50	544.50
1	FRONT BUMPER BRACKET TOP (RH)	SERVICEABLE	22.40	-
1	FRONT BUMPER BRACKET (RH)	SERVICEABLE	24.60	-
1	HEADLAMP (RH)	GRAZED	1,388.00	1,388.00
1	FRONT FENDER (RH)	DENTED	566.30	566.30
1	FRONT FENDER SHIELD (RH)	SERVICEABLE	175.90	-
1	FRONT FENDER RETAINER	SERVICEABLE	24.60	-
1	FRT WHEEL HUB CAP,RH	GRAZED	107.10	107.10
	LESS 20% DISCOUNT		-570.68	-521.18
			2,282.72	2,084.72
LABOUR				
	PANEL BEATING.		440.00	300.00
	SPRAY PAINTING CHARGE.		440.00	400.00
	WIRING.		30.00	20.00
	TUFF KOTE.		50.00	20.00
	FRT WHEEL ALIGNMENT.	NOT NECESSARY	80.00	-
			1,040.00	740.00
GRAND TOTAL			3,322.72	2,824.72
RECOMMENDED COST OF LUMP SUM REPAIRS (TO ITS PRE-ACCIDENT CONDITION) (CONFIRMED)				2,250.00
