1. Policy Particulars :- THIRD PARTY CLAIM

Insured Veh.	SLK 5081H	Veh. Inspected	SHA 3242Z
Policy No.	5097260551	Coverage (\$)	0.00
Claim No.	MT/1014417-002	Excess (\$)	0.00
Assign From		Assign Date	05/10/2018

4. Description of Damages

ADJUSTMENT ON REPAIR COST FOR VEHICLE NO. SHA 3242Z

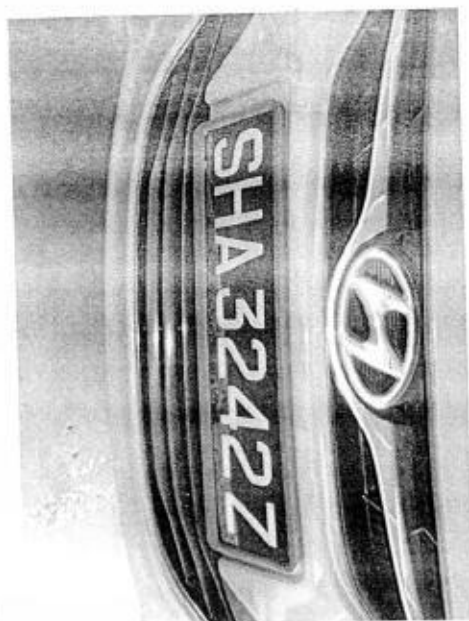
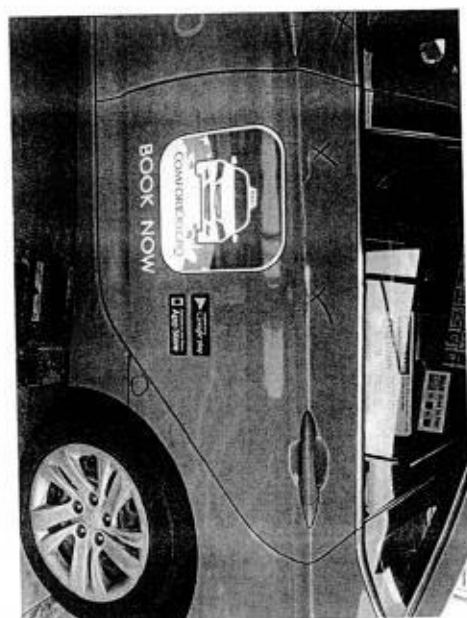
The UIC / Chassis frame / Body Structure affected due to collision.

THE VEHICLE SUSTAINED DAMAGES AT THE N/S BODY.
DAMAGES SEE DETAILS.

Qty	Description of Parts	Condition	Estimate By Workshop (\$)	Our Adjusted (\$)
<u>REPLACEMENT OF PARTS</u>				
1	REAR DOOR (LH)	TO REPAIR SEE LABOUR	2,201.10	-
1	FRONT DOOR (LH)	TO REPAIR SEE LABOUR	2,256.40	-
1	FRONT DOOR GLASS (LH)	TO REPAIR SEE LABOUR	228.20	-
1	FRONT DOOR OUTER MOULDING (LH)	DENTED	47.10	47.10
1	FRONT DOOR MIRROR ASSY (LH)	BROKEN	670.00	670.00
	LESS 20% DISCOUNT		-1,080.56	-143.42
			4,322.24	573.68
<u>SPECIAL NETT ITEMS</u>				
1	REAR DOOR COMFORTDELGRO & APPS STICKER (LH) (SN)	NECESSARY	80.00	80.00
1	FRONT DOOR COLOURED COMFORT LOGO (LH) (SN)	NECESSARY	75.00	75.00

155.00	155.00
<u>LABOUR</u>				
	PANEL BEATING. INCLUSIVE OF THE REPAIR OF REAR DOOR (LH), FRONT DOOR (LH) AND FRONT DOOR GLASS (LH).		220.00	200.00
	SPRAY PAINTING CHARGE.		500.00	450.00
	WIRING CHARGE.		30.00	20.00
	TUFF KOTE.	NOT NECESSARY	50.00	-
	TRANSFER OF DOOR.	NOT NECESSARY	160.00	-

-		-	-
	-		-	-
	-		-	-
			960.00	670.00
GRAND TOTAL			5,437.24	1,398.68
RECOMMENDED COST OF LUMP SUM REPAIRS (TO ITS PRE-ACCIDENT CONDITION) (CONFIRMED)				1,100.00
