Preliminary Advice

Insured Vehicle No	: SLG461Z	Accident Date	: 04/10/2018
TP Vehicle No	: SLJ8238J	Assignment Date	: 08/10/2018
Make	: MITSUBISHI ATTRAGE	Est. Duration of Repair	: 13.00
Date of Inspection	: 09/10/2018		
Inspection At	: PREMIUM CARZ SERVICES PTE LTD (HQ) 1 KAKI BUKIT AVE 6 #01-90 AUTOBAY@KAKI SINGAPORE 417883

VEHICLE DAMAGE INSPECTION REPORT

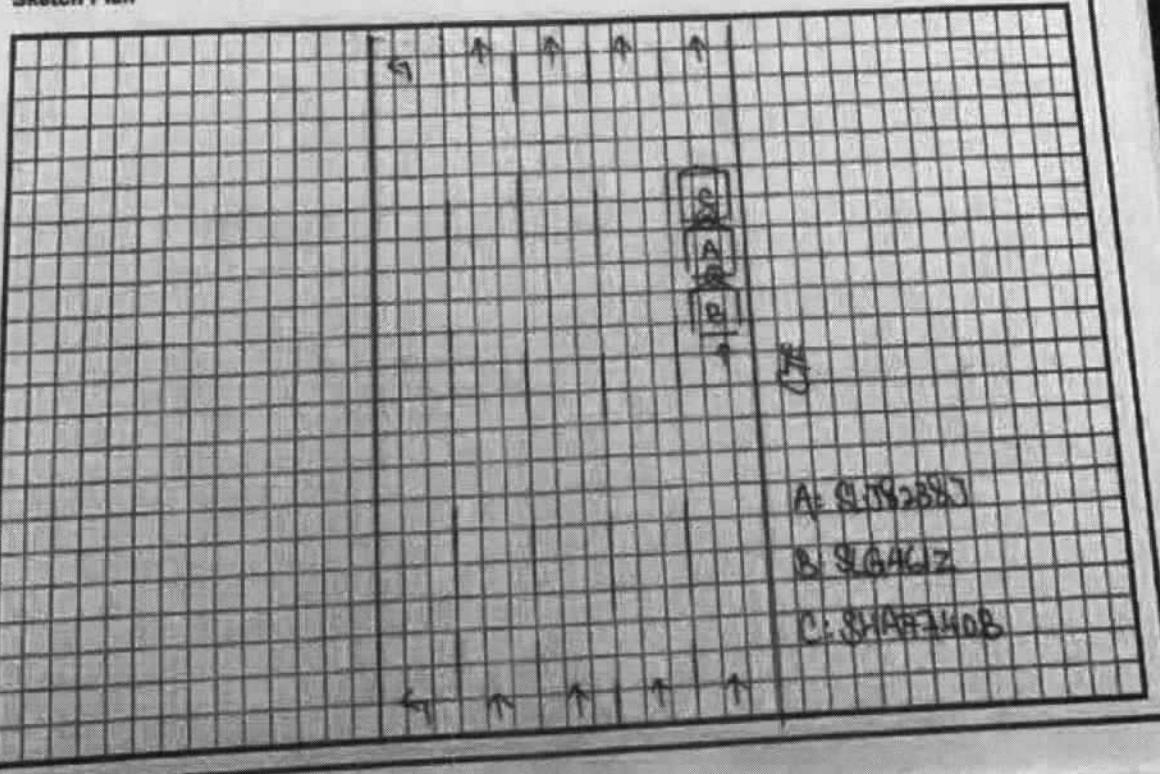
Accident Sketch Plan

I WAS DRIVING ALONG CTE TOWARDS SLE. VEHICLE C IN FRONT OF ME MADE A SUDDEN BRAKE. I MANAGED TO BRAKE IN TIME BUT VEHICLE B BEHIND OF ME COLLIDED ONTO REAR OF MY VEHICLE. I HAVE 2 DAYS OF MC. 3 VEHICLE INVOLVED.
