# National Assessment Centre Services

## 1. Policy Particulars :- THIRD PARTY CLAIM

## 4. Description of Damages

## ADJUSTMENT ON REPAIR COST FOR VEHICLE NO. SHD 4621R

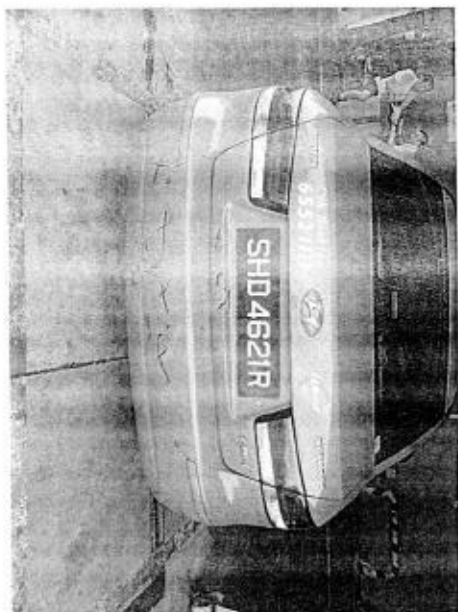
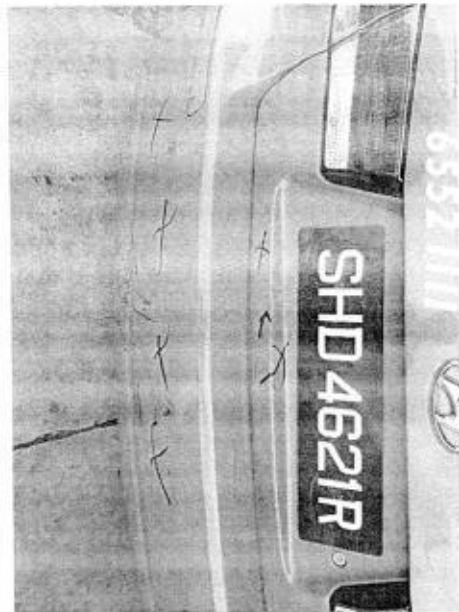
The U/C / Chassis frame / Body Structure affected due to collision.

THE VEHICLE SUSTAINED DAMAGES AT THE REAR PORTION.  
DAMAGES SEE DETAILS.

Qty	Description of Parts	Condition	Estimate By Workshop (\$)	Our Adjusted (\$)
	<b><u>REPLACEMENT OF PARTS</u></b>			
1	REAR BUMPER	DEFORMED	578.40	578.40
10	REAR BUMPER CLIP	NECESSARY	22.00	22.00
1	REAR BUMPER PROTECTOR (LH)	TO REPAIR SEE LABOUR	38.00	-
1	REAR BOOT LID (NPA)	TO REPAIR SEE LABOUR	-	-
	LESS 20% DISCOUNT		-127.68	-120.08
			510.72	480.32
	<b><u>LABOUR</u></b>			
	PANEL BEATING.INCLUSIVE OF THE REPAIR OF REAR BUMPER PROTECTOR (LH) AND REAR BOOT LID.		220.00	200.00
	SPRAY PAINTING CHARGE.		440.00	400.00
	WIRING CHARGE.	NOT NECESSARY	50.00	-
	TUFF KOTE.	NOT NECESSARY	50.00	-
	REMOVE/REFIX REVERSE SENSOR.		80.00	30.00
			840.00	630.00
	<b>GRAND TOTAL</b>		<b>1,350.72</b>	<b>1,110.32</b>
	<b>RECOMMENDED COST OF LUMP SUM REPAIRS (TO ITS PRE-ACCIDENT CONDITION) (CONFIRMED)</b>			<b>900.00</b>
