1. Policy Particulars :- THIRD PARTY CLAIM				
Insured Veh.	GV 3791G	Veh. Inspected	SHC 723L	
Policy No.	5087483248-01	Coverage (\$)	0.00	
Claim No.	MT/1015177-001	Excess (\$)	0.00	
Assign From		Assign Date	09/10/2018

4. Description of Damages				
THE VEHICLE SUSTAINED DAMAGES AT THE O/S FRONT PORTION. DAMAGES SEE DETAILS.				
5. General Information				
Accident Date	07/10/2018	Inspection Date	09/10/2018	
Survey held at	COMFORTDELGRO ENGINEERING PTE LTD 59 LOYANG DRIVE SINGAPORE 508969			
5a. Remarks				
A)THE INSPECTION WAS CONDUCTED ON A"WITHOUT PREJUDICE" BASIS. B)IN ACCORDANCE TO YOUR INSTRUCTIONS, WE HAVE NOT AUTHORISED REPAIRS.				
5b. Estimate Days of Repair				
ESTIMATED NORMAL PERIOD FOR REPAIR:		3 Working Days

ADJUSTMENT ON REPAIR COST FOR VEHICLE NO. SHC 723L

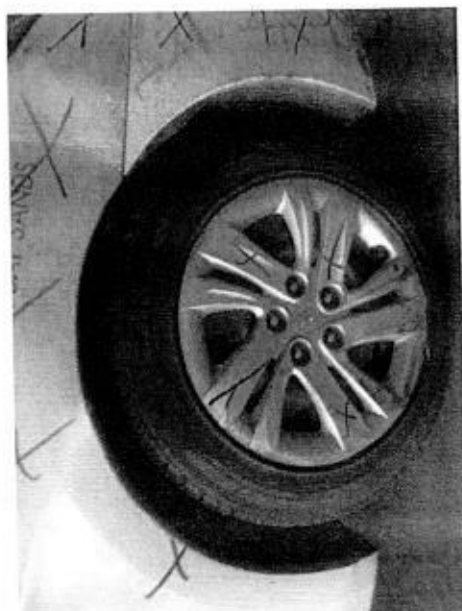
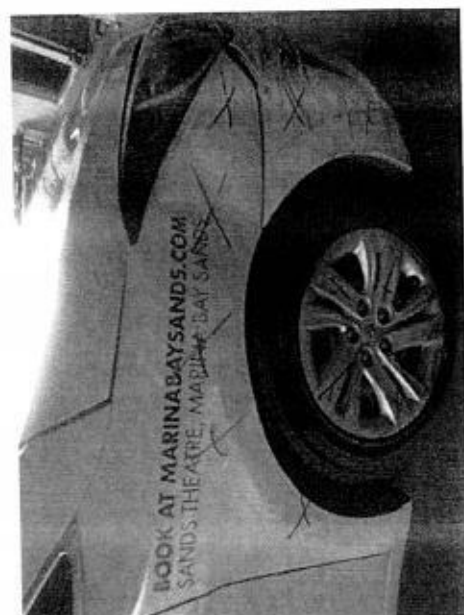
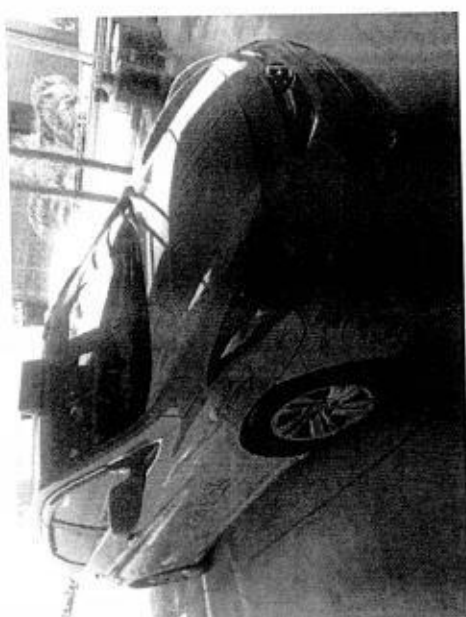
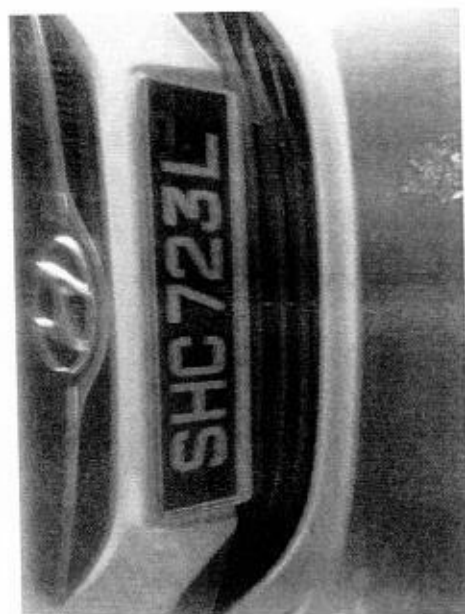
O/S Front

The U/C / Chassis frame / Body Structure affected due to collision.

Qty	Description of Parts	Condition	Estimate By Workshop (\$)	Our Adjusted (\$)
	<u>REPLACEMENT OF PARTS</u>			
1	FRONT BUMPER COVER	DEFORMED	544.50	544.50
1	FRONT BUMPER GRILLE	SERVICEABLE	41.60	-
1	FRONT BUMPER BRACKET TOP (RH)	SERVICEABLE	22.40	-
1	FRONT BUMPER BRACKET (RH)	CRACKED	24.60	24.60
1	HEADLAMP SUPPORT PANEL ASSY	SERVICEABLE	907.40	-
1	HEADLAMP (RH)	CRACKED	1,388.00	1,388.00
1	FRONT FENDER (RH)	DENTED	566.30	566.30
1	FRONT FENDER SHIELD (RH)	SERVICEABLE	175.90	-
1	WIPER CONTAINER	SERVICEABLE	61.90	-
1	WIPER CONTAINER MOTOR	SERVICEABLE	75.00	-
1	FRONT WHEEL HUB CAP (RH)	GRAZED	107.10	107.10
1	FRONT WING MIRROR (RH)(NPA)	TO REPAIR SEE LABOUR	-	-
	LESS 20% DISCOUNT		-782.94	-526.10
			3,131.76	2,104.40
	<u>SPECIAL NETT ITEMS</u>			
1	FRONT FENDER ADVERTISEMENT LOGO (RH)(SN)	NECESSARY	100.00	100.00
1	FRT TYRE (RH)(SN)	SERVICEABLE	216.00	-

316.00	100.00
	<u>LABOUR</u>			
	PANEL BEATING.INCLUSIVE OF THE REPAIR OF FRONT WING MIRROR (RH).		660.00	400.00
	SPRAY PAINTING CHARGE.		550.00	450.00
	WIRING CHARGE.		50.00	30.00
	TUFF KOTE.		50.00	30.00
	TOWING CHARGE.		60.00	-
	FRT WHEEL ALIGNMENT.	NOT NECESSARY	80.00	-
	REMOVE/REFIX AIRCON & REFILL GAS.	NOT NECESSARY	150.00	-
			1,600.00	910.00
	GRAND TOTAL		5,047.76	3,114.40

RECOMMENDED COST OF LUMP SUM REPAIRS (TO ITS PRE-ACCIDENT CONDITION) (CONFIRMED)			2,500.00
--	--	--	----------
