**OWN DAMAGE CLAIM (FIRE)**  
**PZ 8118 R FIRE INCIDENT ON 27/9/2018 AT YISHUN AVENUE 7 HEAVY VEHICLE**  
**CARPARK.**  
**POLICY HOLDER :- YEOONG CHARTER BUS**  
**POLICY NO. :- VFX/P1173830**  
**VEHICLE NO. : PZ 8118 R**

1. We refer to your letter dated 11 October 2018 and the instructions therein.
2. Our analysis, comments and opinions with respect to the cause of fire to the insured vehicle PZ 8118R (herein referred to as "**Insured Vehicle**") are set out below.

Vehicle Registration No.	: PZ 8118R
Make / Model	: ISUZU LT 134P
Chassis No	: JALLT134P77000316
Year of Registration	: May 2008
Mileage	: 380,293km

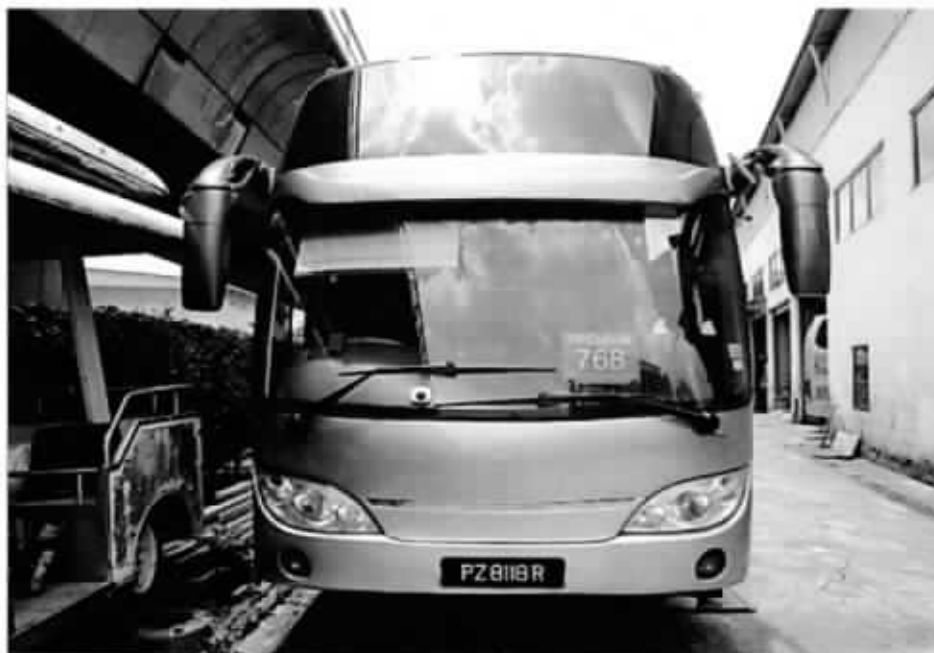
**Photo 1** shows the general view of the front portion of the Insured Vehicle at the time of our inspection. The front portion of the Insured Vehicle was relatively unaffected by the fire.

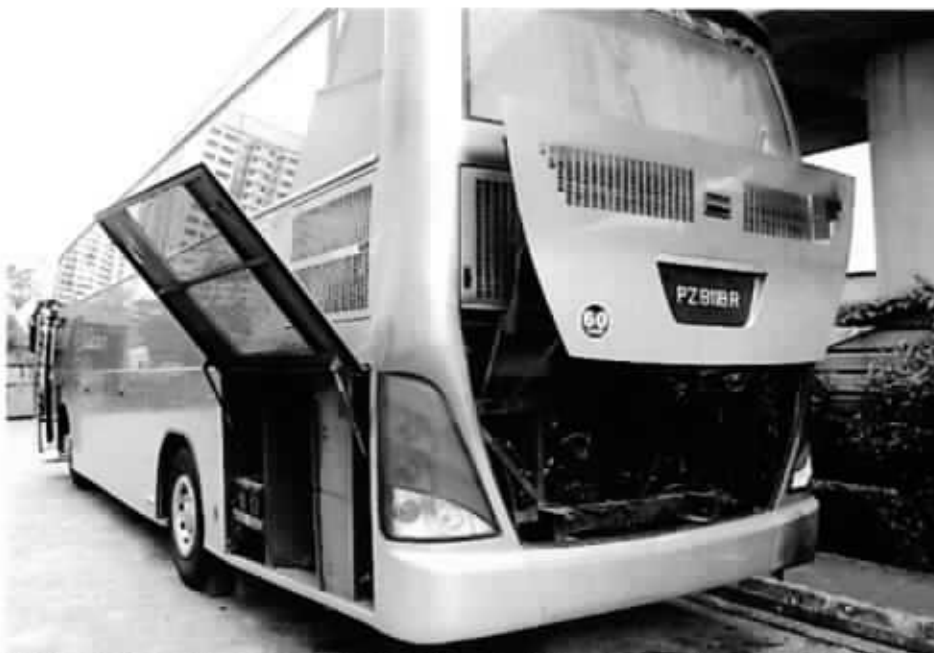
**Photo 2** shows the general view of the rear left portion of the Insured Vehicle at the time of our inspection. The rear left portion of the Insured Vehicle was relatively unaffected by the fire.

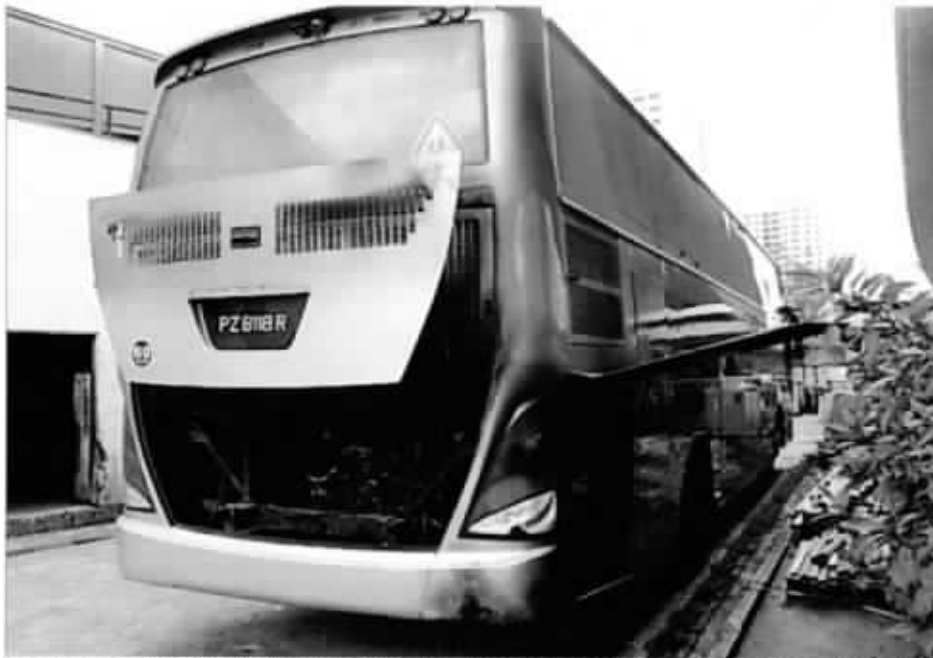
**Photo 3** shows the general view of the right rear portion of the Insured Vehicle at the time of our inspection. The exterior body of the Insured Vehicle had sustained significant fire damage at the rear right portion.

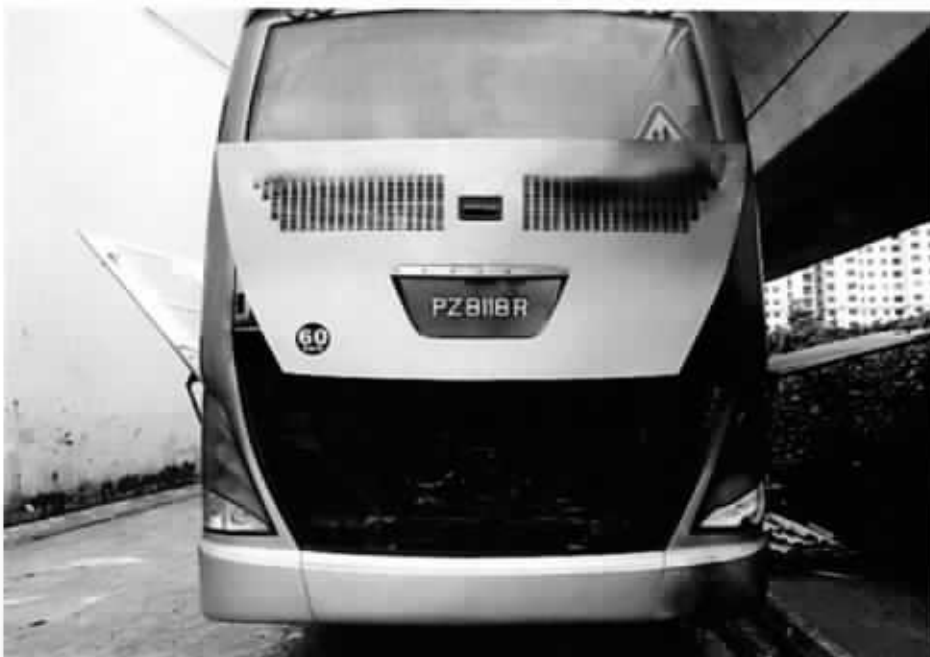
5. The exterior body of the Insured Vehicle had sustained fire damage at the rear portion. Affected parts had included the rear windscreen, engine panel, side panels, tail lights and rear bumper, amongst others. The engine compartment of the Insured Vehicle had sustained significant fire damage. The interior compartment of the Insured Vehicle was observed to be unaffected by the fire. See photos 1 – 6 below.

**Photo 4** shows the general view of the rear portion of the Insured Vehicle at the time of our inspection. The Insured Vehicle had sustained fire damage at the rear portion. Affected parts had included the rear windscreen, engine panel, side panels, tail lights and rear bumper, amongst others.

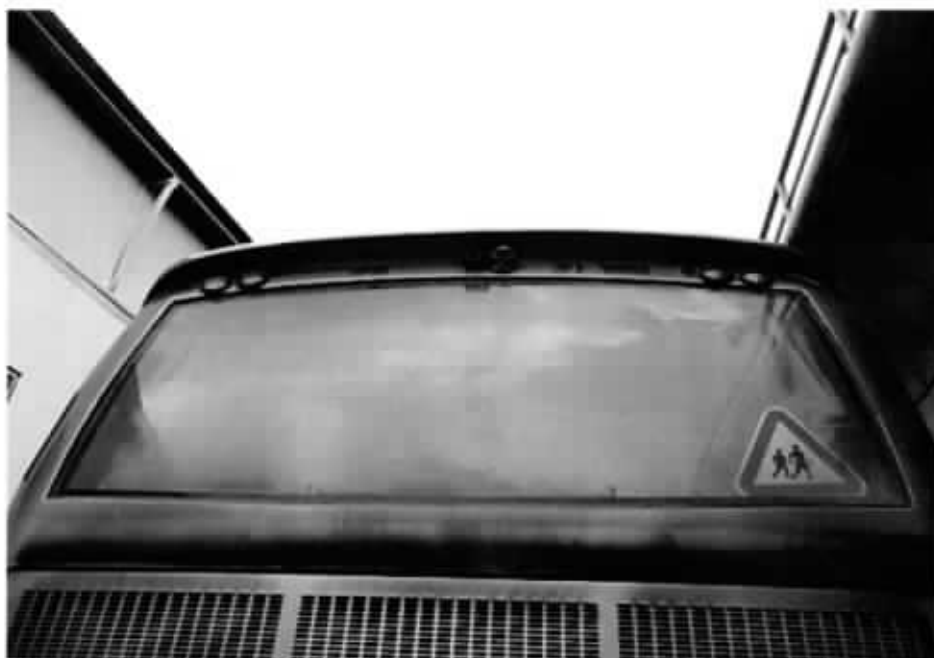
**Photo 5** shows the general view of the damaged rear windscreen of the Insured Vehicle at the time of our inspection.

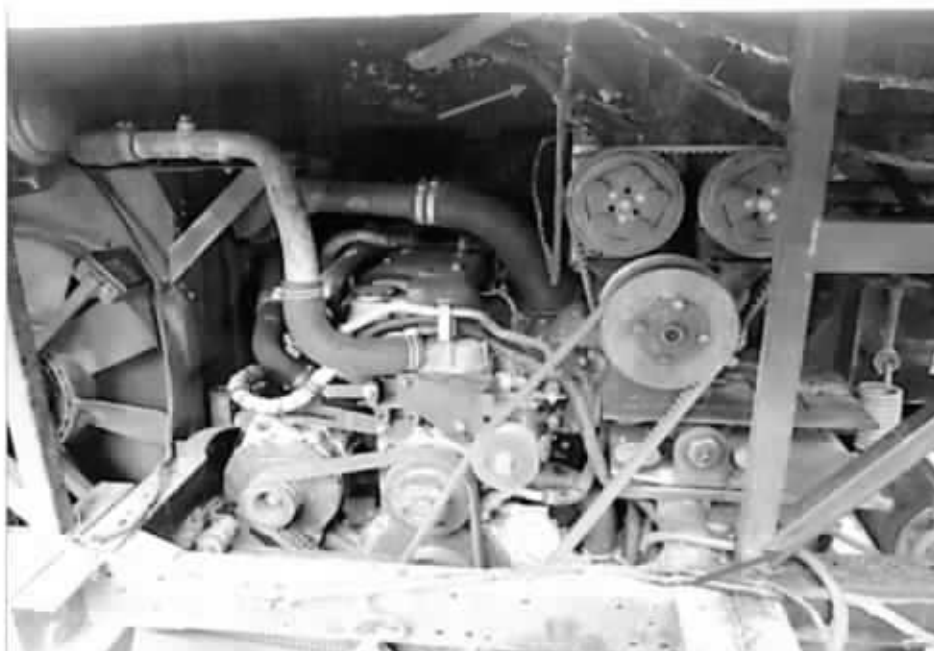
7. Upon closer examination of the rear right portion of the engine compartment of the Insured Vehicle as well as around the immediate vicinity to where the fire had likely started, we had found greenish residue on several burnt stretches of original factory fitted wirings around the rear right portion of the engine compartment. The presence of such greenish residue indicates internal heating of copper wires, a sign of an electrical short circuit occurring. The greenish residue is normally left behind from oxidation as a result of chemical reaction involving the copper wires. This physical evidence would then appear to suggest that the cause of fire to the Insured Vehicle could have possibly been due to electrical in nature. See photos 7 - 10 below.

**Photo 7** shows a closer view of the burnt engine compartment of the Insured Vehicle. The fire damage was more extensive at the rear right portion (arrowed). The rear left portion had sustained minimal fire damage.

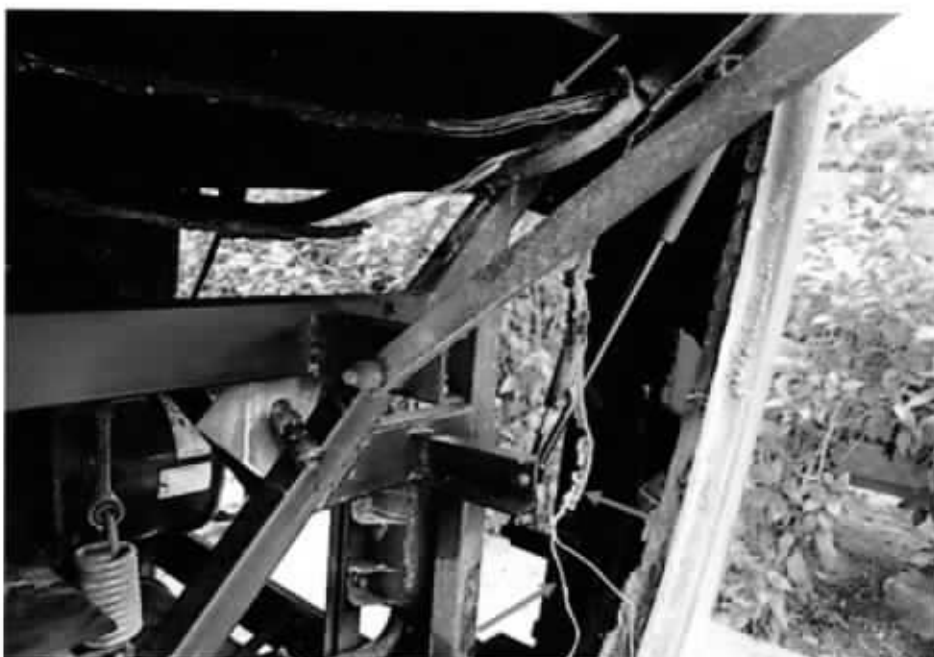
**Photo 8** shows a view of the greenish residue found on several burnt stretches of original factory fitted wirings around the rear right portion of the engine compartment (arrowed) of the Insured Vehicle.

18. The possibility of the fire being due to electrical in nature would then seem more likely given that engine overheating and external factors would seem unlikely. The fire being due to electrical nature is also supported by greenish residue found on several burnt stretches of original factory fitted wirings around the rear right portion of the engine compartment of the Insured Vehicle, which was earlier discussed in paragraph 7 above.

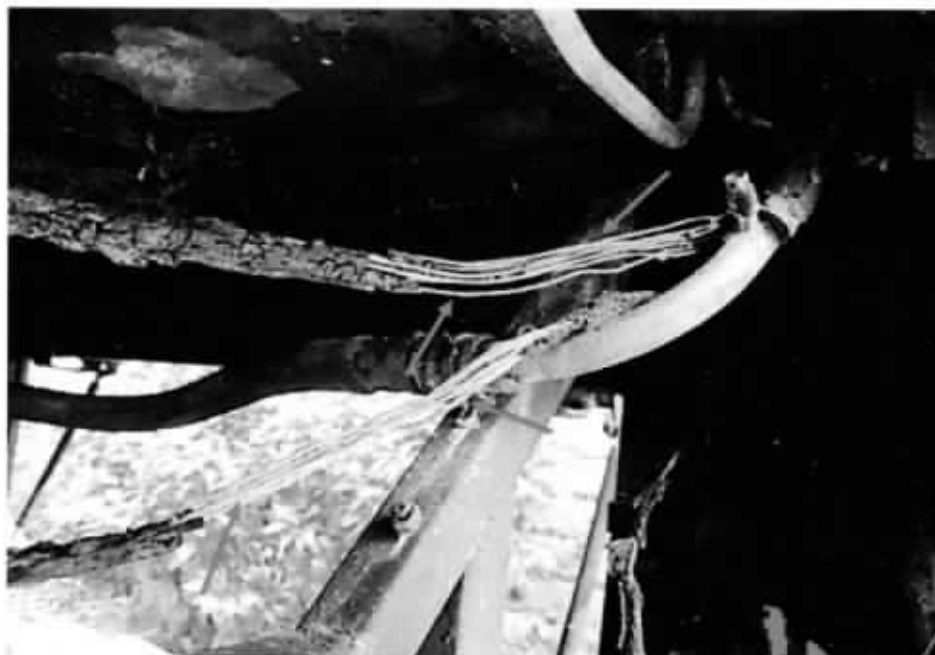
**Photo 9** shows a closer view of the greenish residue that was found on several burnt stretches of original factory fitted wirings around the rear right portion of the engine compartment (arrowed) of the Insured Vehicle.

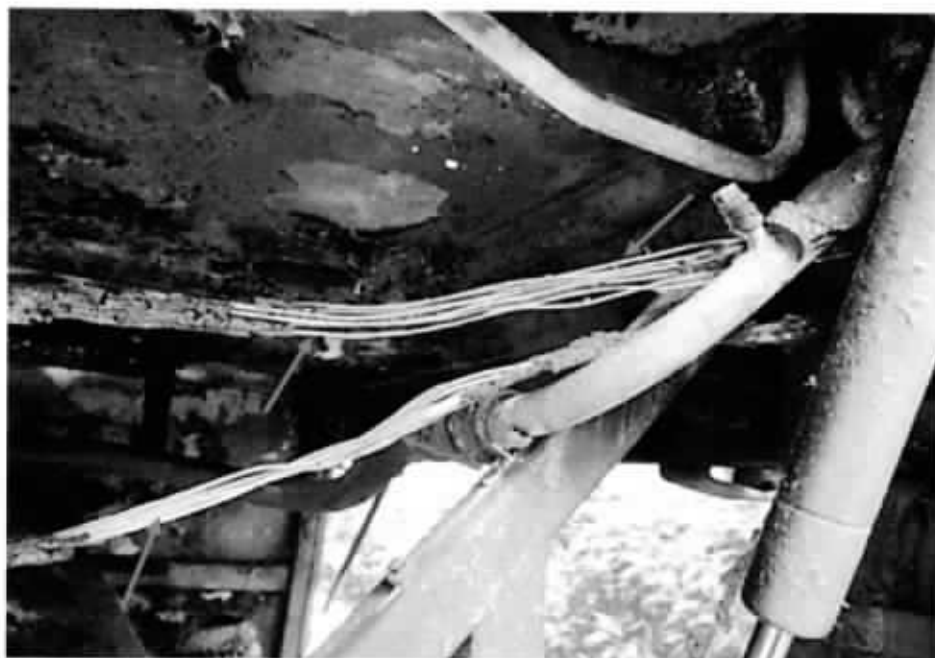
**Photo 10** shows a close up view of the greenish residue that was found on several burnt stretches of original factory fitted wirings around the rear right portion of the engine compartment (arrowed) of the Insured Vehicle.

20. Having investigated and technically analysed the damages of burnt nature to the Insured Vehicle, we are of the view that the cause of fire to the Insured Vehicle was of electrical in nature. For this particular case, the fire had originated along the original factory fitted wirings around the rear right portion of the engine compartment of the Insured Vehicle.
21. We did not find any evidence which had suggested that the cause of fire to the Insured Vehicle was due to poor maintenance and/or recurring electrical problem.
22. Our investigations had also revealed that at the time of writing this report, there is no manufacturer recall of electrical nature to similar make and model vehicle as the Insured Vehicle that may pose a fire risk.
