**Preliminary Advice**

Vehicle No	: SLH216K	Accident Date	: 09/10/2018
Make	: MERCEDES-BENZ C180	Policy No.	: DMPCSN3094911700
Assignment Date	: 12/10/2018	Excess	: S\$900.00
Date of Inspection	: 15/10/2018	Est. Duration of Repair	: 5.00
Inspection At	: CYCLE & CARRIAGE INDUSTRIES PTE LTD (PANDAN LOOP) 188 PANDAN LOOP SINGAPORE 128378

**VEHICLE DAMAGE INSPECTION REPORT**China Taiping Insurance (Singapore) Pte. Ltd.  
3 Anson Road, #16-00 Springleaf Tower  
Singapore 079909**Our File No:** CS/CTI18018612/R1QD3E2**Date:** 26/02/2019REFERENCE

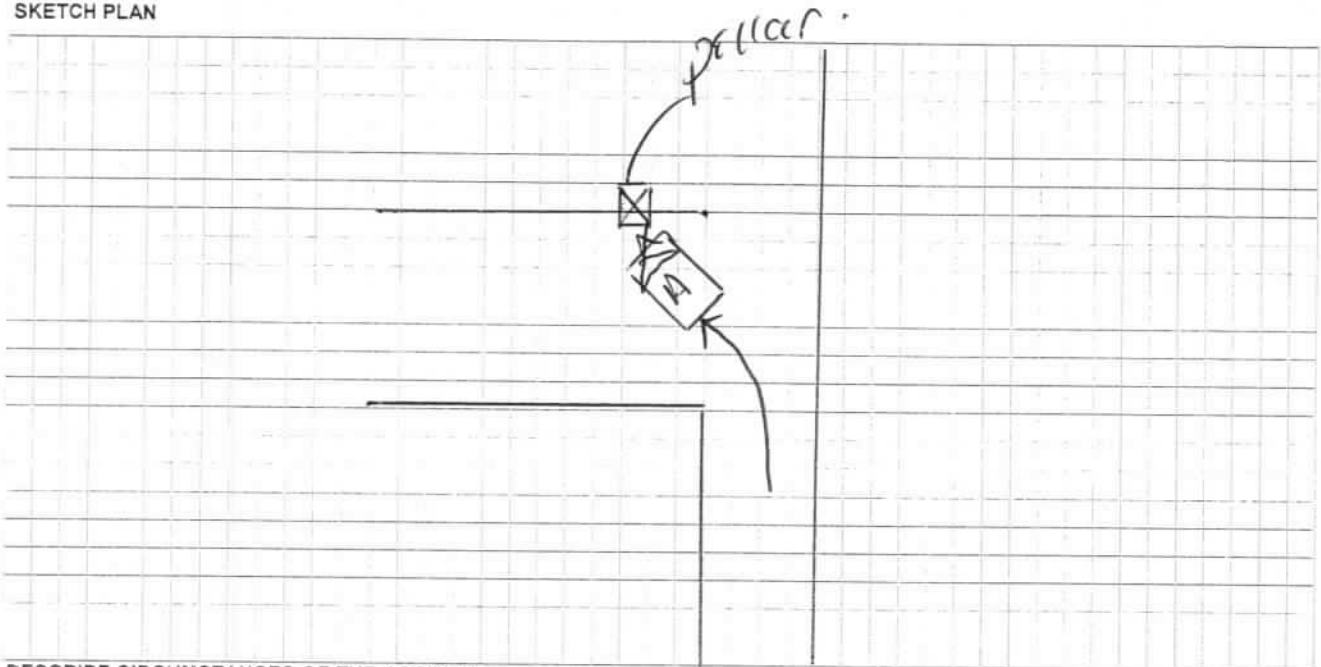
SKETCH PLAN

DESCRIBE CIRCUMSTANCES OF THE ACCIDENT

While turning left in the carpark,  
my car skidded slightly due to  
the wet surface and knocked  
into the pillar.
