1. Policy Particulars :- THIRD PARTY CLAIM

4. Description of Damages

THE VEHICLE SUSTAINED DAMAGES AT THE FRONT N/S PORTION.
DAMAGES SEE DETAILS.

ADJUSTMENT ON REPAIR COST FOR VEHICLE NO. SH 8339D

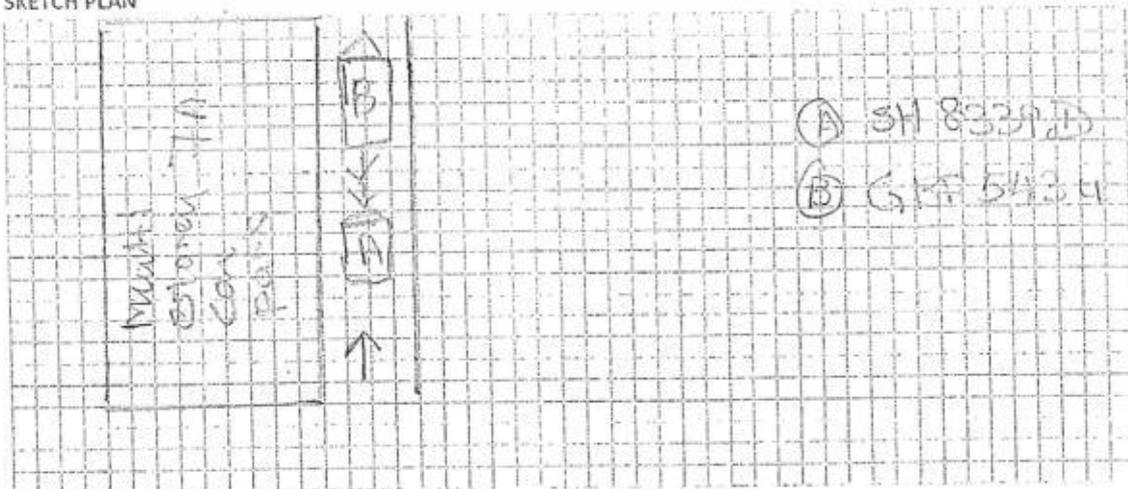
SKETCH PLAN

On 11/10/2018 at about 1500hrs, I vehicle A was sent
 my passenger at Holland close. Then I drive along Carpark
 Block FA drive way. There was heavy and road
 surface was wet while I was following the lobby in
 Carpark. Suddenly vehicle B stop and engage reverse
 gear. I keep on horn at him and he still keep on
 reversing his lobby and bang into vehicle A front.
