8KP 8805 C

Make: **B.M.W 520i AT** c.c. **1997**
 Colour: **Black** A/C: Insured / Std / NI / NA
 Sp.Reading: **43802** T/Radio: Insured / Std / NI / NA

RE: VEHICLE REPAIR QUOTATION

VEHICLE DAMAGE INSPECTION REPORT

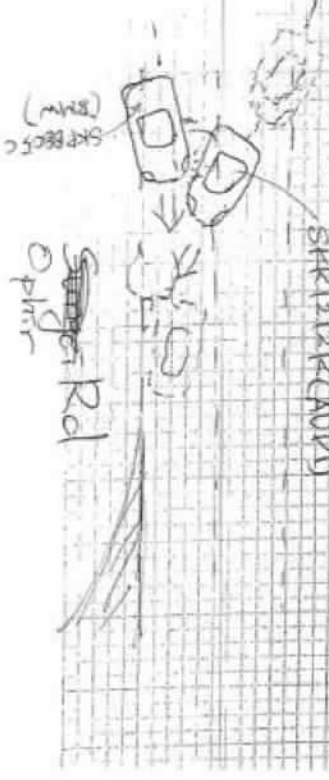
Sketch Plan #2

I was driving BMW (5K1212F5) and changing lane with indicator "on" and had checked to be sure safety before I turn the overpass. There were clear and no any cars the lane. When my car already into the lane, back colour Audi (5K1212F5) cut ~~into~~ in front of my car with very speed without any indicator sign on. There has contact my car left front side bumper has scratch Audi. Right rear door. Audi was behind of me before I changed lane but it came with high speed and cut in front of my lane therefore, my (BMW) damaged front side, Audi damaged side rear door.

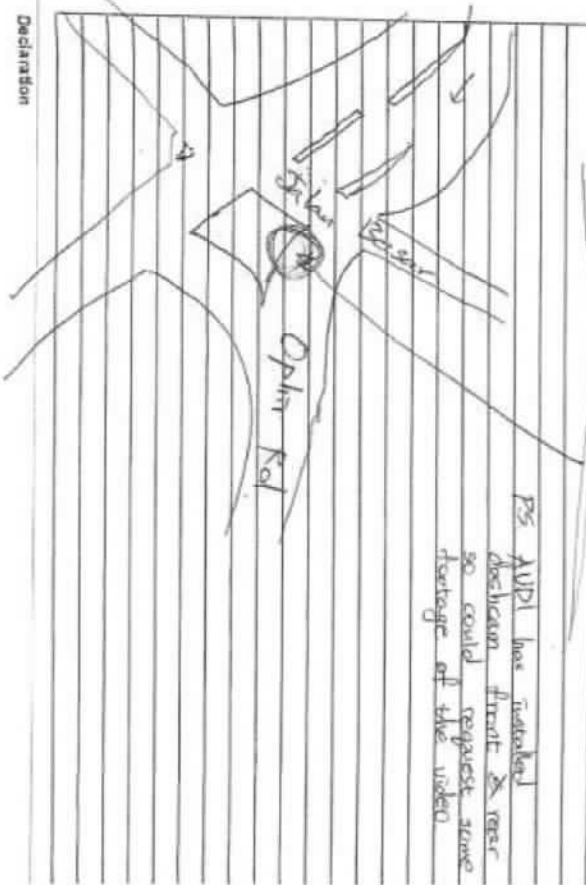
It was happened at 4:20 pm 23th Sep 2018 Intersection Opht Rd and Jalan Besar.
