Veh No: SHC 8693L Yr Regt: 10 Dec 2015

NTUC INCOME INSURANCE CO-OPERATIVE LTD Ref: NS/INC18018768/K1sbs2				
73 BRAS BASAH ROAD #05-01 NTUC TRADE UNION HOUSESINGAPORE 189556			Date: 26-10-2018 Code: INC4

4. Description of Damages				
THE VEHICLE SUSTAINED DAMAGES AT THE O/S BODY. DAMAGES SEE DETAILS.				
5. General Information				
Accident Date	13/10/2018	Inspection Date	16/10/2018	
Survey held at	COMFORTDELGRO ENGINEERING PTE LTD 59 LOYANG DRIVE SINGAPORE 508969			
5a. Remarks				
A)THE INSPECTION WAS CONDUCTED ON A"WITHOUT PREJUDICE" BASIS. B)IN ACCORDANCE TO YOUR INSTRUCTIONS, WE HAVE NOT AUTHORISED REPAIRS.				
5b. Estimate Days of Repair				
ESTIMATED NORMAL PERIOD FOR REPAIR:		2 Working Days

ADJUSTMENT ON REPAIR COST FOR VEHICLE NO. SHC 8693L

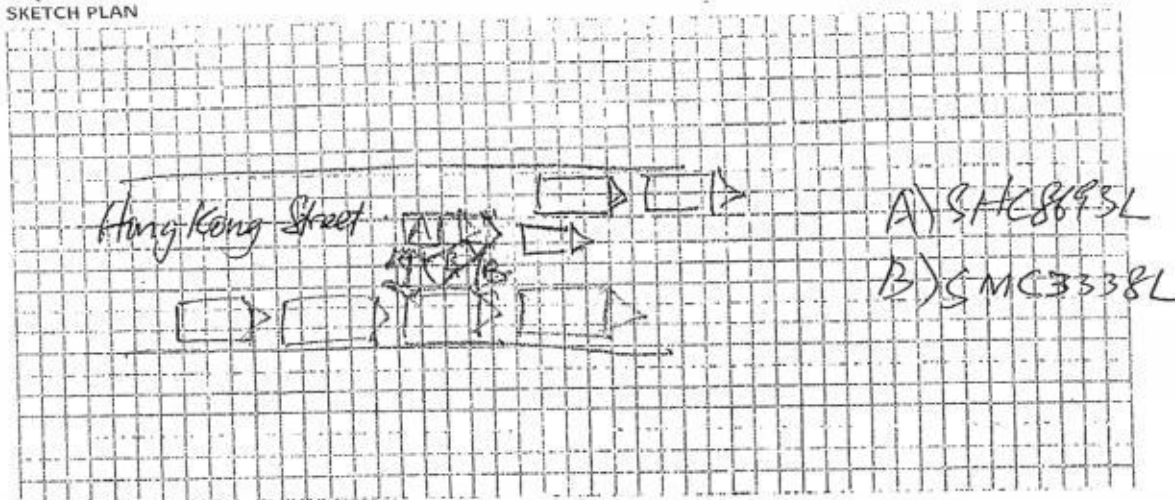
SKETCH PLAN

On 13/10/18 at about 2230 hrs while I Veh A was moving forward, Veh B that was stationary with Hazard light turned "on", suddenly swayed to the left when I passed it almost 1/3 of my vehicle. My right rear door was damaged and Veh B damage was on the left front portion.

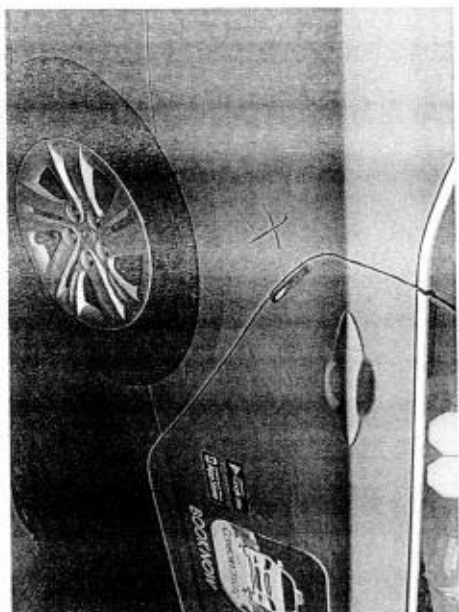
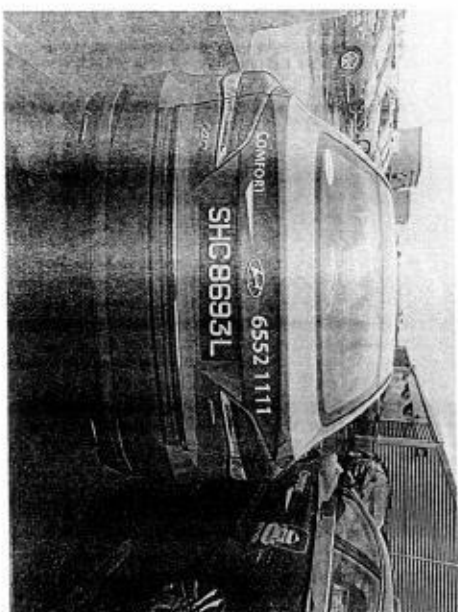
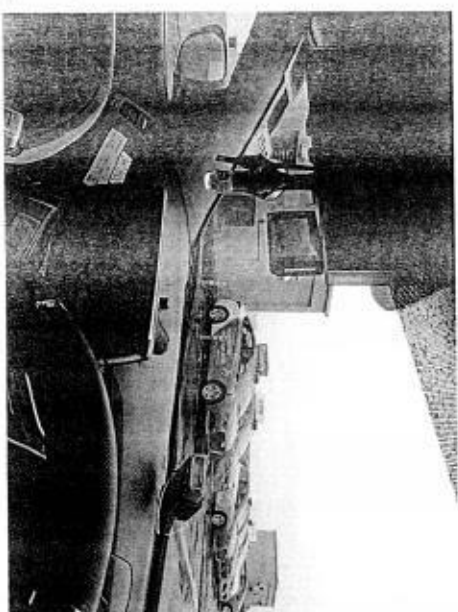
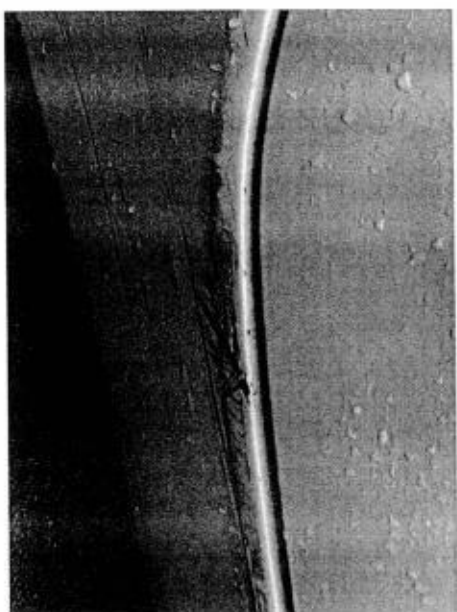
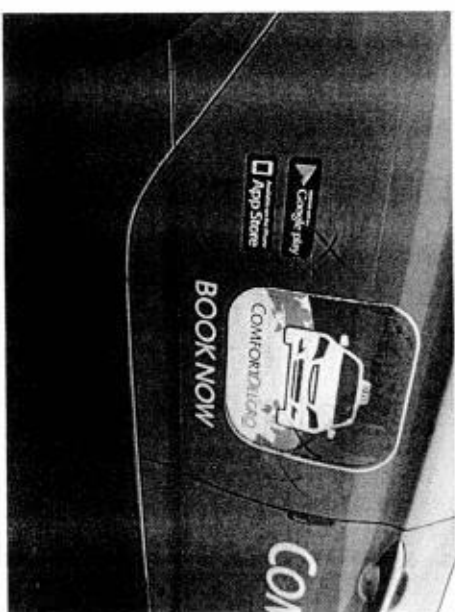
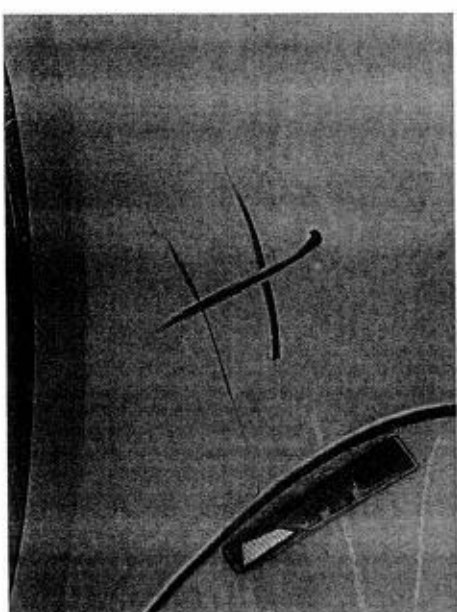
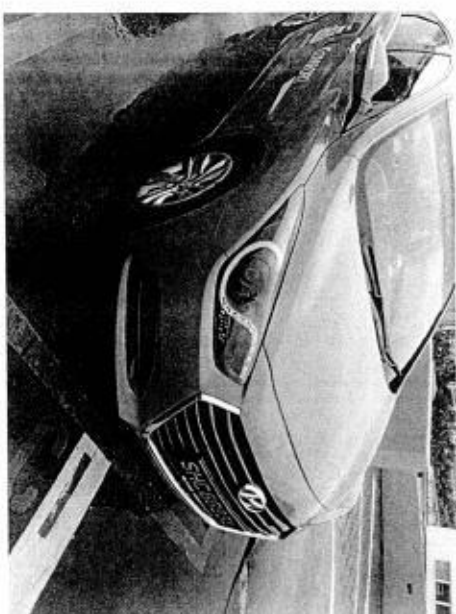
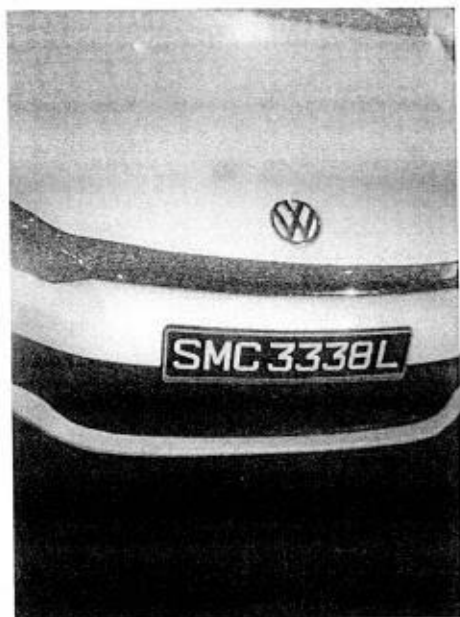
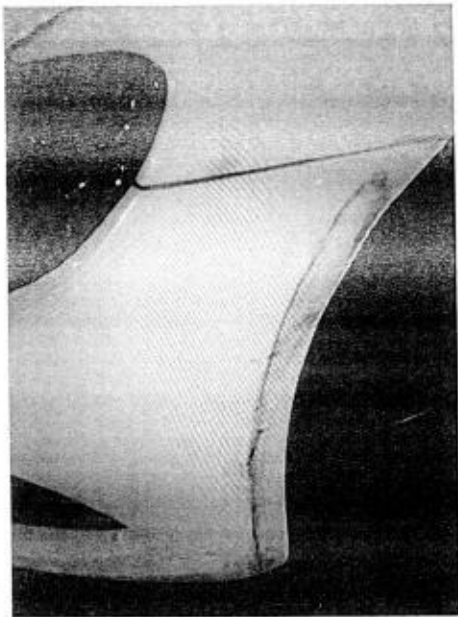
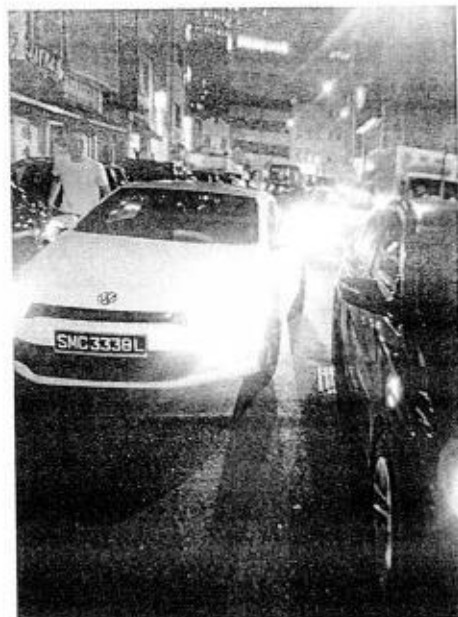
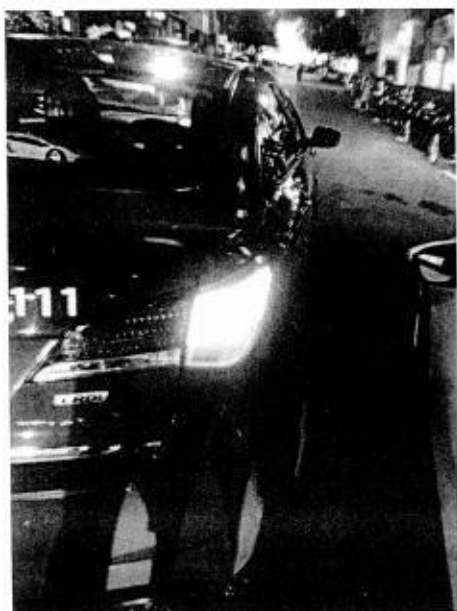
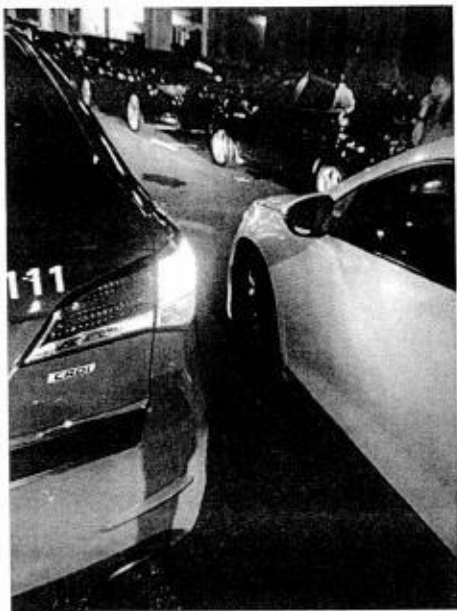
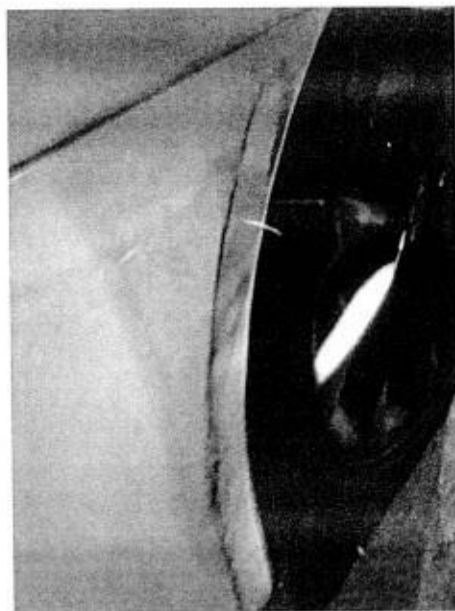
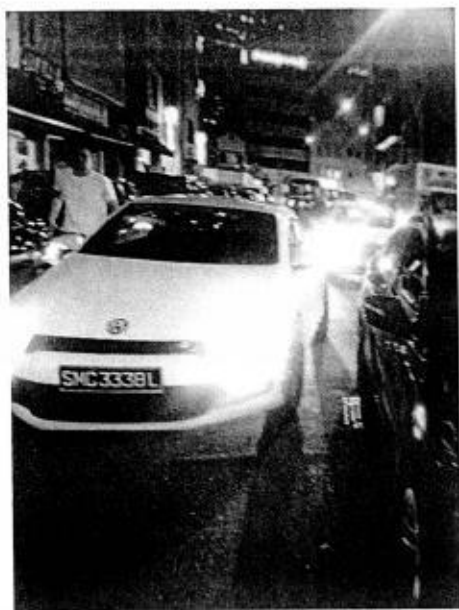
The U/C / Chassis frame / Body Structure affected due to collision.

Qty	Description of Parts	Condition	Estimate By Workshop (\$)	Our Adjusted (\$)
REPLACEMENT OF PARTS				
1	REAR DOOR COMFORTDELGRO & APPS STICKER (RH) (SN)	NECESSARY	80.00	80.00
1	REAR DOOR (RH)(SN)(NPA)	TO REPAIR SEE LABOUR	-	-
1	ROCKER PANEL (RH)(SN)(NPA)	TO REPAIR SEE LABOUR	-	-
			80.00	80.00
LABOUR				
	PANEL BEATING INCLUSIVE OF THE REPAIR OF REAR DOOR (RH) AND ROCKER PANEL (RH).		220.00	200.00
	SPRAY PAINTING CHARGE-DOOR/ROCKER PANEL.		440.00	400.00
			660.00	600.00
GRAND TOTAL			740.00	680.00
RECOMMENDED COST OF LUMP SUM REPAIRS (TO ITS PRE-ACCIDENT CONDITION) (CONFIRMED)				500.00
