PRELIMINARY ADVICE OF VEHICLE NO.

SHC6007G

ADJUSTMENT ON REPAIR COST FOR VEHICLE NO. SHC 6007G

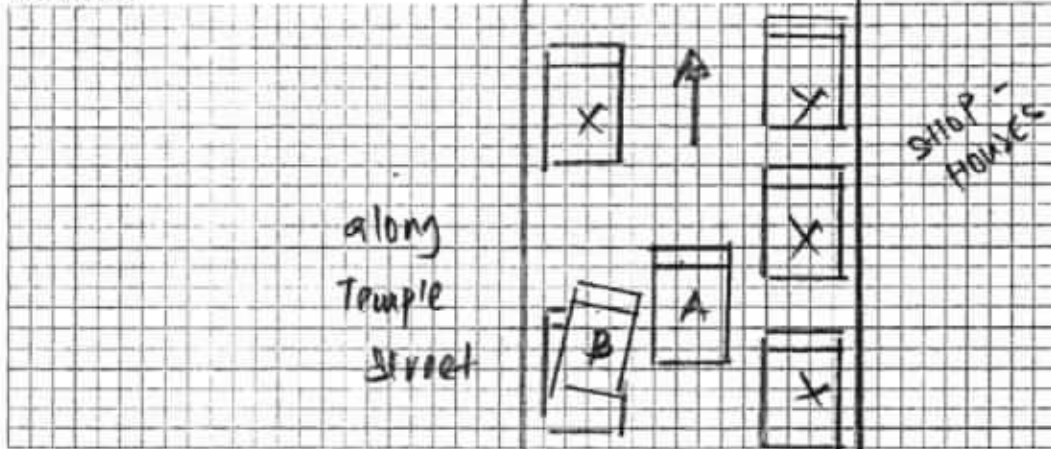
SKETCH PLAN

ON 14/10/2018 AT ABOUT 1950HRS, I WAS DRIVING MY TAXI (SHC 6007 G) TRAVELLING ALONG TEMPLE STREET – ON A SINGLE LANE OF ONE WAY ROUTE.

THERE WERE VEHICLES PARKED ALONG THE RIGHT & THE LEFT SIDE OF THE ROAD.

WHILE I WAS MOVING STRAIGHT AHEAD, SUDDENLY I FELT AN IMPACT FROM THE LEFT.

WHEN INSPECTED, I DISCOVERED THAT VEHICLE B (SGH 916 H – KIA PICANTO/WHITE) WHICH WAS INITIALLY STATIONARY/PARKED ALONG THE LEFT SIDE OF THE ROAD – HAD COLLIDED ONTO THE LEFT PORTION OF TAXI WHILE HE WAS MOVING OFF AHEAD.

DUE TO THE IMPACT, MY TAXI HAD DAMAGES ON THE LEFT PORTION AND VEHICLE B HAD DAMAGES ON THE RIGHT PORTION.

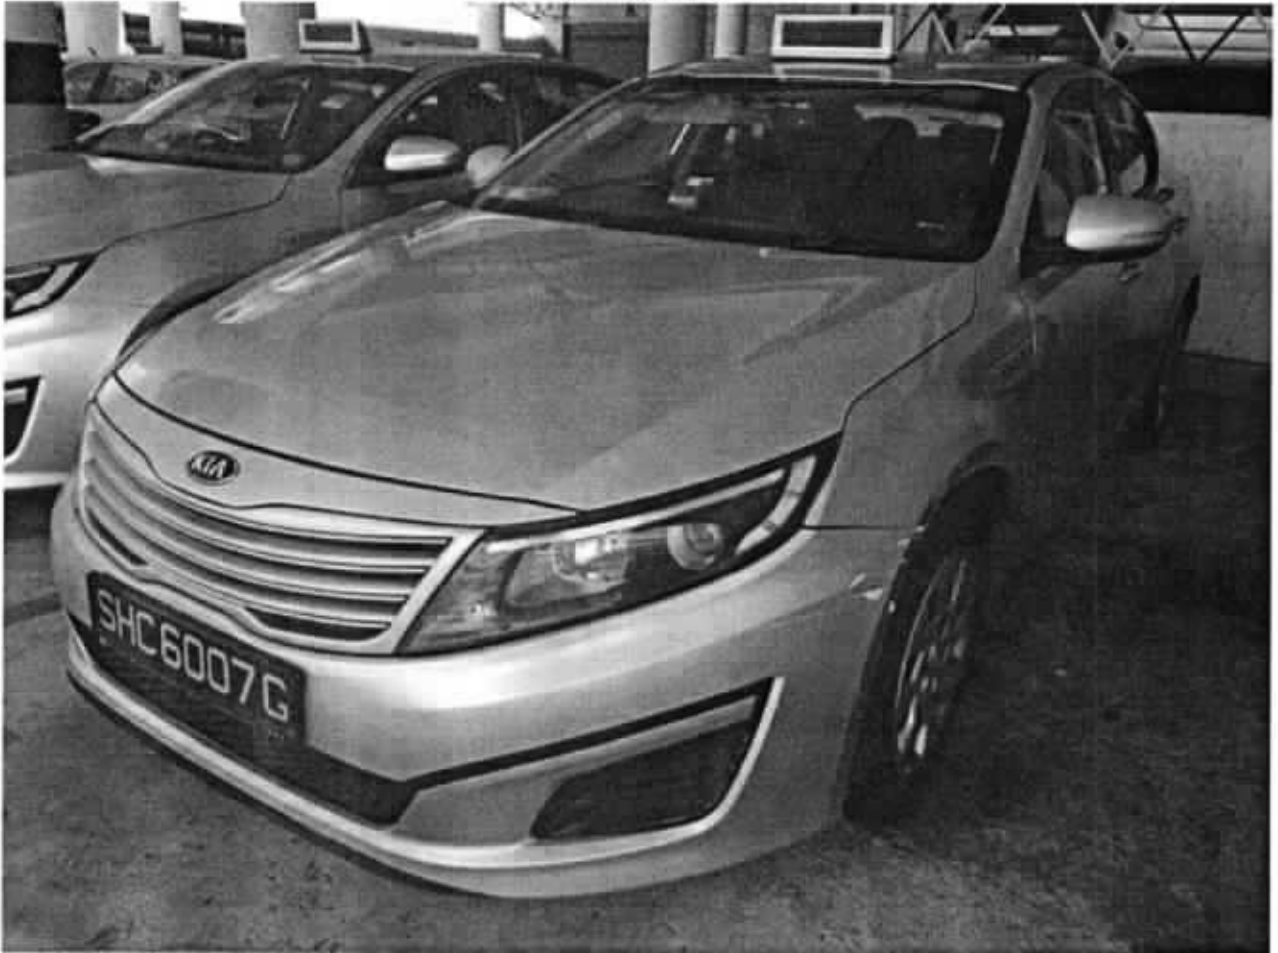
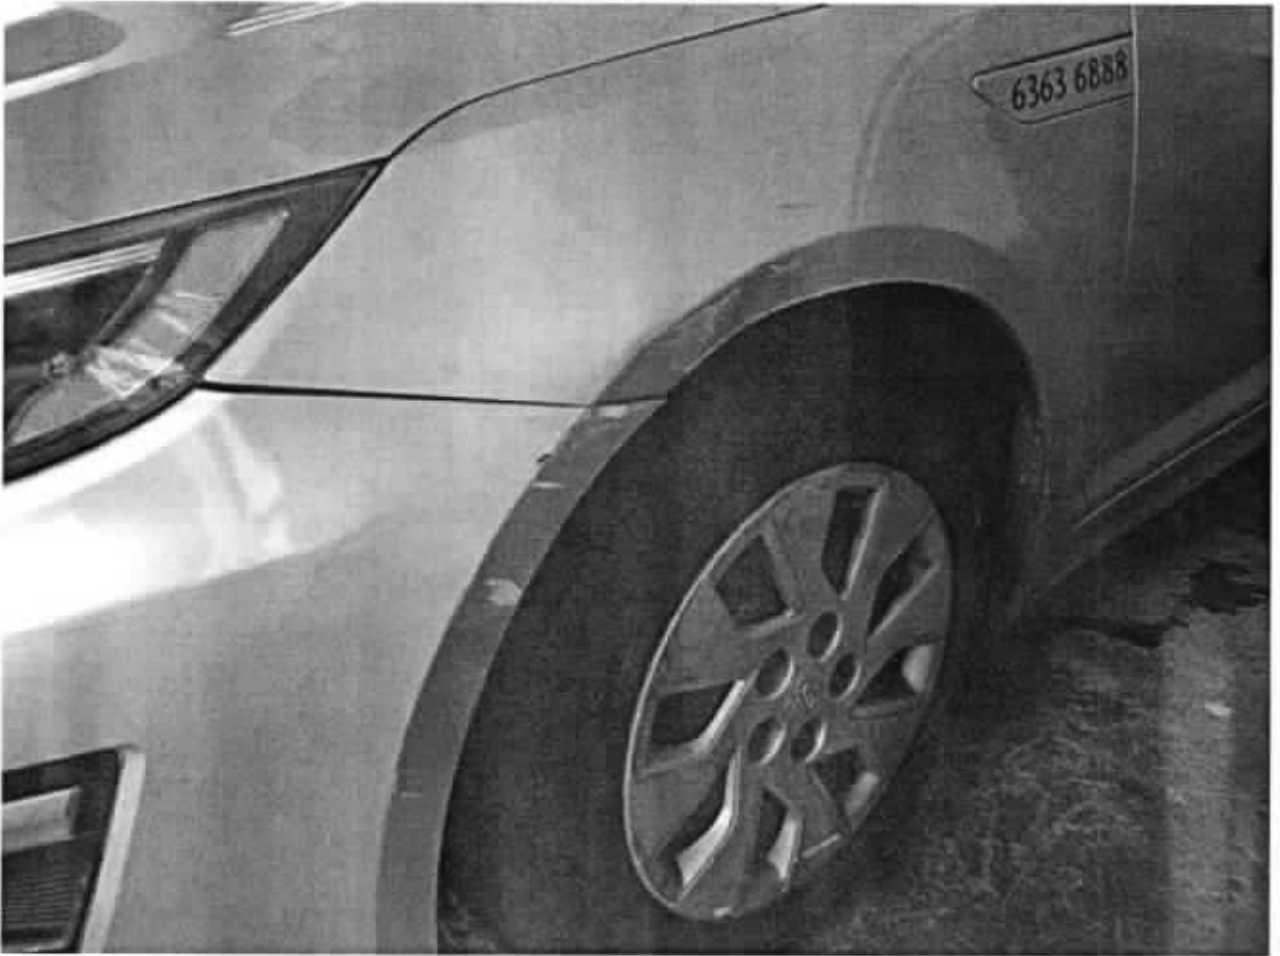
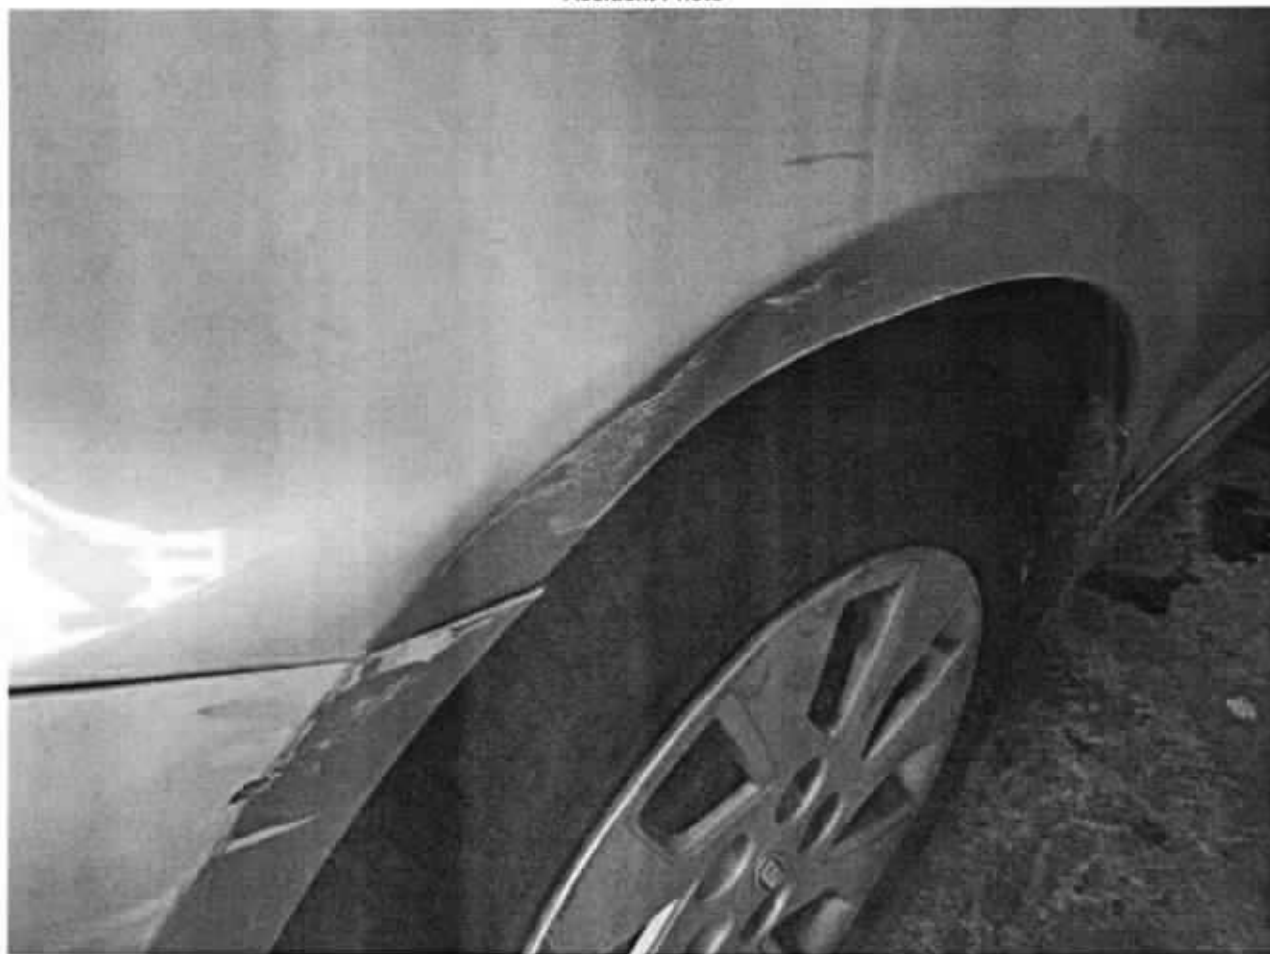
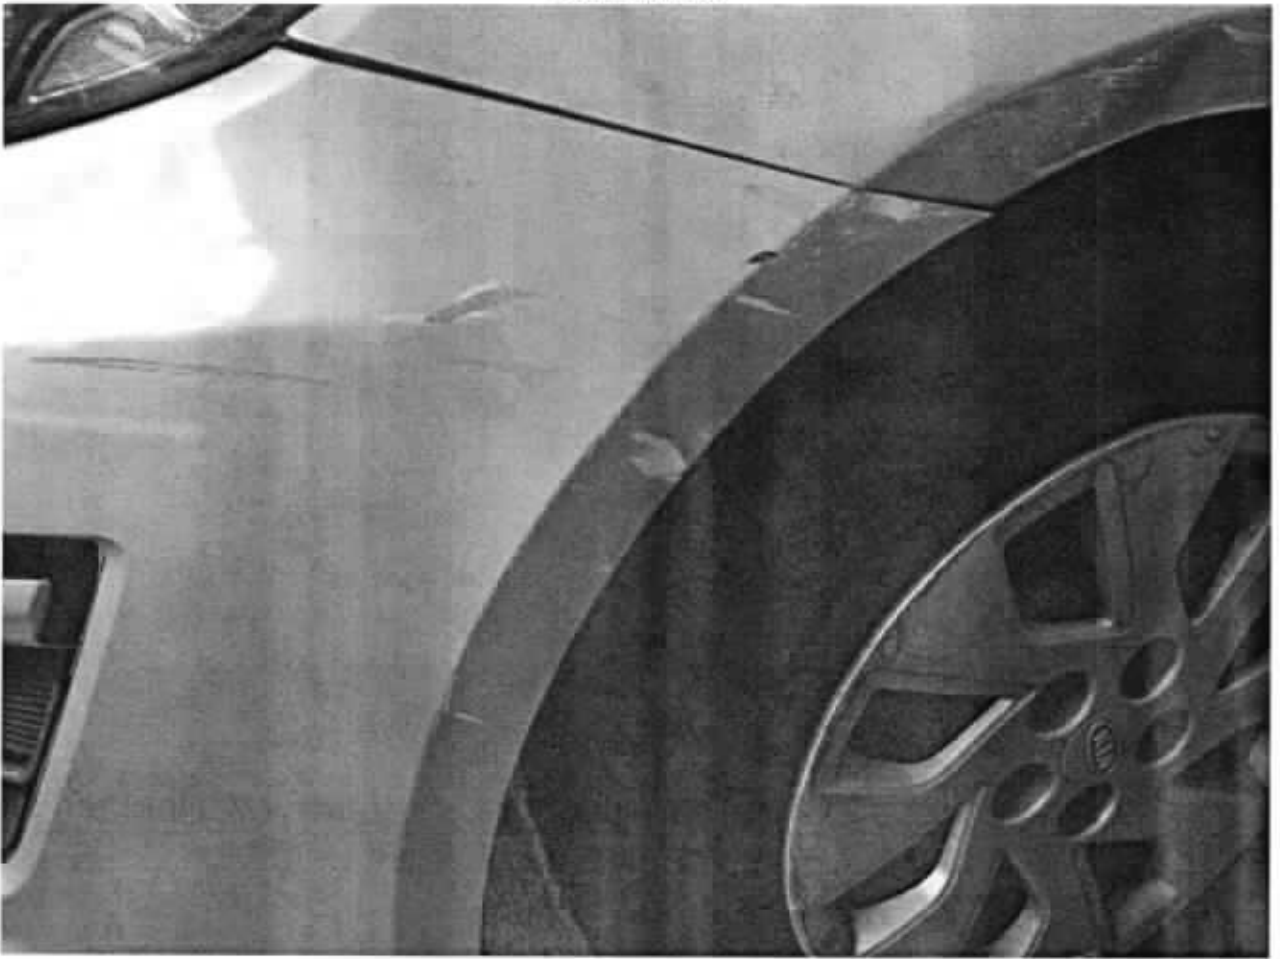
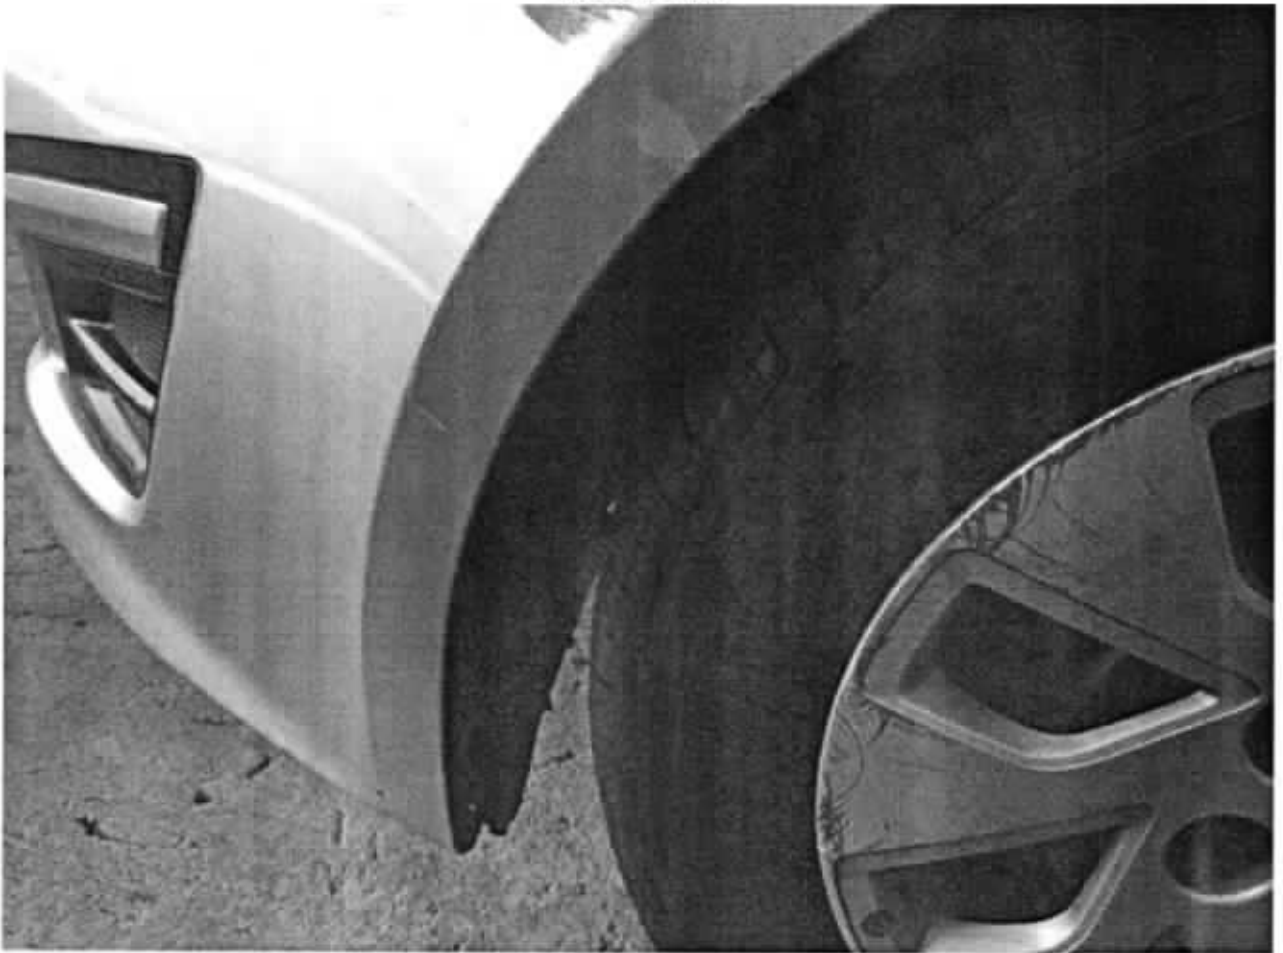
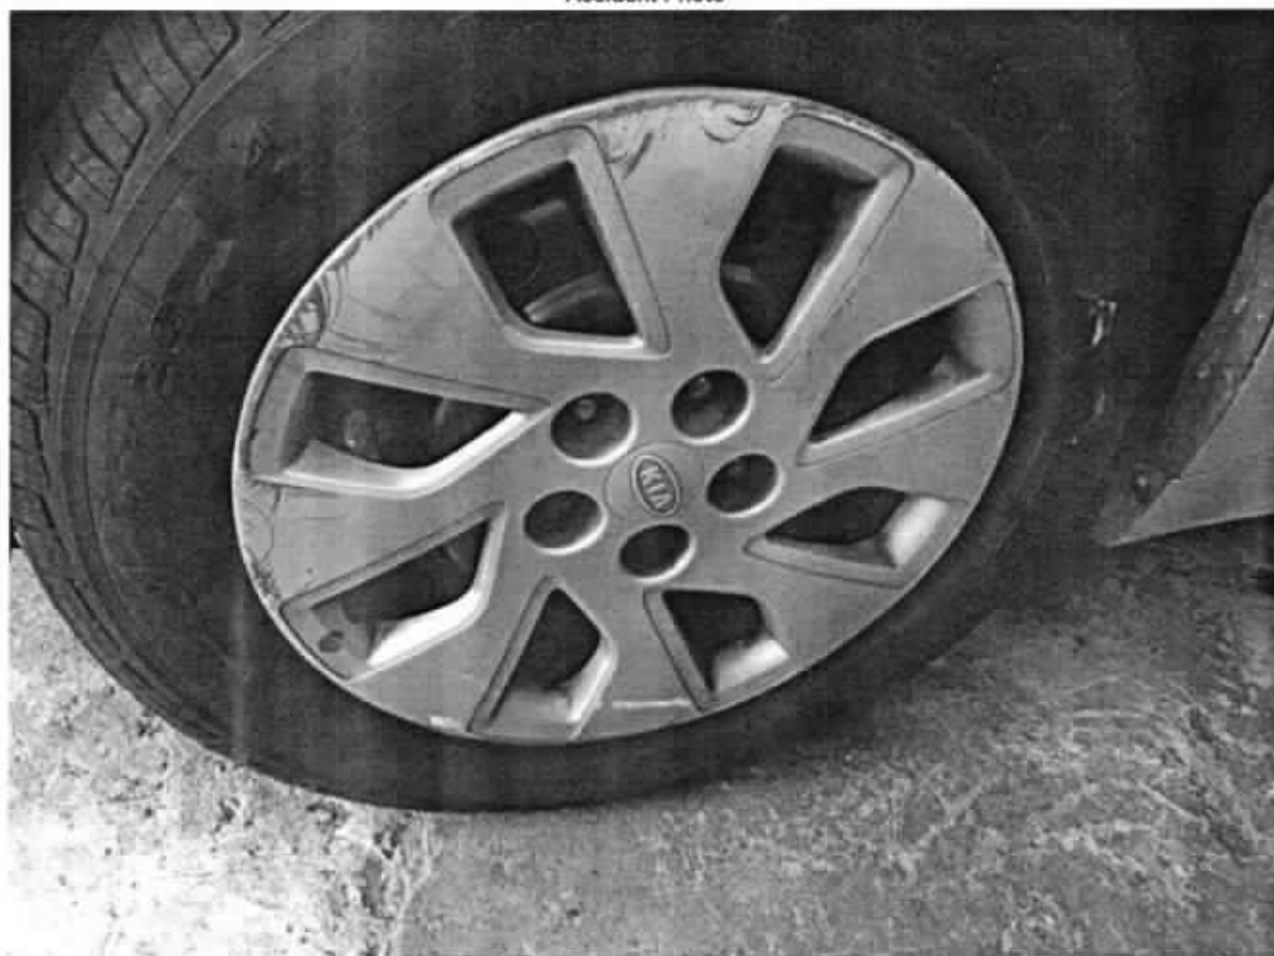
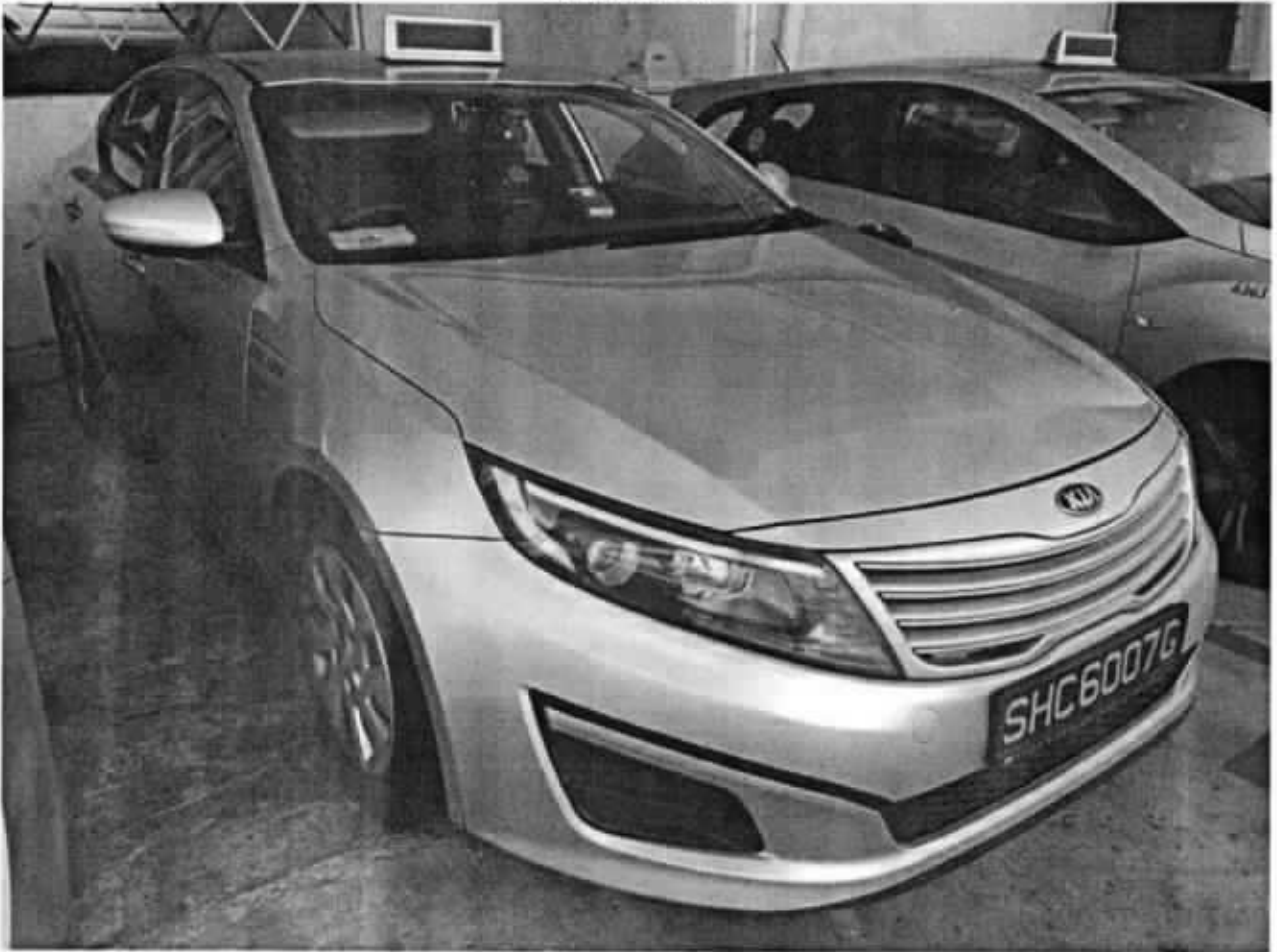
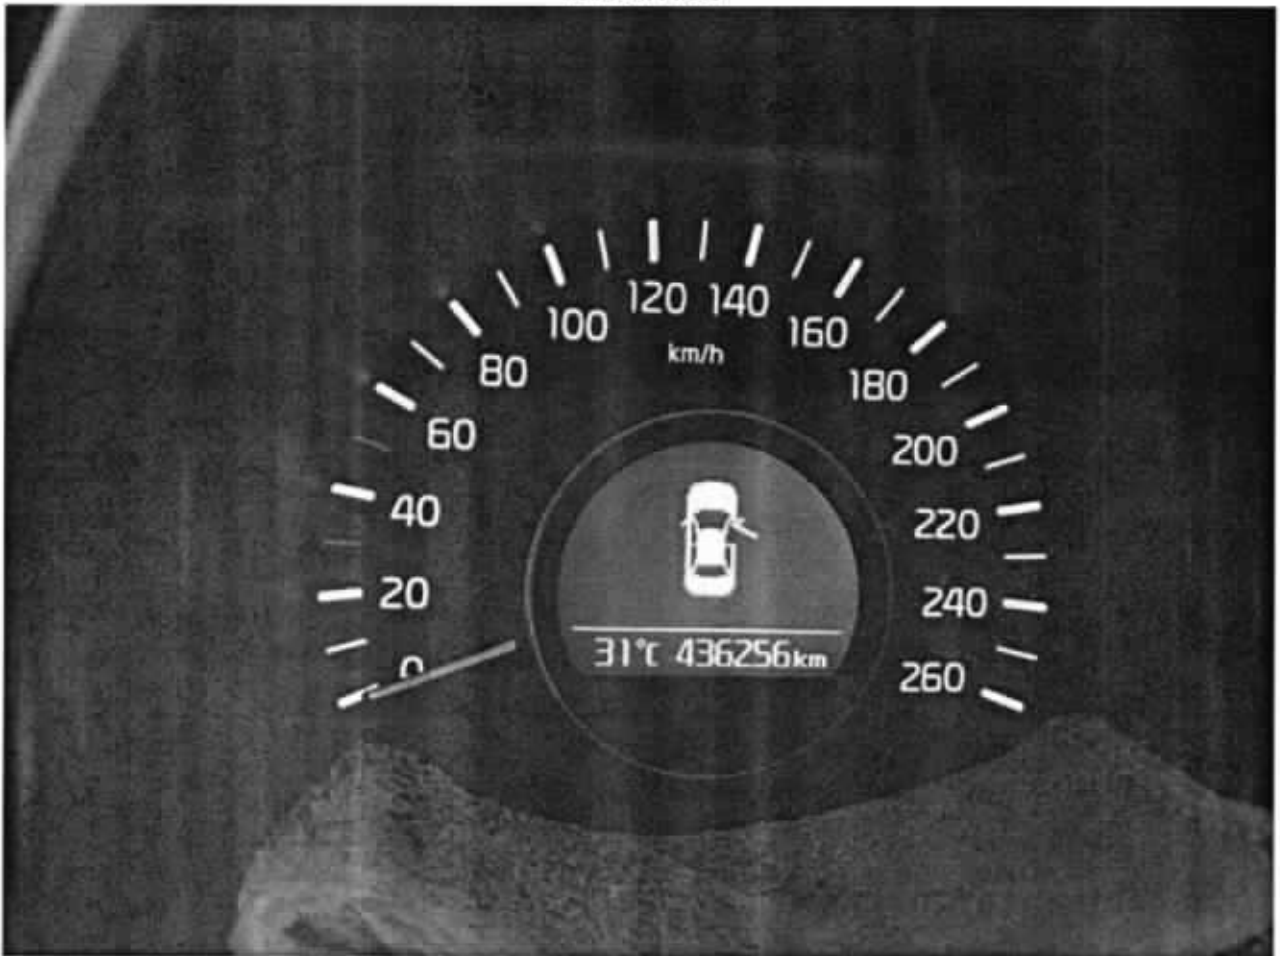
The vehicle sustained damages at the
N/S Front Portion

Damages Consistent

4. Description of Damages				
THE VEHICLE SUSTAINED DAMAGES AT THE N/S FRONT PORTION. DAMAGES SEE DETAILS.				
5. General Information				
Accident Date	14/10/2018	Inspection Date	15/10/2018	
Survey held at	PREMIER AUTOMOTIVE SERVICES PTE LTD 23 CHANGI SOUTH AVENUE 2 #01-02 SINGAPORE 486443			
5a. Remarks				
A)THE INSPECTION WAS CONDUCTED ON A"WITHOUT PREJUDICE" BASIS. B)IN ACCORDANCE TO YOUR INSTRUCTIONS, WE HAVE NOT AUTHORISED REPAIRS.				
5b. Estimate Days of Repair				
ESTIMATED NORMAL PERIOD FOR REPAIR:		2 Working Days

Qty	Description of Parts	Condition	Estimate By Workshop (\$)	Our Adjusted (\$)
REPLACEMENT OF PARTS				
1	FRONT BUMPER EMBLEM	NECESSARY	44.00	44.00
1	FRONT BUMPER	TO REPAIR SEE LABOUR	531.00	-
1	FRONT BUMPER N/S SIDE RETAINER	SERVICEABLE	16.00	-
1	FRONT N/S FENDER	DENTED	384.00	384.00
1	FRONT N/S FENDER INNER SHIELD	SERVICEABLE	120.00	-
1	FRONT N/S WHEEL COVER	TO REPAIR SEE LABOUR	116.00	-
	LESS 10% DISCOUNT		-121.10	-42.80
			1,089.90	385.20
SPECIAL NETT ITEMS				
1	SET FRONT N/S FENDER INNER SHIELD CLIPS (SN)	NOT NECESSARY	28.00	-
1	SET FRONT BUMPER CLIPS (SN)	NOT NECESSARY	48.00	-
1	FRONT N/S FENDER STICKER (SN)	NOT NECESSARY	30.00	-
1	SUNDRY (SN)	NECESSARY	50.00	20.00

156.00	20.00
LABOUR				
	TO CHECK WHEEL ALIGNMENT .	NOT NECESSARY	80.00	-
	TO DISMANTLE /REFIT THE INNER GARNISHES ,INNER LININGS ,INNER TRIMS ,CUSHION SEAT ,CARPET ,ETC TO FACILITATE REPAIRS.	NOT NECESSARY	180.00	-
	TO LABOUR CHARGE FOR DISMANTLE AND RENEW THE ACCIDENT DAMAGED PARTS ,INCLUDING KNOCK - OUT ,STRAIGHTEN ,REPAIR,RESHAPE AND ADJUST OF THE SAME ,ETC .INCLUSIVE OF THE REPAIR OF FRONT BUMPER AND FRONT N/S WHEEL COVER .		550.00	400.00
	TO PUTTY AND SPRAY PAINTING ON FRONT BUMPER ,FRONT N/S FENDER.		400.00	360.00
	TO APPLY RUSTPROOFING ON THE REPAIRED AND REPLACED PANELS.		80.00	20.00

RECOMMENDED COST OF LUMP SUM REPAIRS (TO ITS PRE-ACCIDENT CONDITION)			950.00
---	--	--	--------

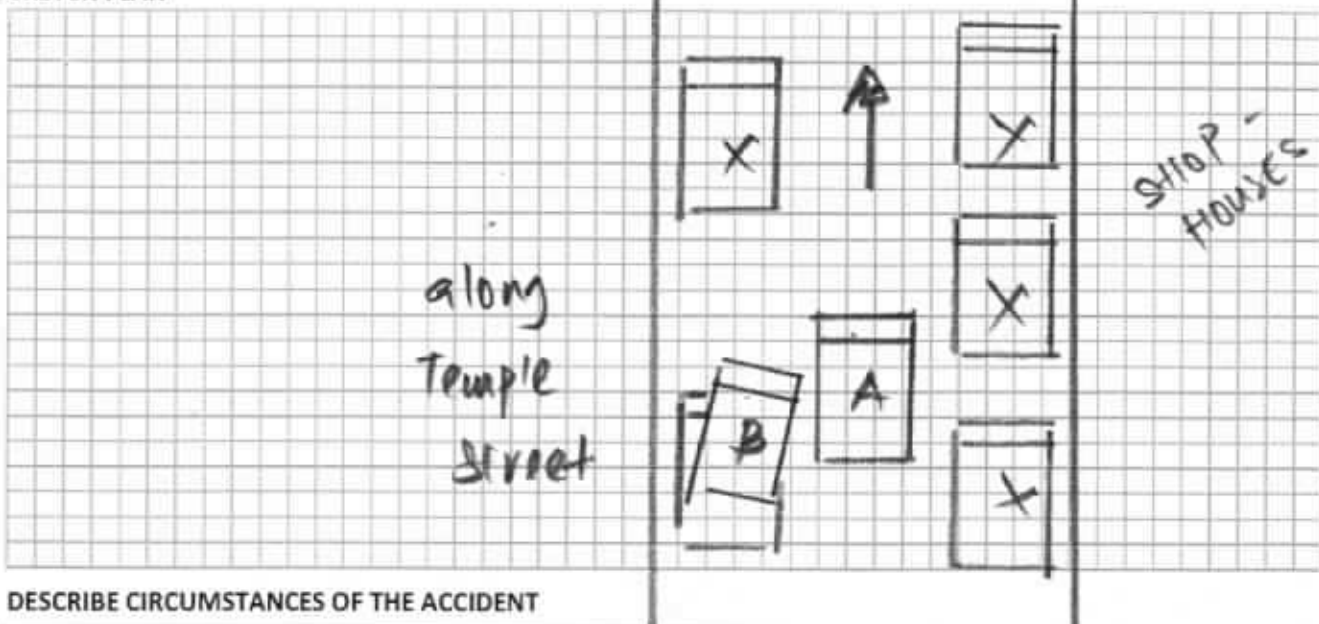
SKETCH PLAN

ON 14/10/2018 AT ABOUT 1950HRS, I WAS DRIVING MY TAXI (SHC 6007 G)
TRAVELLING ALONG TEMPLE STREET – ON A SINGLE LANE OF ONE WAY ROUTE.

THERE WERE VEHICLES PARKED ALONG THE RIGHT & THE LEFT SIDE OF THE
ROAD.

WHILE I WAS MOVING STRAIGHT AHEAD, SUDDENLY I FELT AN IMPACT FROM THE
LEFT.

WHEN INSPECTED, I DISCOVERED THAT VEHICLE B (SGH 916 H – KIA
PICANTO/WHITE) WHICH WAS INITIALLY STATIONARY/PARKED ALONG THE
LEFT SIDE OF THE ROAD – HAD COLLIDED ONTO THE LEFT PORTION OF TAXI WHILE
HE WAS MOVING OFF AHEAD.

DUE TO THE IMPACT, MY TAXI HAD DAMAGES ON THE LEFT PORTION AND VEHICLE
B HAD DAMAGES ON THE RIGHT PORTION.
