ACCIDENT INVOLVING GOVERNMENT VEHICLE QX592E AND OTHER VEHICLE PC7107A ON 9/10/2018

AUTOMOTIVE ENGINEERING & MGT DIVISION Ref : CS/SPF18018837/Kcbe2

4. Description of Damages

ADJUSTMENT ON REPAIR COST FOR VEHICLE NO. PC 7107A

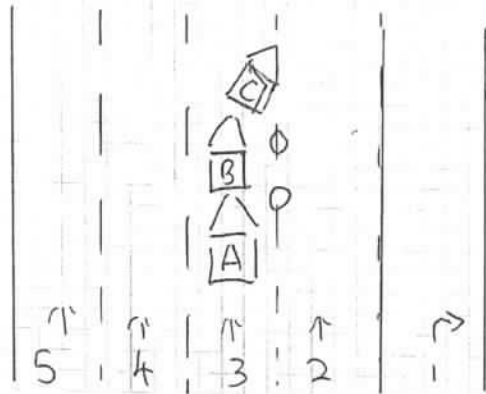
ATTACHMENT

A - PC 7107 A

B - SGR 5062 K

C - QX 592 E

The accident cause by the Police vehicle, QX 592 E
We doing a third Party claim against QX 592 E.
