1. Policy Particulars :- THIRD PARTY CLAIM

4. Description of Damages

THE VEHICLE SUSTAINED DAMAGES AT THE REAR O/S PORTION. DAMAGES SEE DETAILS.
--

ADJUSTMENT ON REPAIR COST FOR VEHICLE NO. SH 6771B

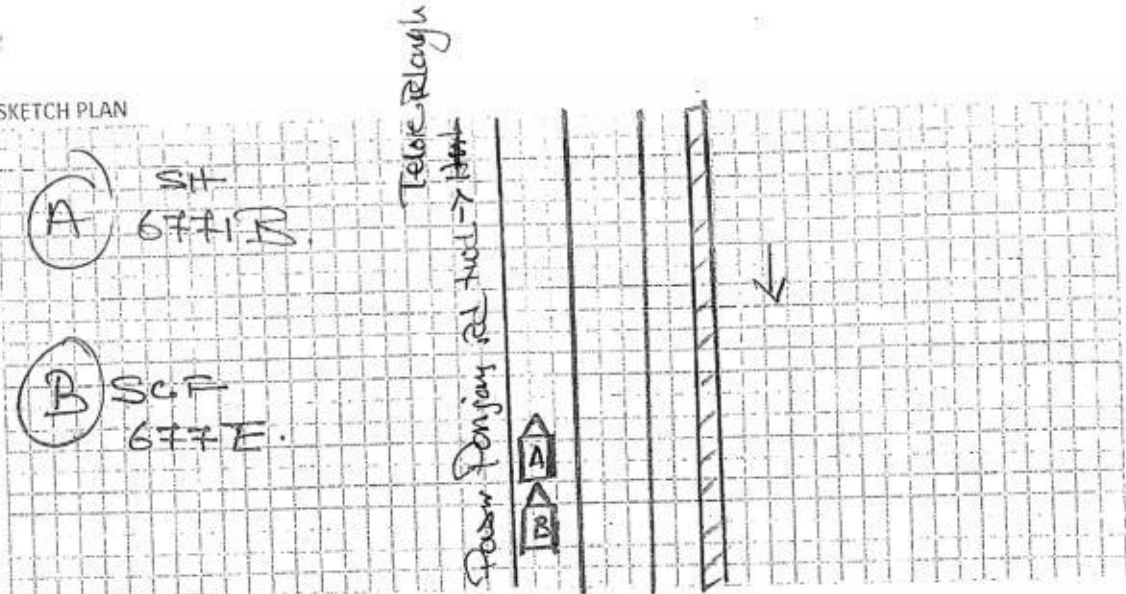
SKETCH PLAN

ON. 16 OCT 2018 @ 09:55 hr I

veh A was driving along the above

location vehicle instant stop. I

veh A also stop. Suddenly veh B

from the rear hit veh A rear. at

the point of accident veh A ferry

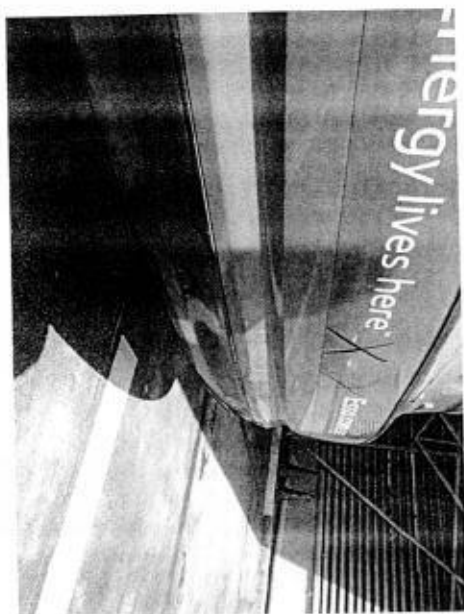
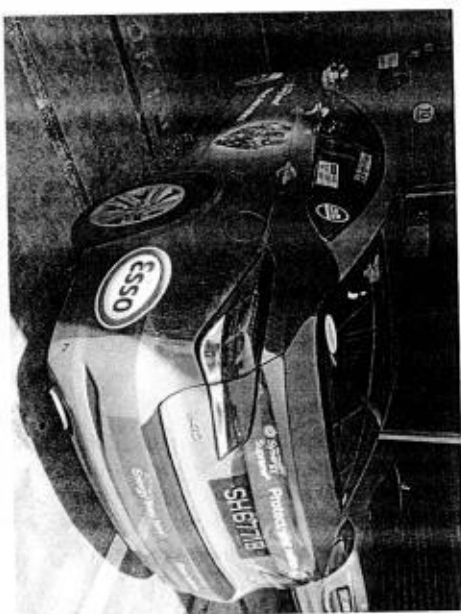
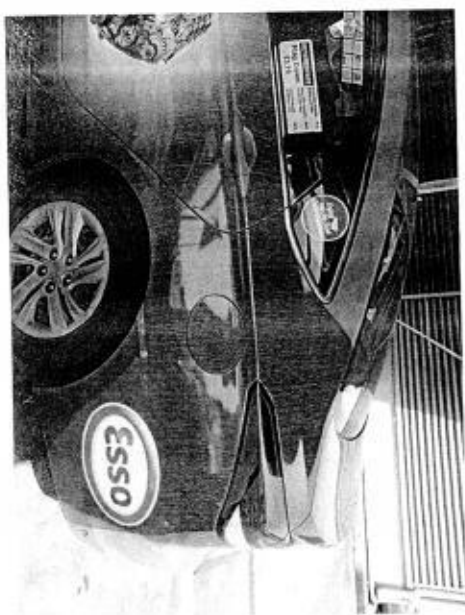
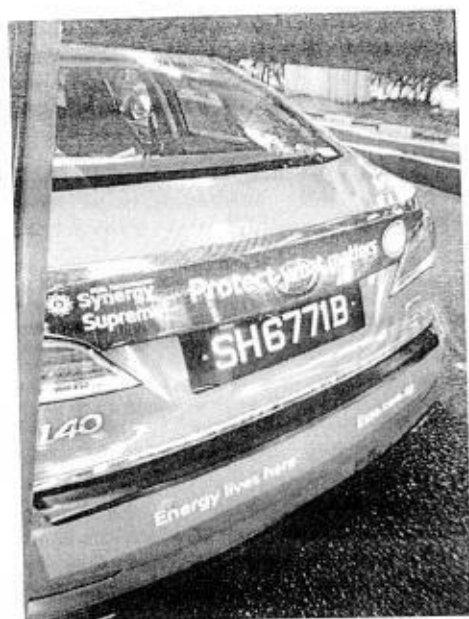
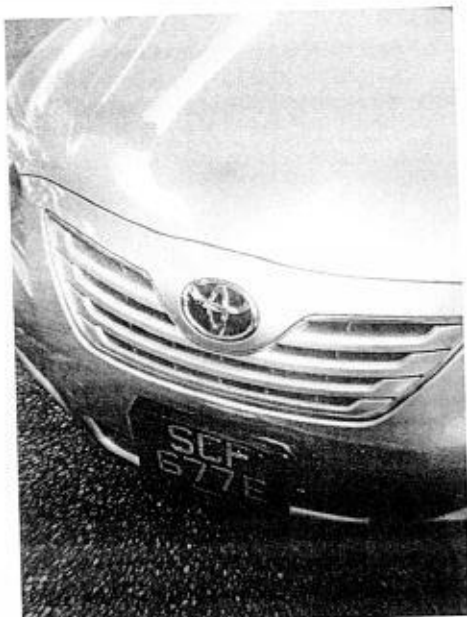
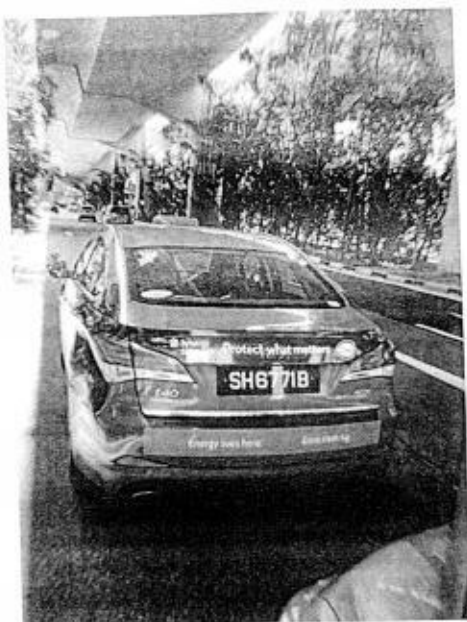
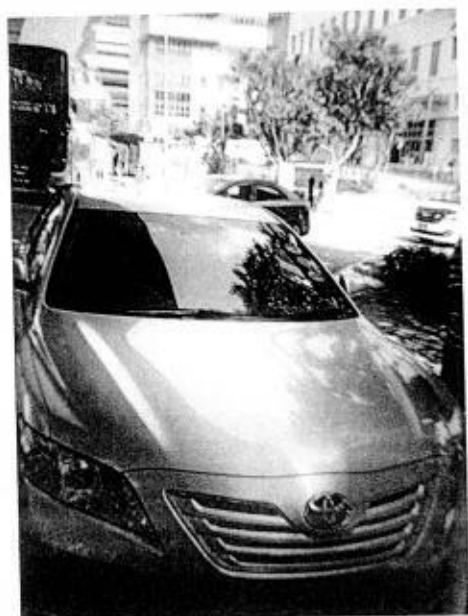
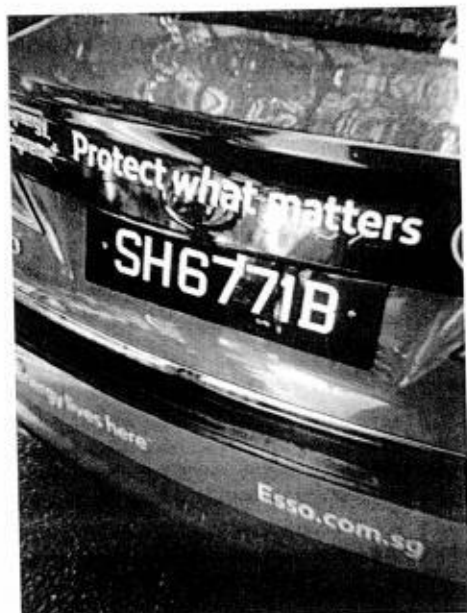
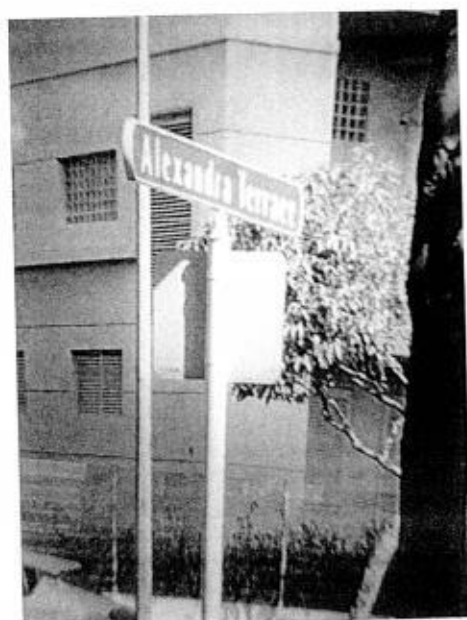
Remark: The veh had commenced its repair at the time of inspection.

Rear o/s

The U/C / Chassis frame / Body Structure affected due to collision.

Qty	Description of Parts	Condition	Estimate By Workshop (\$)	Our Adjusted (\$)
<u>REPLACEMENT OF PARTS</u>				
1	REAR BUMPER	DEFORMED	553.00	553.00
10	REAR BUMPER CLIP	NECESSARY	22.00	22.00
	LESS 20% DISCOUNT		-115.00	-115.00
			460.00	460.00
<u>SPECIAL NETT ITEMS</u>				
1	REAR BUMPER RUBBER MAT (SN)	NECESSARY	50.00	50.00
1	REAR BUMPER ADVERTISEMENT LOGO (SN)	NECESSARY	50.00	50.00
2	REAR FENDER ADVERTISEMENT LOGO (LH/RH) @\$100.00 (SN)	NECESSARY	200.00	200.00
			300.00	300.00
<u>LABOUR</u>				
	PANEL BEATING.	NOT NECESSARY	400.00	200.00
	SPRAY PAINTING CHARGE.		300.00	200.00
	WIRING CHARGE.		30.00	-
	REMOVE/REFIX REVERSE SENSOR.		80.00	30.00
			810.00	430.00
GRAND TOTAL			1,570.00	1,190.00
RECOMMENDED COST OF LUMP SUM REPAIRS (TO ITS PRE-ACCIDENT CONDITION) (CONFIRMED)				950.00
