NS/INC18018921/Klvb12

### 1. Policy Particulars :- THIRD PARTY CLAIM

### 4. Description of Damages

## ADJUSTMENT ON REPAIR COST FOR VEHICLE NO. SHC 3839S

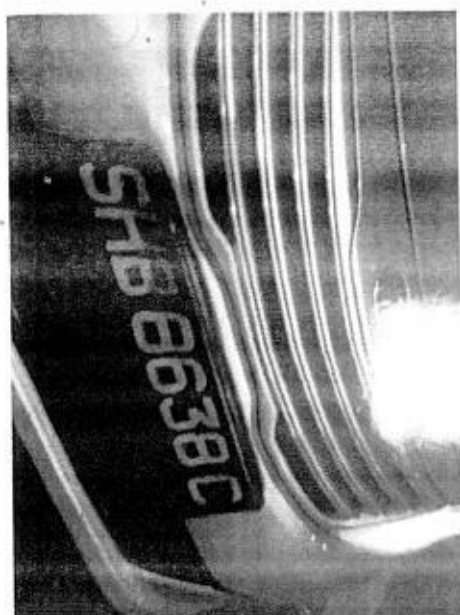
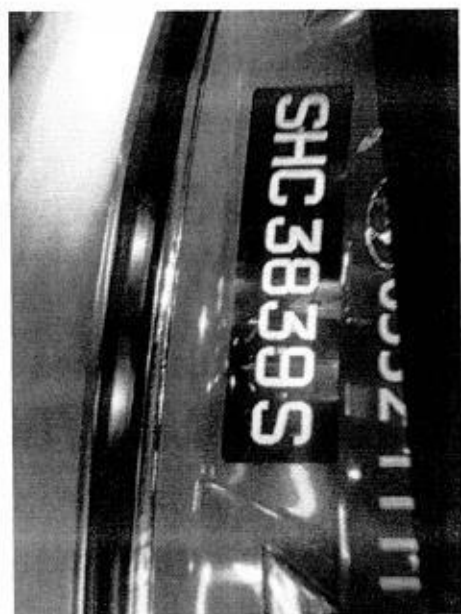
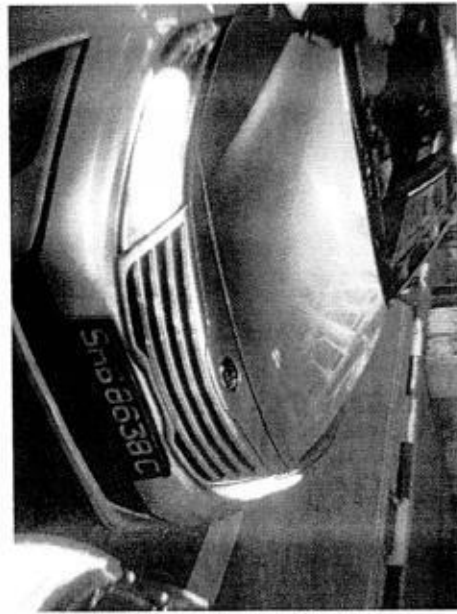
THE VEHICLE SUSTAINED DAMAGES AT THE REAR PORTION. DAMAGES SEE DETAILS.
--

Qty	Description of Parts	Condition	Estimate By Workshop (\$)	Our Adjusted (\$)
	<b><u>REPLACEMENT OF PARTS</u></b>			
1	REAR BUMPER	DEFORMED	553.00	553.00
10	REAR BUMPER CLIP	NECESSARY	22.00	22.00
	LESS 20% DISCOUNT		-115.00	-115.00
			460.00	460.00
	<b><u>SPECIAL NETT ITEMS</u></b>			
1	REAR BUMPER RUBBER MAT (SN)	NECESSARY	50.00	50.00
			50.00	50.00
	<b><u>LABOUR</u></b>			
	PANEL BEATING.		220.00	200.00
	SPRAY PAINTING CHARGE.		220.00	200.00
			440.00	400.00
	<b>GRAND TOTAL</b>		<b>950.00</b>	<b>910.00</b>
	<b>RECOMMENDED COST OF LUMP SUM REPAIRS (TO ITS PRE-ACCIDENT CONDITION) (CONFIRMED)</b>			<b>700.00</b>
