ASSIGNMENT

1. Policy Particulars :- THIRD PARTY CLAIM				
Insured Veh.	SJM 5512U	Veh. Inspected	SHA 8238D	
Policy No.	5101414854	Coverage (\$)	0.00	
Claim No.	MT/1016204-002	Excess (\$)	0.00	
Assign From		Assign Date	19/10/2018

4. Description of Damages				
THE VEHICLE SUSTAINED DAMAGES AT THE O/S FRONT PORTION. DAMAGES SEE DETAILS.				
5. General Information				
Accident Date	18/10/2018	Inspection Date	19/10/2018	
Survey held at	COMFORTDELGRO ENGINEERING PTE LTD 59 LOYANG DRIVE SINGAPORE 508969			
5a. Remarks				
A)THE INSPECTION WAS CONDUCTED ON A"WITHOUT PREJUDICE" BASIS. B)IN ACCORDANCE TO YOUR INSTRUCTIONS, WE HAVE NOT AUTHORISED REPAIRS.				
5b. Estimate Days of Repair				
ESTIMATED NORMAL PERIOD FOR REPAIR:		2 Working Days

ADJUSTMENT ON REPAIR COST FOR VEHICLE NO. SHA 8238D

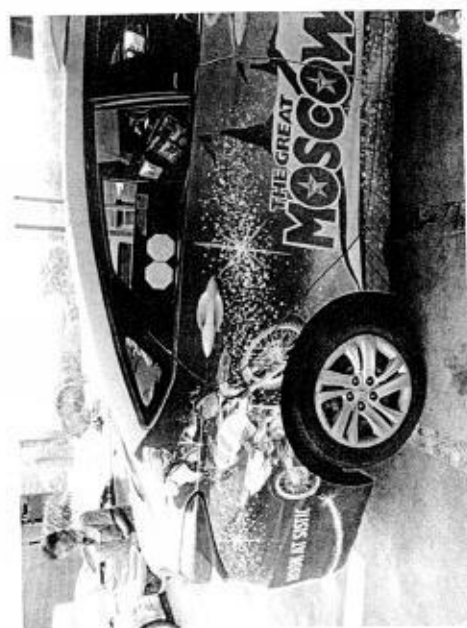
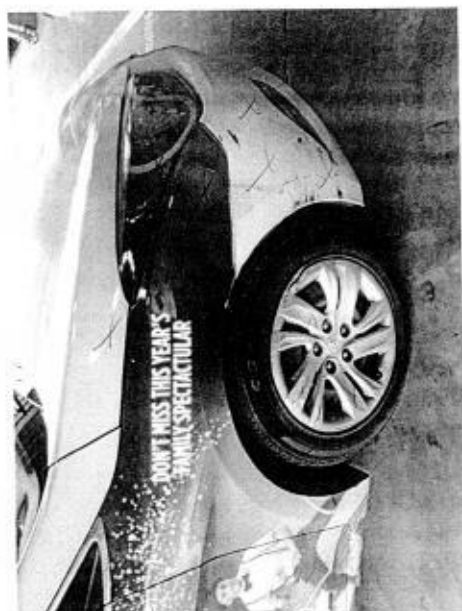
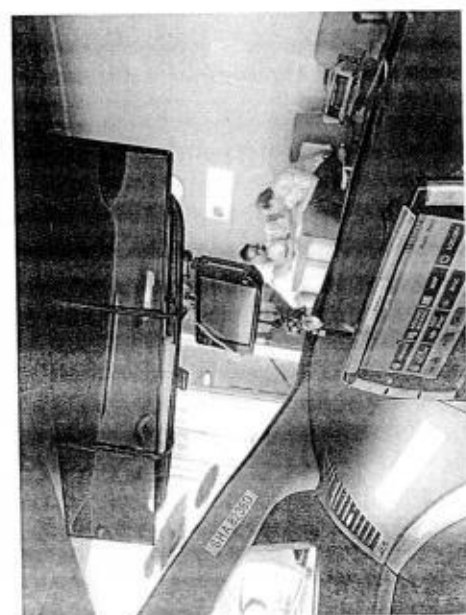
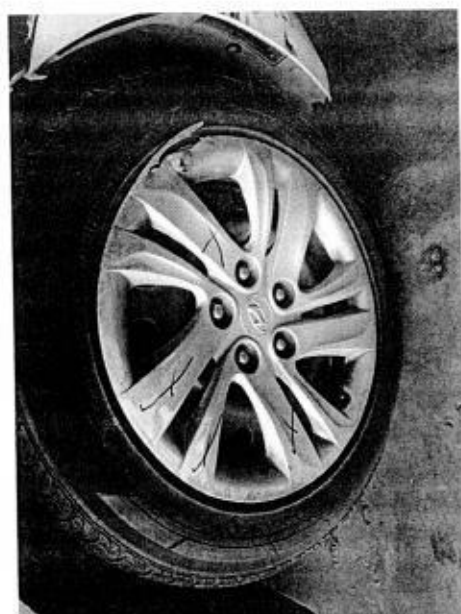
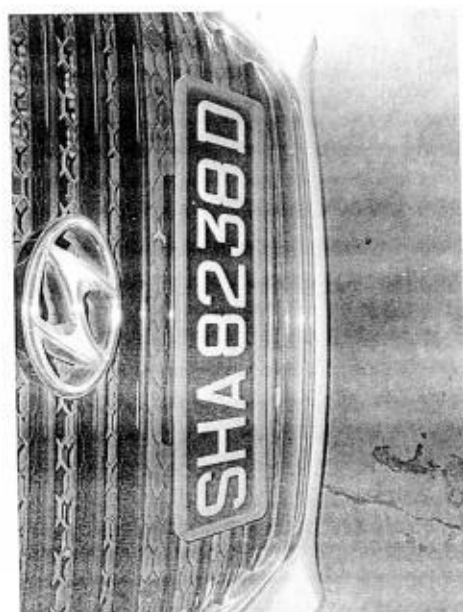
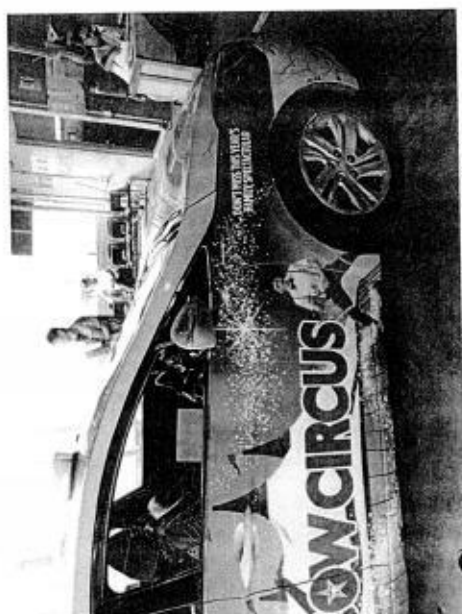
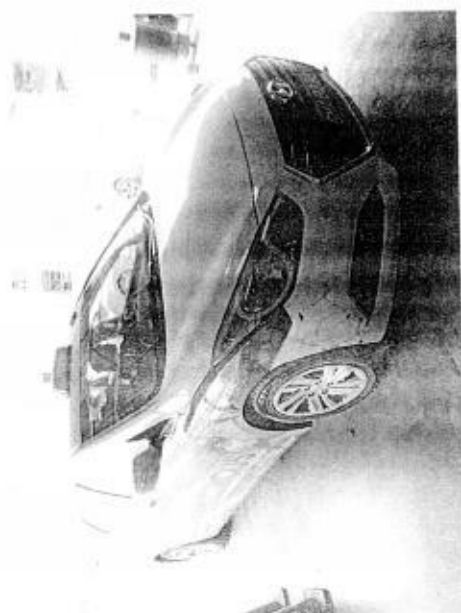
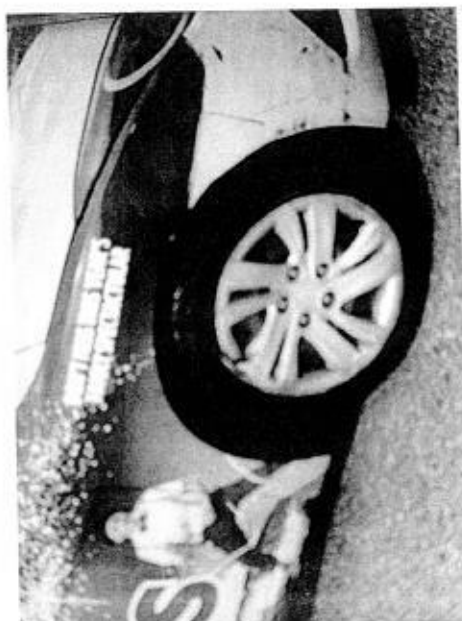
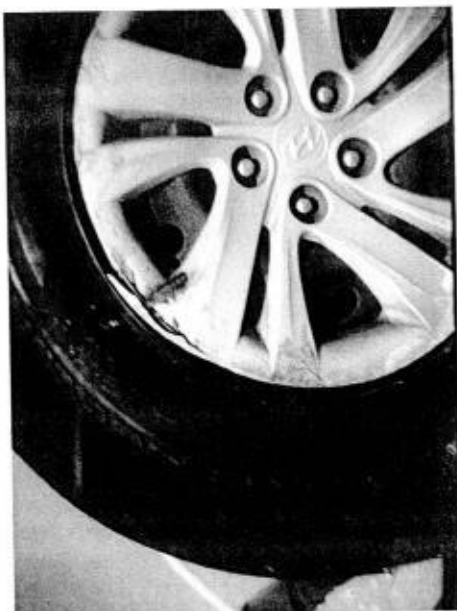
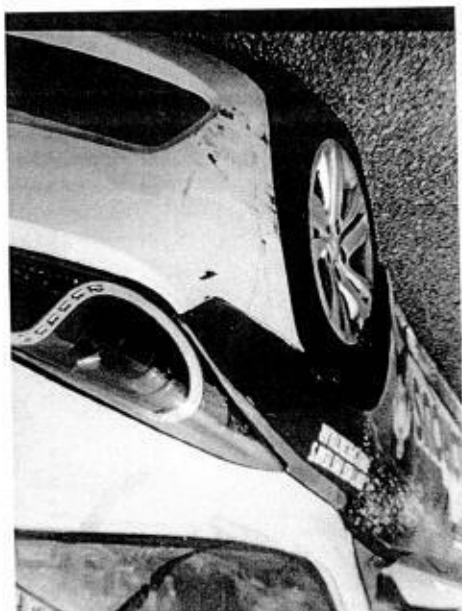
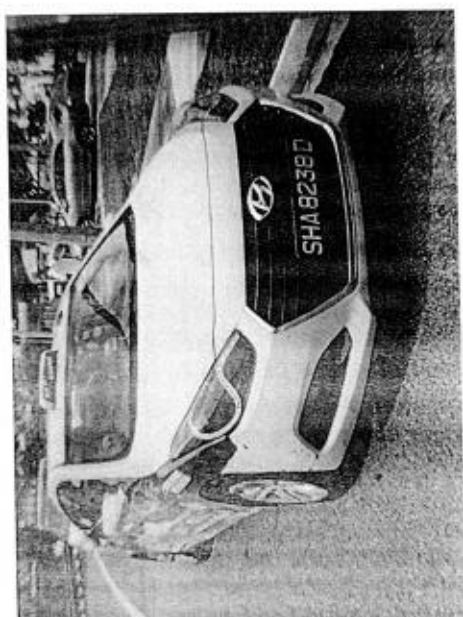
O/S Front.

The U/C / Chassis frame / Body Structure affected due to collision.

Qty	Description of Parts	Condition	Estimate By Workshop (\$)	Our Adjusted (\$)
REPLACEMENT OF PARTS				
1	FRONT BUMPER COVER	DEFORMED	544.50	544.50
1	FRONT BUMPER BRACKET (RH)	SERVICEABLE	22.40	-
1	FRONT BUMPER BRACKET (RH)	CRACKED	24.60	24.60
1	FRONT FENDER (RH)	DENTED	566.30	566.30
1	FRONT FENDER SHIELD (RH)	SERVICEABLE	175.90	-
1	FRONT FENDER RETAINER	SERVICEABLE	24.60	-
1	FRT WHEEL HUB CAP, RH	GRAZED	107.10	107.10
1	FRONT HEADLAMP (LH)	CRACKED	1,388.00	1,388.00
	LESS 20% DISCOUNT		-570.68	-526.10
			2,282.72	2,104.40
SPECIAL NETT ITEMS				
1	FRONT FENDER ADVERTISEMENT LOGO (RH)(SN)	NECESSARY	100.00	100.00

100.00	100.00
LABOUR				
	PANEL BEATING.		400.00	300.00
	SPRAY PAINTING CHARGE.		500.00	400.00
	WIRING.		30.00	20.00
	TUFF KOTE.		50.00	20.00
	FRT WHEEL ALIGNMENT.	NOT NECESSARY	80.00	-
			1,060.00	740.00
GRAND TOTAL			3,442.72	2,944.40
RECOMMENDED COST OF LUMP SUM REPAIRS (TO ITS PRE-ACCIDENT CONDITION) (CONFIRMED)				2,350.00
