NS/INC18019055 / K14bn2

NTUC INCOME INSURANCE CO-OPERATIVE LTD Ref: NS/INC18019055/K1tbn2				
73 BRAS BASAH ROAD #05-01 NTUC TRADE UNION HOUSESINGAPORE 189556			Date: 26-10-2018

4. Description of Damages				
THE VEHICLE SUSTAINED DAMAGES AT THE O/S REAR PORTION. DAMAGES SEE DETAILS.				
5. General Information				
Accident Date	19/10/2018	Inspection Date	19/10/2018	
Survey held at	COMFORTDELGRO ENGINEERING PTE LTD 59 LOYANG DRIVE SINGAPORE 508969			
5a. Remarks				
A)THE INSPECTION WAS CONDUCTED ON A"WITHOUT PREJUDICE" BASIS. B)IN ACCORDANCE TO YOUR INSTRUCTIONS, WE HAVE NOT AUTHORISED REPAIRS.				
5b. Estimate Days of Repair				
ESTIMATED NORMAL PERIOD FOR REPAIR:		2 Working Days

ADJUSTMENT ON REPAIR COST FOR VEHICLE NO. SH 6190C

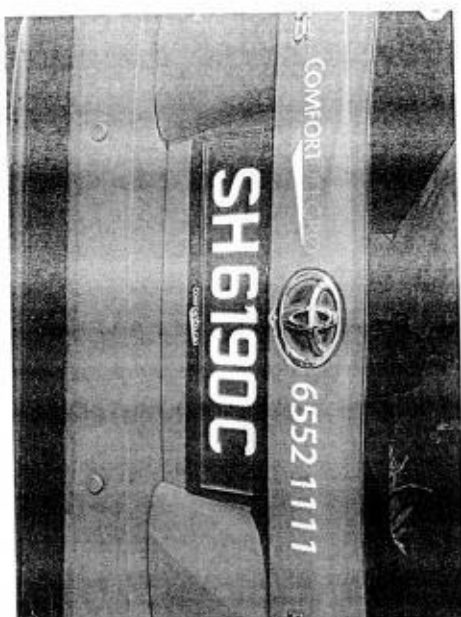
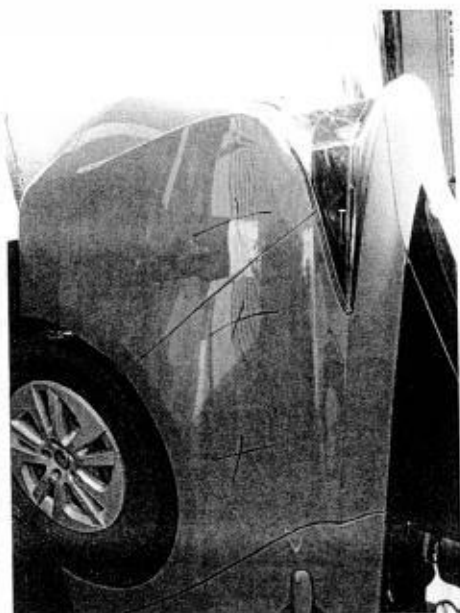
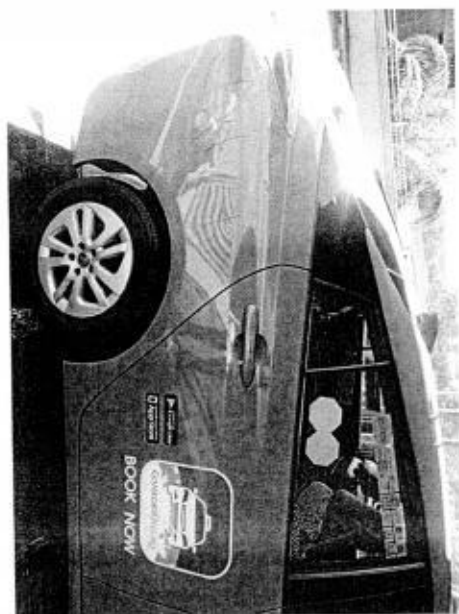
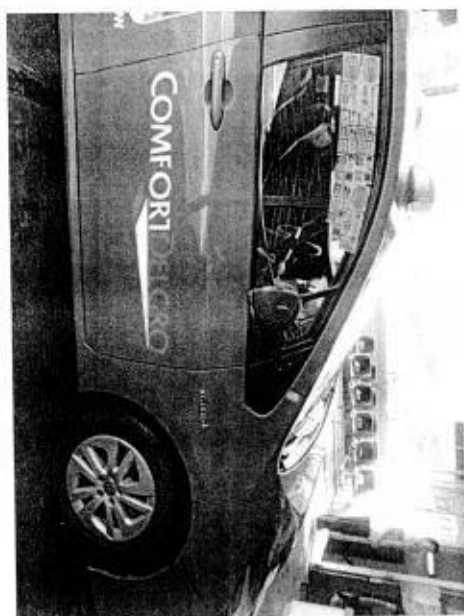
o/s Rear

The U/C / Chassis frame / Body Structure affected due to collision.

Qty	Description of Parts	Condition	Estimate By Workshop (\$)	Our Adjusted (\$)
	<u>REPLACEMENT OF PARTS</u>			
1	TAIL LAMP ASSY (UPPER)(RH)	CRACKED	557.90	557.90
1	REAR BUMPER (NPA)	TO REPAIR SEE LABOUR	-	-
1	REAR FENDER (RH)(NPA)	TO REPAIR SEE LABOUR	-	-
	LESS 20% DISCOUNT		-111.58	-
	LESS 25% DISCOUNT		-	-139.47
			446.32	418.43
	<u>LABOUR</u>			
	PANEL BEATING.INCLUSIVE OF THE REPAIR OF REAR BUMPER AND REAR FENDER (RH).		400.00	200.00
	SPRAY PAINTING CHARGE-FENDER/BUMPER.		600.00	400.00
	TUFF KOTE.	NOT NECESSARY	50.00	-
			1,050.00	600.00
	GRAND TOTAL		1,496.32	1,018.43
RECOMMENDED COST OF REPAIRS (CONFIRMED)				1,018.43
