REF:

1. Policy Particulars :- THIRD PARTY CLAIM				
Insured Veh.	PA 5248A	Veh. Inspected	SHD 3293K	
Policy No.	5085550657-02	Coverage (\$)	0.00	
Claim No.	MT/1017229-001	Excess (\$)	0.00	
Assign From		Assign Date	22/10/2018

4. Description of Damages				
THE VEHICLE SUSTAINED DAMAGES AT THE O/S FRONT PORTION. DAMAGES SEE DETAILS.				
5. General Information				
Accident Date	19/10/2018	Inspection Date	22/10/2018	
Survey held at	COMFORTDELGRO ENGINEERING PTE LTD 59 LOYANG DRIVE SINGAPORE 508969			
5a. Remarks				
A)THE INSPECTION WAS CONDUCTED ON A"WITHOUT PREJUDICE" BASIS. B)IN ACCORDANCE TO YOUR INSTRUCTIONS, WE HAVE NOT AUTHORISED REPAIRS.				
5b. Estimate Days of Repair				
ESTIMATED NORMAL PERIOD FOR REPAIR:		3 Working Days

ADJUSTMENT ON REPAIR COST FOR VEHICLE NO. SHD 3293K

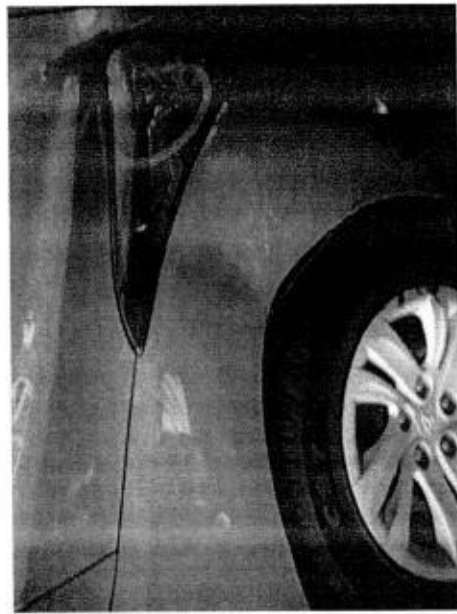
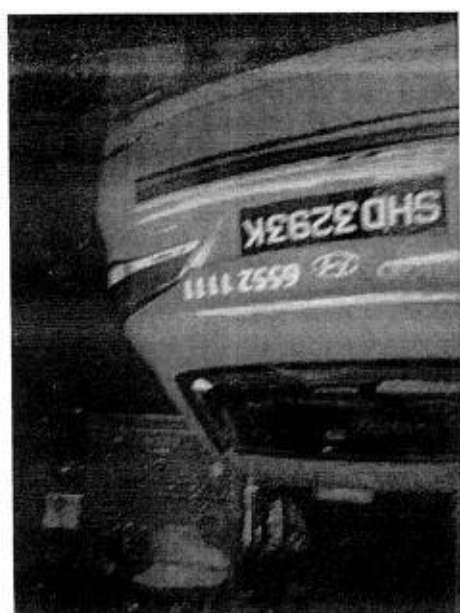
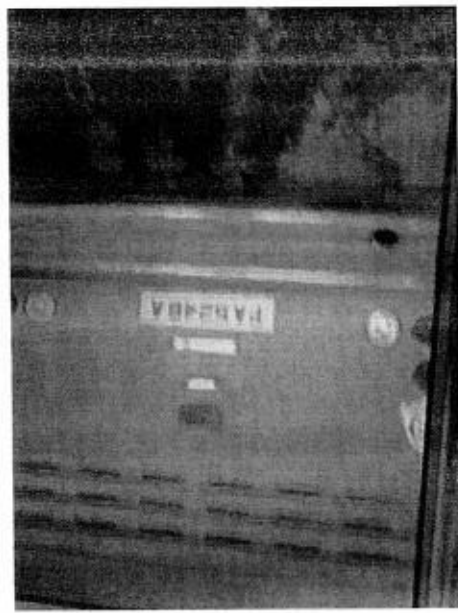
O/S Front.

The U/C / Chassis frame / Body Structure affected due to collision.

Qty	Description of Parts	Condition	Estimate By Workshop (\$)	Our Adjusted (\$)
REPLACEMENT OF PARTS				
1	FRONT BUMPER COVER	DEFORMED	544.50	544.50
1	FRONT BUMPER BRACKET TOP (RH)	CRACKED	22.40	22.40
1	FRONT BUMPER RETAINER MOUNTING (RH)	SERVICEABLE	9.20	-
1	HEADLAMP (RH)	SERVICEABLE	1,388.00	-
1	FRONT FENDER (RH)	DENTED	566.30	566.30
1	FRONT FENDER SHIELD (RH)	SERVICEABLE	175.90	-
1	FRONT FENDER RETAINER (RH)	SERVICEABLE	24.60	-
1	FRONT WHEEL HUB CAP (RH)	GRAZED	107.10	107.10
	LESS 20% DISCOUNT		-567.60	-248.06
			2,270.40	992.24
LABOUR				
	PANEL BEATING.		400.00	300.00
	SPRAY PAINTING CHARGE.		600.00	400.00
	WIRING CHARGE.	NOT NECESSARY	30.00	-
	TUFF KOTE.		50.00	20.00
	FRT WHEEL ALIGNMENT.	NOT NECESSARY	120.00	-
			1,200.00	720.00
GRAND TOTAL			3,470.40	1,712.24
RECOMMENDED COST OF REPAIRS (CONFIRMED)				1,712.24
