REF: NO/INC18019175/Klgbnz

Veh No: SHC 8296A Yr Regn: 6 Aug 2015

4. Description of Damages			
THE VEHICLE SUSTAINED DAMAGES AT THE REAR N/S PORTION.			
DAMAGES SEE DETAILS.			
5. General Information			
Accident Date	21/10/2018	Inspection Date	22/10/2018
Survey held at	COMFORTDELGRO ENGINEERING PTE LTD		
	59 LOYANG DRIVE		
	SINGAPORE 508969		
5a. Remarks

ADJUSTMENT ON REPAIR COST FOR VEHICLE NO. SHC 8296A

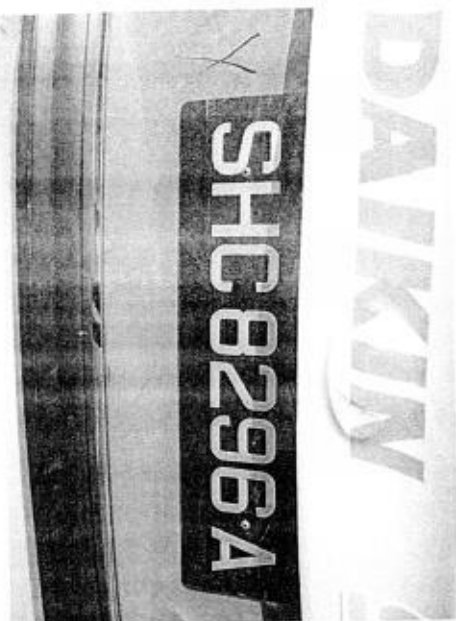
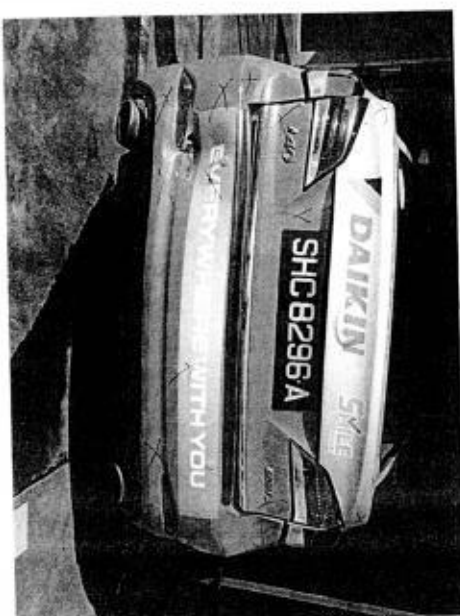
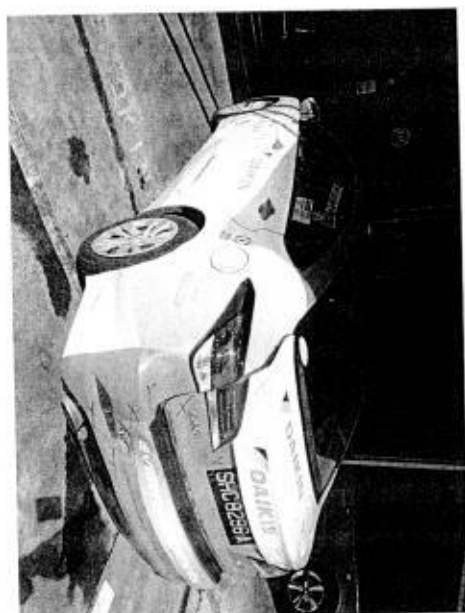
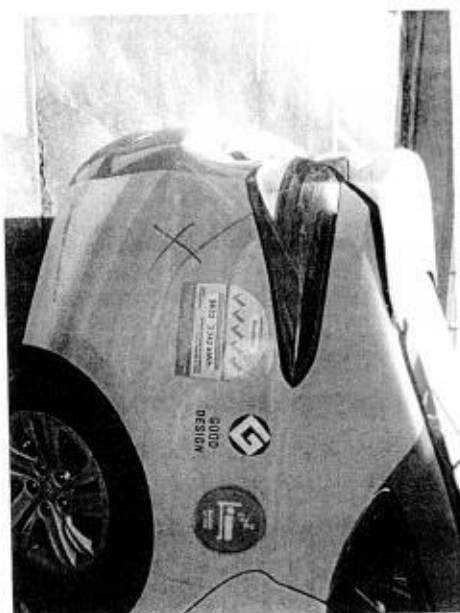
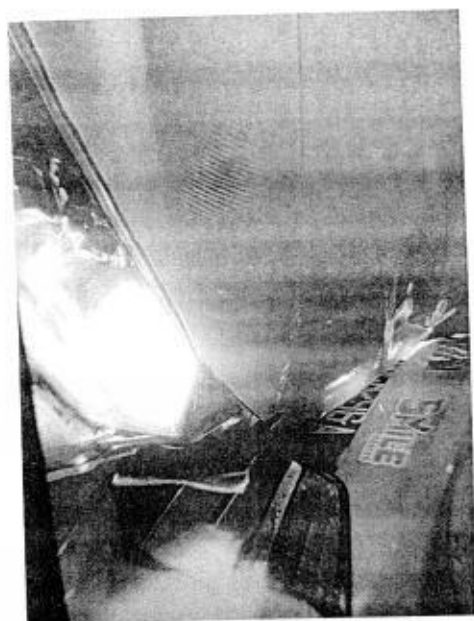
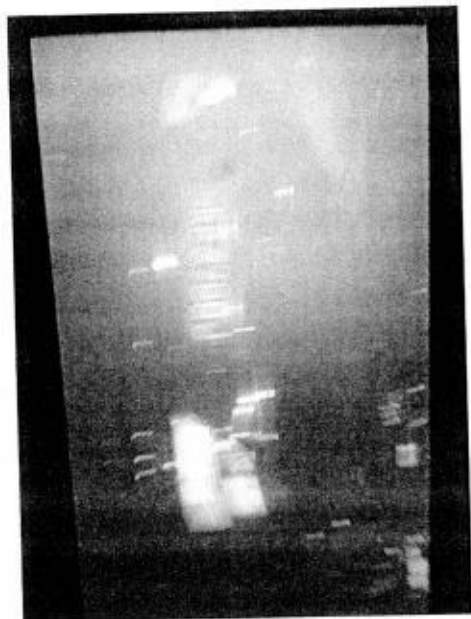
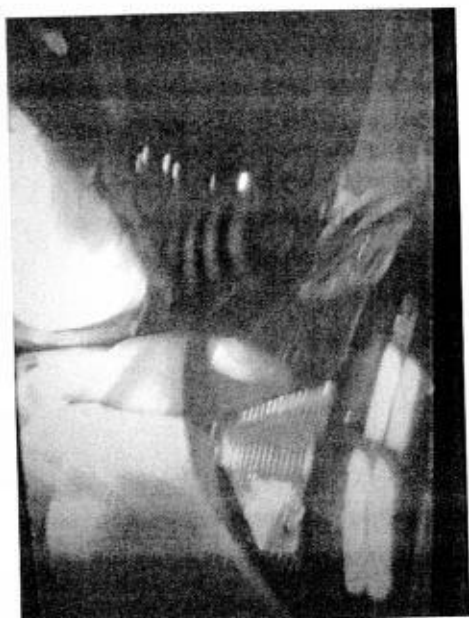
Rear N/S

The U/C / Chassis frame / Body Structure affected due to collision.

Qty	Description of Parts	Condition	Estimate By Workshop (\$)	Our Adjusted (\$)
<u>REPLACEMENT OF PARTS</u>				
1	BOOT LID	DENTED	2,174.90	2,174.90
1	BOOT LID LOCK UPPER	SERVICEABLE	102.60	-
1	BOOT LID LOCK LOWER	SERVICEABLE	31.70	-
1	BOOT LID "H" EMBLEM	NECESSARY	28.70	28.70
1	BOOT LID CRDI PLATE	NECESSARY	27.90	27.90
1	BOOTLID MOULDING	SERVICEABLE	227.90	-
1	BOOTLID I40 EMBLEM	NECESSARY	27.90	27.90
1	BOOTLID LOWER GARNISH	TO REPAIR SEE LABOUR	227.90	-
1	REAR BUMPER	DEFORMED	553.00	553.00
1	REAR BUMPER REINFORCEMENT	CRACKED	428.40	428.40
2	REAR BUMPER REINFORCEMENT BRACKET (LH/RH) @\$80.30	N/S BENT / O/S TO REPAIR SEE LABOUR	160.60	80.30
10	REAR BUMPER CLIP	NECESSARY	22.00	22.00
2	REAR BUMPER BRACKET @\$35.60	SERVICEABLE	71.20	-
1	REAR BUMPER SPONGE	TORN	103.50	103.50
1	REAR BUMPER UNDER COVER	CUT	228.00	228.00
1	REAR BUMPER REFLECTOR LAMP (LH)	CRACKED	30.60	30.60
	LESS 20% DISCOUNT		-889.36	-741.04
			3,557.44	2,964.16

Qty	Description of Parts	Condition	Estimate By Workshop (\$)	Our Adjusted (\$)
	LABOUR			
	PANEL BEATING, INCLUSIVE OF THE REPAIR OF BOOTLID LOWER GARNISH AND O/S REAR BUMPER REINFORCEMENT BRACKET.		800.00	400.00
	SPRAY PAINTING CHARGE.		900.00	600.00
	WIRING CHARGE.	NOT NECESSARY	30.00	-
	TUFF KOTE.		50.00	30.00
	REMOVE/REFIX REVERSE SENSOR.		80.00	40.00
			1,860.00	1,070.00
	GRAND TOTAL		5,983.14	4,599.86
	RECOMMENDED COST OF LUMP SUM REPAIRS (TO ITS PRE-ACCIDENT CONDITION) (CONFIRMED)			3,700.00
