NTUC INCOME INSURANCE CO-OPERATIVE LTD Ref: NS/INC18019256/K1sbn2

1. Policy Particulars :- THIRD PARTY CLAIM

Insured Veh.	SLP 3505P	Veh. Inspected	SHB 6395R
Policy No.	5083404689-02	Coverage (\$)	0.00
Claim No.	MT/1016705-002	Excess (\$)	0.00
Assign From		Assign Date	23/10/2018

ADJUSTMENT ON REPAIR COST FOR VEHICLE NO. SHB 6395R

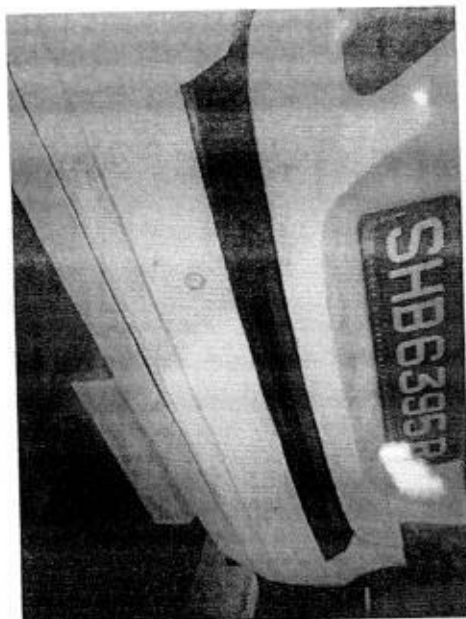
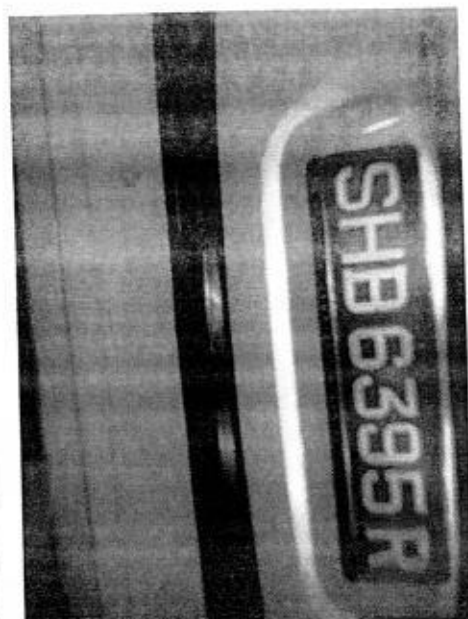
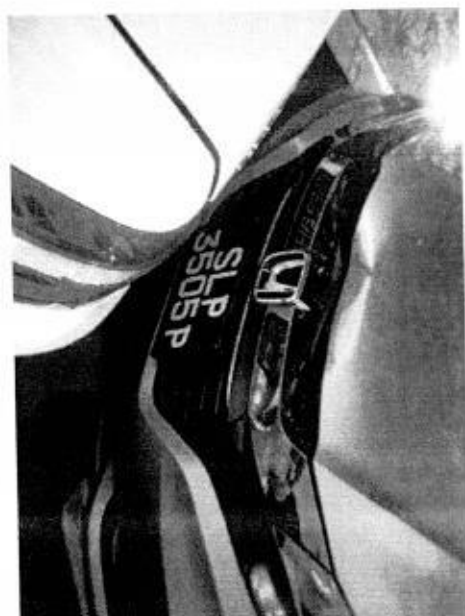
Rear

The U/C / Chassis frame / Body Structure affected due to collision.

THE VEHICLE SUSTAINED DAMAGES AT THE REAR PORTION. DAMAGES SEE DETAILS.
--

463.00	463.00
LABOUR				
	PANEL BEATING.INCLUSIVE OF THE REPAIR OF REAR BUMPER LOWER COVER.		800.00	400.00
	SPRAY PAINTING CHARGE.		600.00	400.00
	WIRING CHARGE.	NOT NECESSARY	30.00	-
	TUFF KOTE.	NOT NECESSARY	50.00	-
	REMOVE/REFIX REVERSE SENSOR.		120.00	30.00
			1,600.00	830.00
GRAND TOTAL			5,309.88	3,543.88
RECOMMENDED COST OF LUMP SUM REPAIRS (TO ITS PRE-ACCIDENT CONDITION) (CONFIRMED)				2,800.00
