NTUC INCOME INSURANCE CO-OPERATIVE LTD Ref: NS/INC18019259/K1vbn2	
73 BRAS BASAH ROAD #05-01 NTUC TRADE UNION HOUSESINGAPORE 189556	Date: 26-10-2018
Code: INC4

### 1. Policy Particulars :- THIRD PARTY CLAIM

THE VEHICLE SUSTAINED DAMAGES AT THE O/S BODY. DAMAGES SEE DETAILS.
--

## ADJUSTMENT ON REPAIR COST FOR VEHICLE NO. SHD 3338R

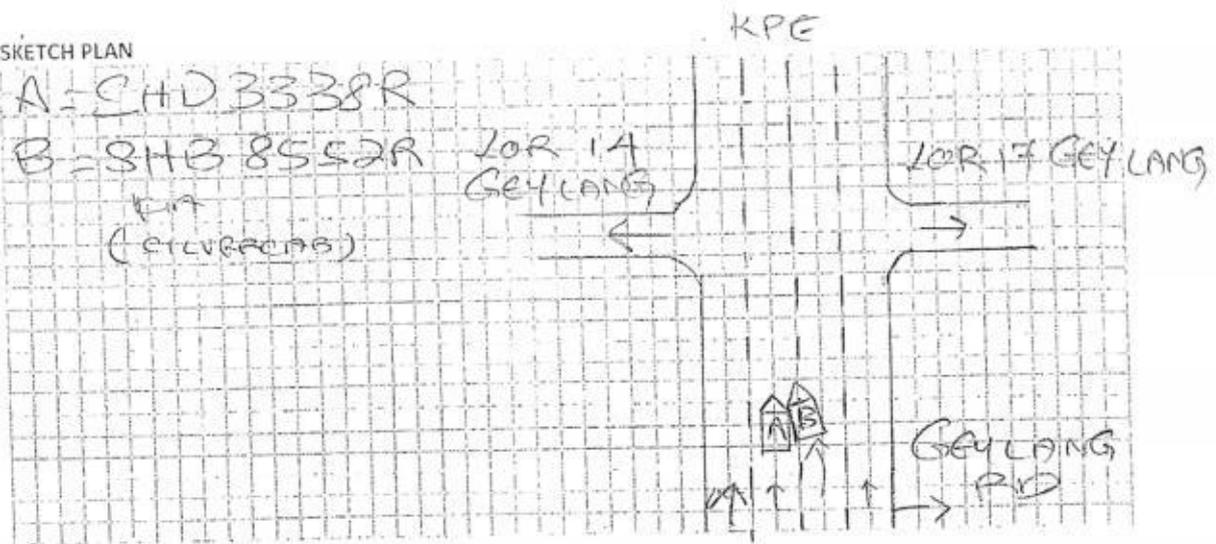
SKETCH PLAN

On 23/10/2018 at about 01:40hrs, I was driving along Geylang Rd towards KPE.

Suddenly the SHB8552R silvercab encroached into my lane and grazed onto my right front door and my wing mirror.
