### 1. Policy Particulars :- THIRD PARTY CLAIM

### 4. Description of Damages

THE VEHICLE SUSTAINED DAMAGES AT THE N/S BODY.  
DAMAGES SEE DETAILS.

## ADJUSTMENT ON REPAIR COST FOR VEHICLE NO. SHD 3042T

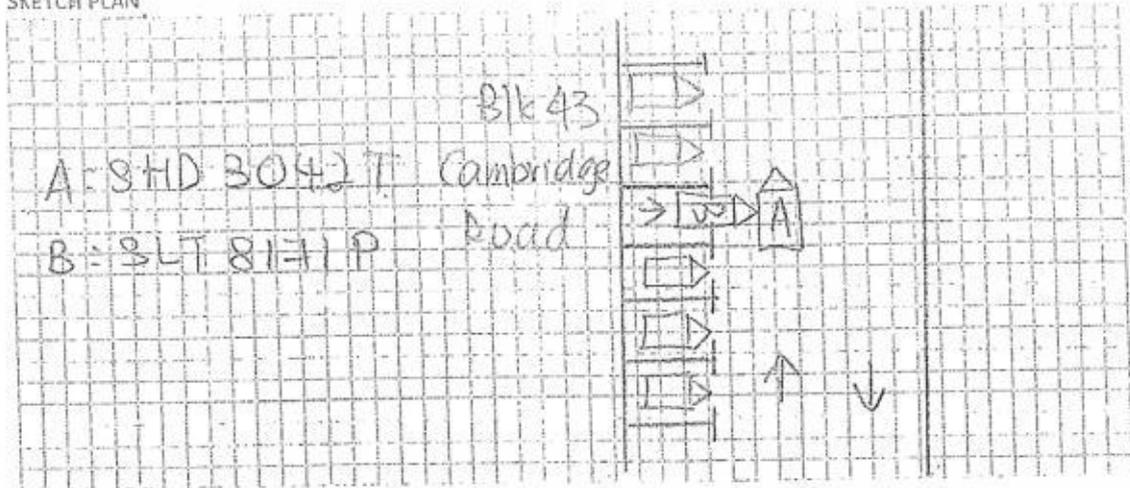
SKETCH PLAN

On 23/10/18 at about 07:15 hrs, I was driving at above said location with a male pax.

Out of sudden, a vehicle bearing SLT 8171P drive out from a car park lot without stopping.

Due to this cause, Veh B it front portion collided onto the left front portion of my taxi.

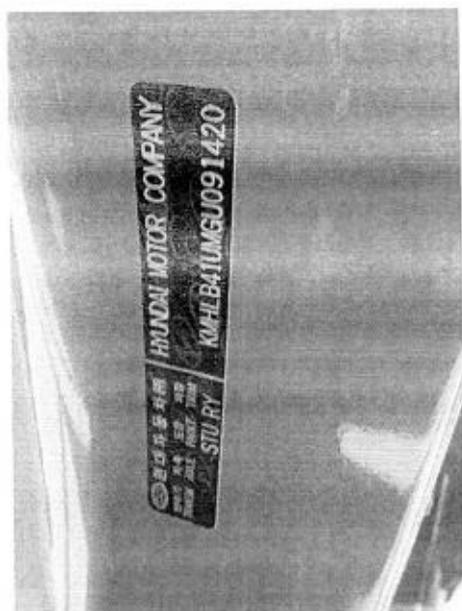
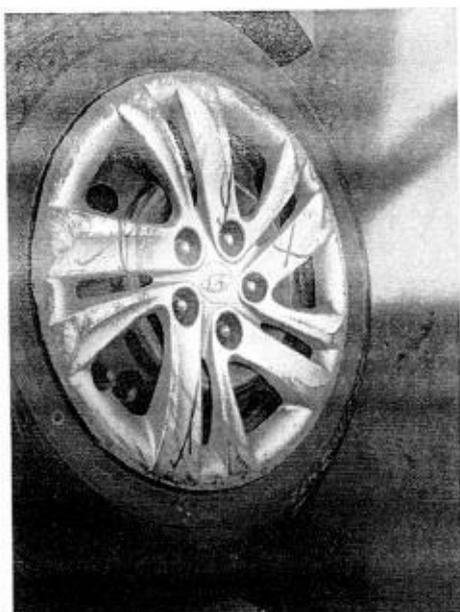
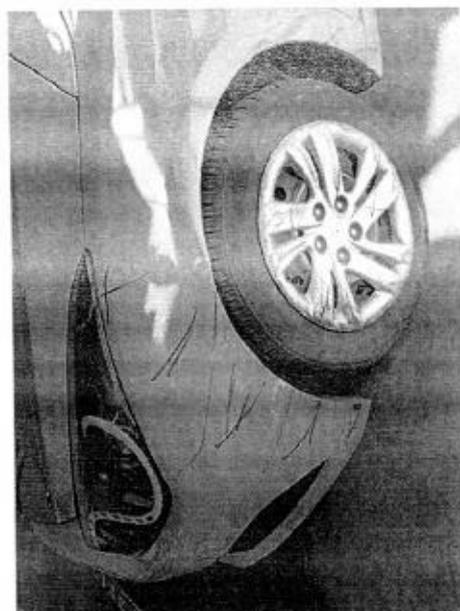
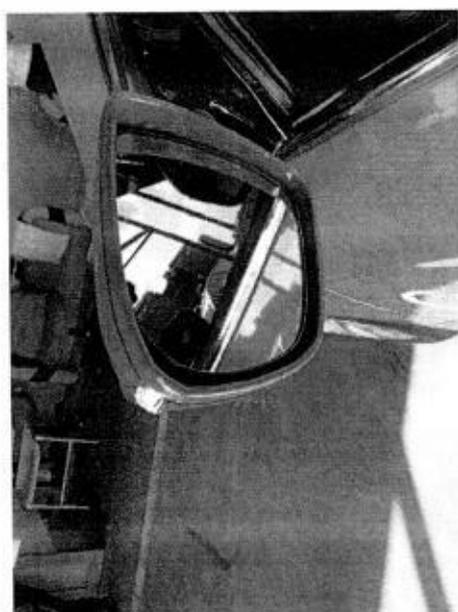
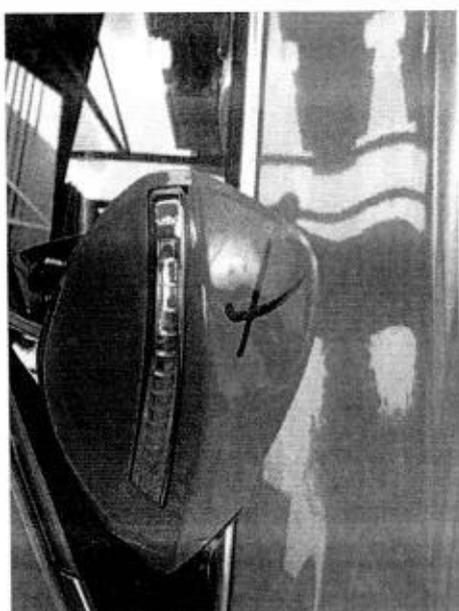
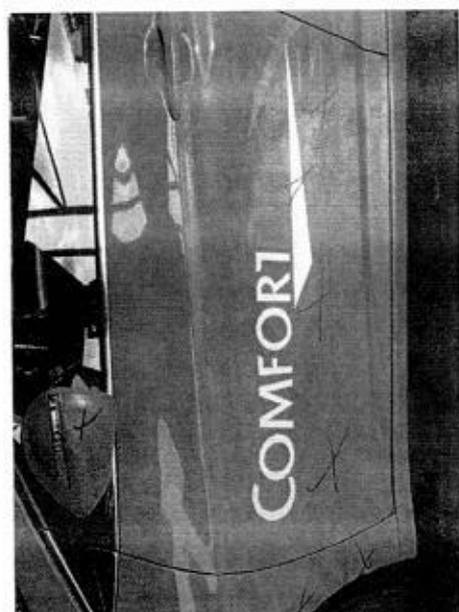
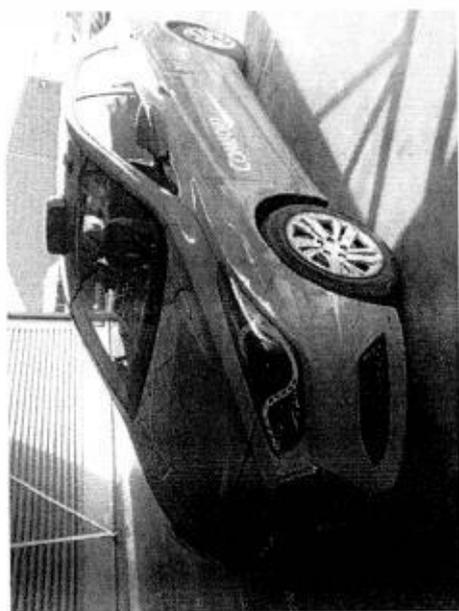
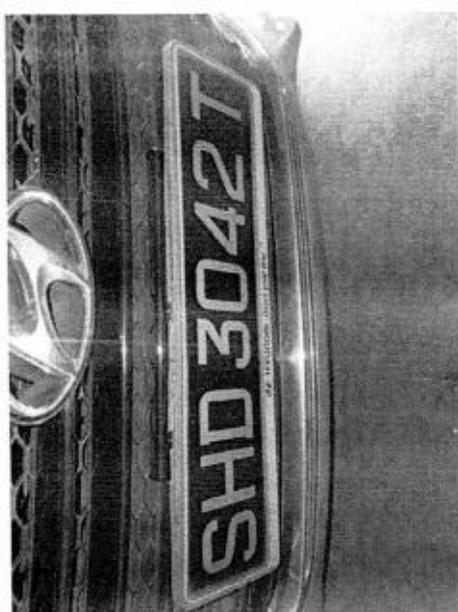
Qty	Description of Parts	Condition	Estimate By Workshop (\$)	Our Adjusted (\$)
<b><u>REPLACEMENT OF PARTS</u></b>				
1	FRONT FENDER (LH)	DENTED	566.30	566.30
1	FRONT FENDER SHIELD (LH)	SERVICEABLE	175.90	-
1	FRONT FENDER RETAINER	SERVICEABLE	24.60	-
1	FRT WHEEL HUB CAP,LH	GRAZED	107.10	107.10
1	FRONT BUMPER (NPA)	TO REPAIR SEE LABOUR	-	-
1	FRONT DOOR (LH)(NPA)	TO REPAIR SEE LABOUR	-	-
1	REAR DOOR (LH)(NPA)	TO REPAIR SEE LABOUR	-	-
	LESS 20% DISCOUNT		-174.78	-134.68

155.00	155.00
<b><u>LABOUR</u></b>				
	PANEL BEATING.INCLUSIVE OF THE REPAIR OF FRONT BUMPER,FRONT DOOR (LH) AND REAR DOOR (LH).		400.00	300.00
	SPRAY PAINTING CHARGE.		1,200.00	800.00
	TUFF KOTE.		50.00	20.00
	FRT WHEEL ALIGNMENT.	NOT NECESSARY	80.00	-

-		-	-
	-		-	-
	-		-	-
			1,730.00	1,120.00
<b>GRAND TOTAL</b>			<b>2,584.12</b>	<b>1,813.72</b>
<b>RECOMMENDED COST OF LUMP SUM REPAIRS (TO ITS PRE-ACCIDENT CONDITION) (CONFIRMED)</b>				<b>1,450.00</b>
