Notification of Accident

SINGAPORE ACCIDENT STATEMENT

4. Description of Damages				
THE VEHICLE SUSTAINED DAMAGES AT THE FRONT N/S PORTION.				
DAMAGES SEE DETAILS.				
5. General Information				
Accident Date	06/10/2013	Inspection Date	07/10/2013	
Survey held at	TRANS-CAB AUTO SERVICES PTE LTD NO.2 ANG MO KIO ST 63 SINGAPORE 569111			
5a. Remarks				
A)THE INSPECTION WAS CONDUCTED ON A"WITHOUT PREJUDICE" BASIS. B)IN ACCORDANCE TO YOUR INSTRUCTIONS, WE HAVE NOT AUTHORISED REPAIRS.				
5b. Estimate Days of Repair				
ESTIMATED NORMAL PERIOD FOR REPAIR:		1.500 Working Days

ADJUSTMENT ON REPAIR COST FOR VEHICLE NO. SHD 9563S

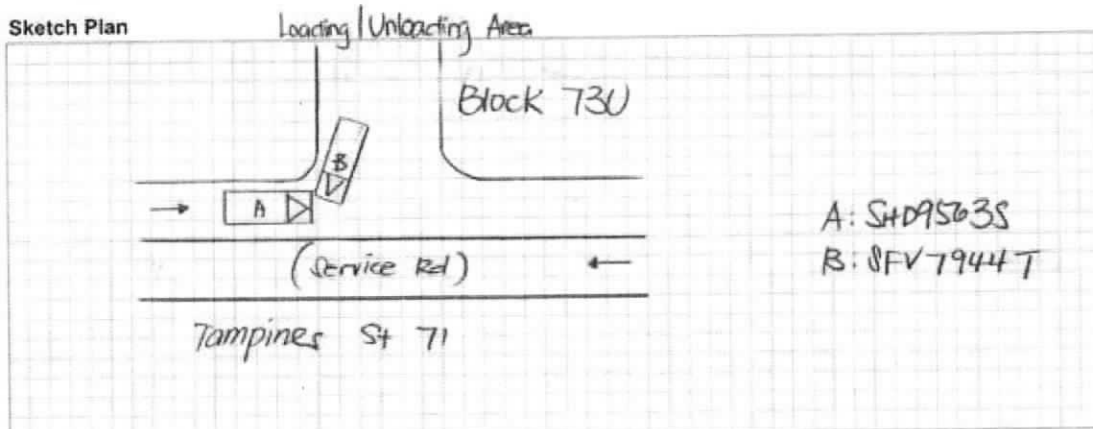
Sketch Plan

ON 06.10.2013 AT ABOUT 1755HRS, I DROVE INTO THE SERVICE ROAD OF BLOCK 730 TAMPINES STREET 71 TO ALIGHT MY PASSENGERS. WHILE TRAVELING STRAIGHT VEHICLE B - SFV7944T SUDDENLY DASHED OUT FROM THE LOADING AND UNLOADING BAY TO TURN RIGHT. RESULTED, HIS VEHICLE TO HIT ONTO THE FRONT LEFT PORTION OF MY TAXI. AFTER THE IMPACT THE DRIVER OF VEHICLE B APOLOGISED TO ME AND MENTIONED THAT HE DID NOT SEE MY TAXI. VEHICLE A - 2 PASSENGERS VEHICLE B - 1 PASSENGER

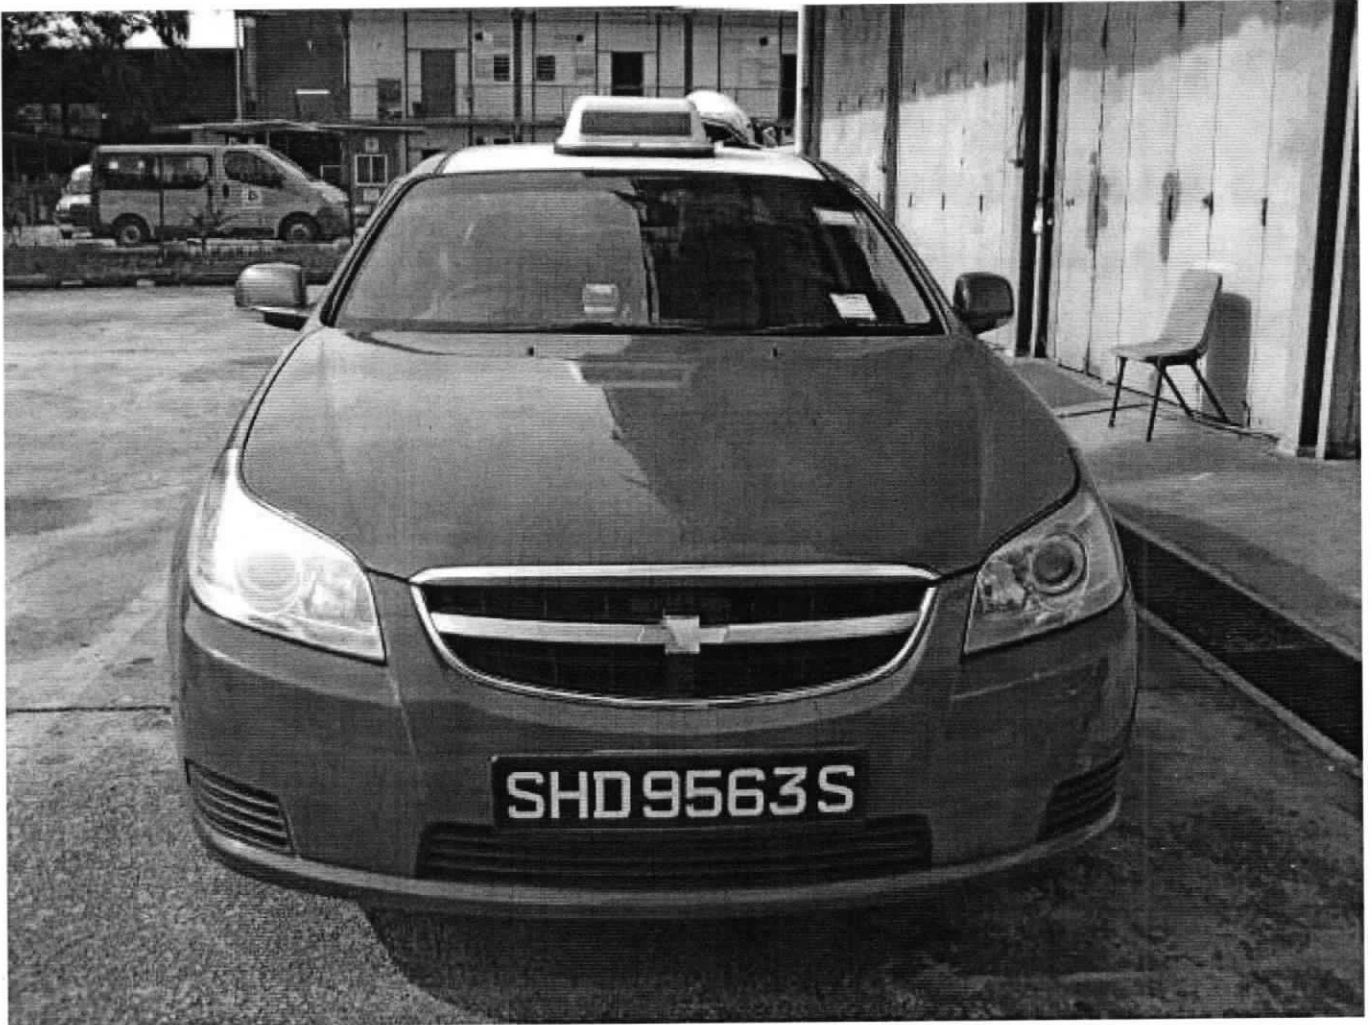
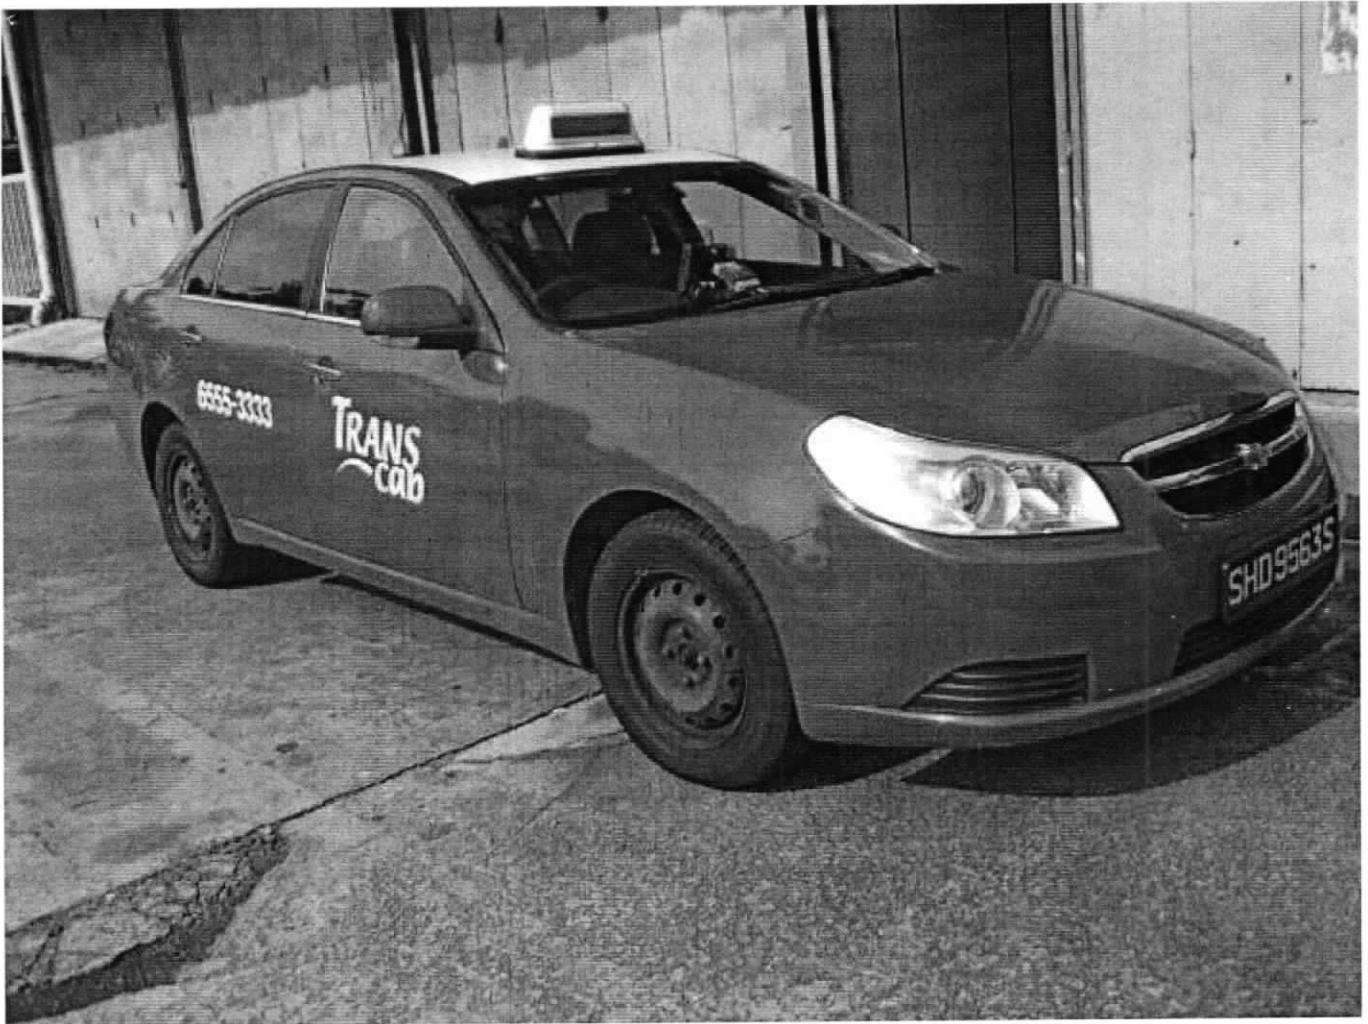
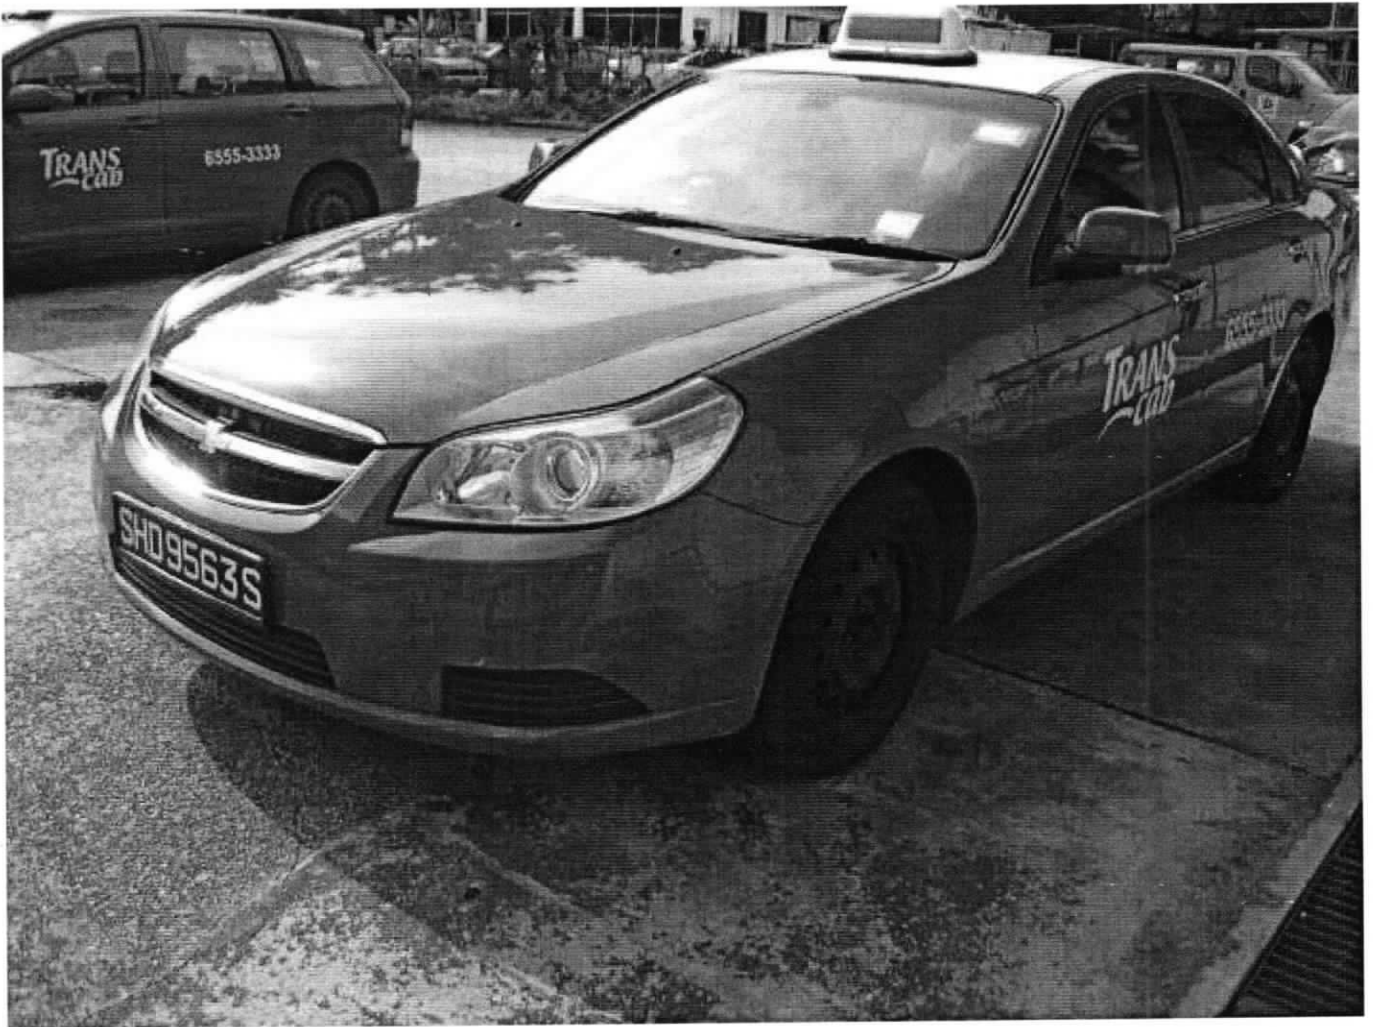
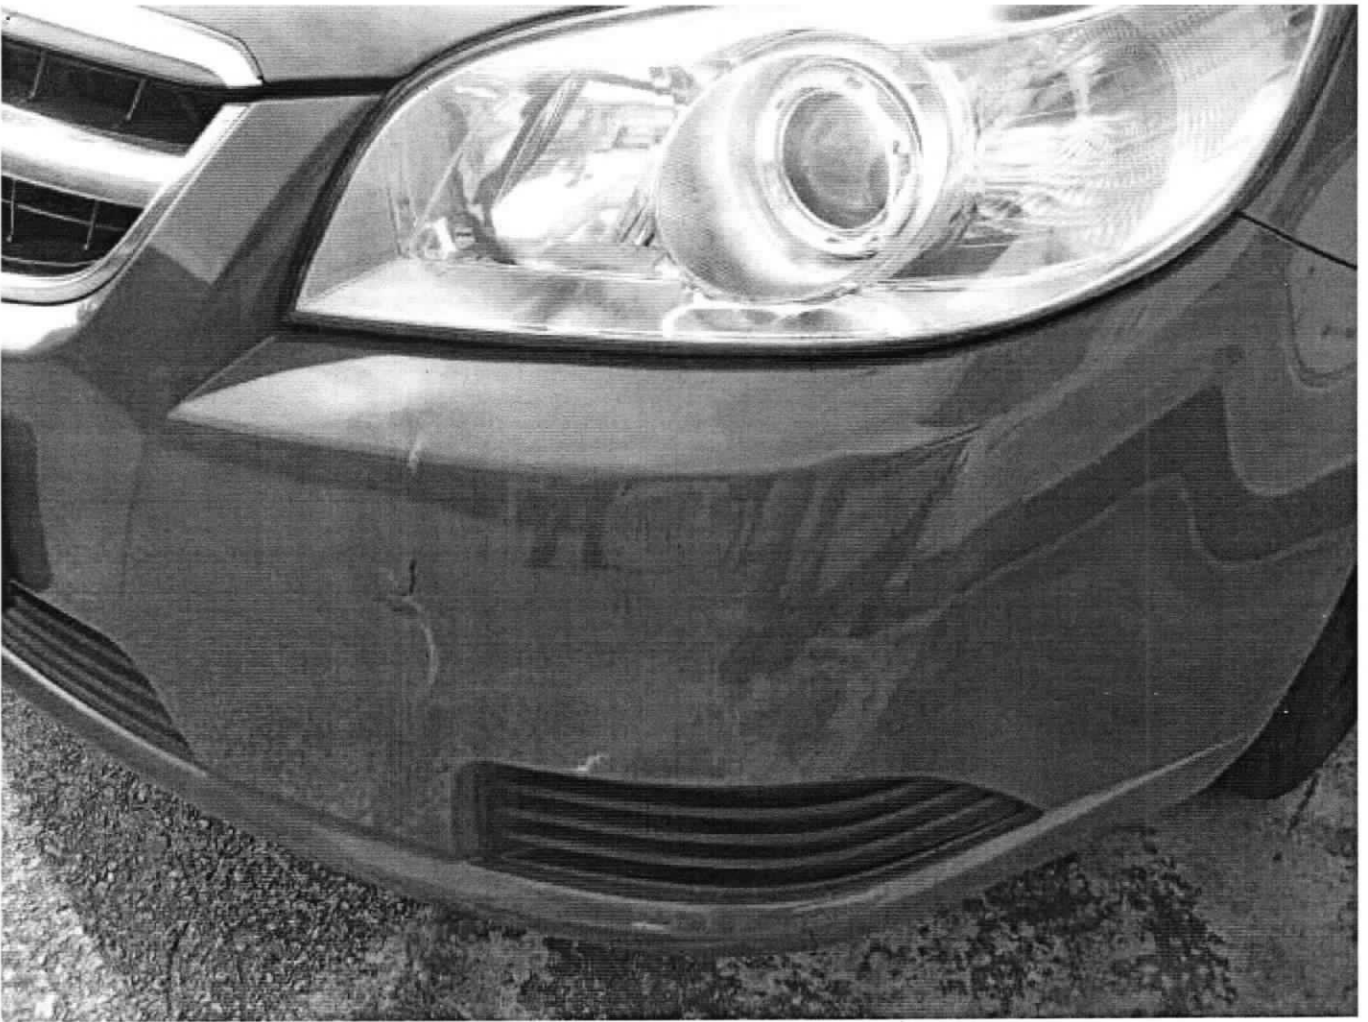
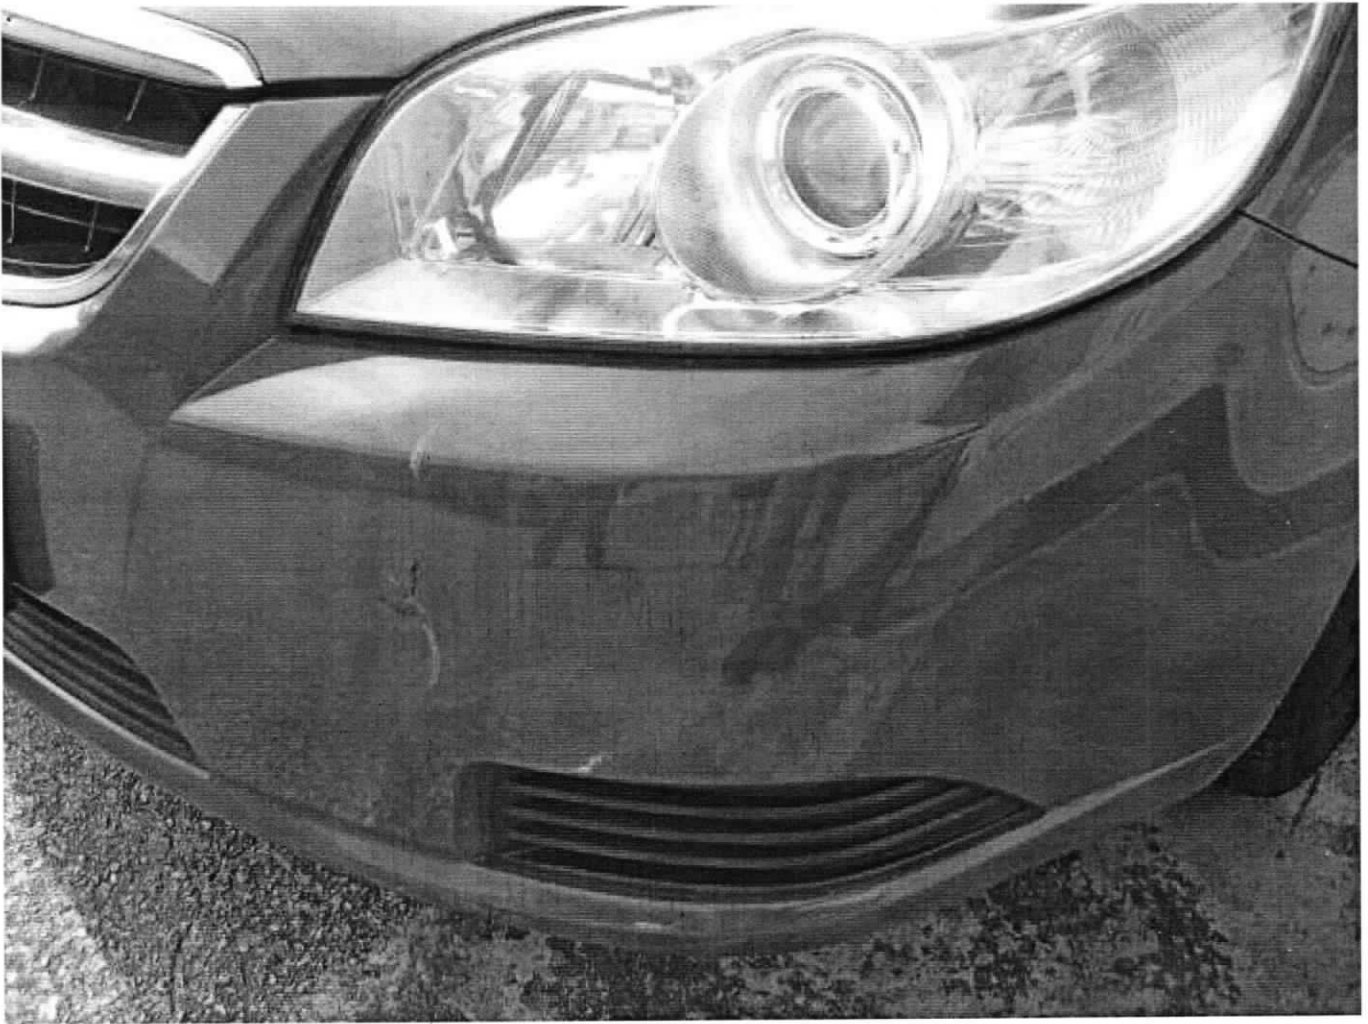
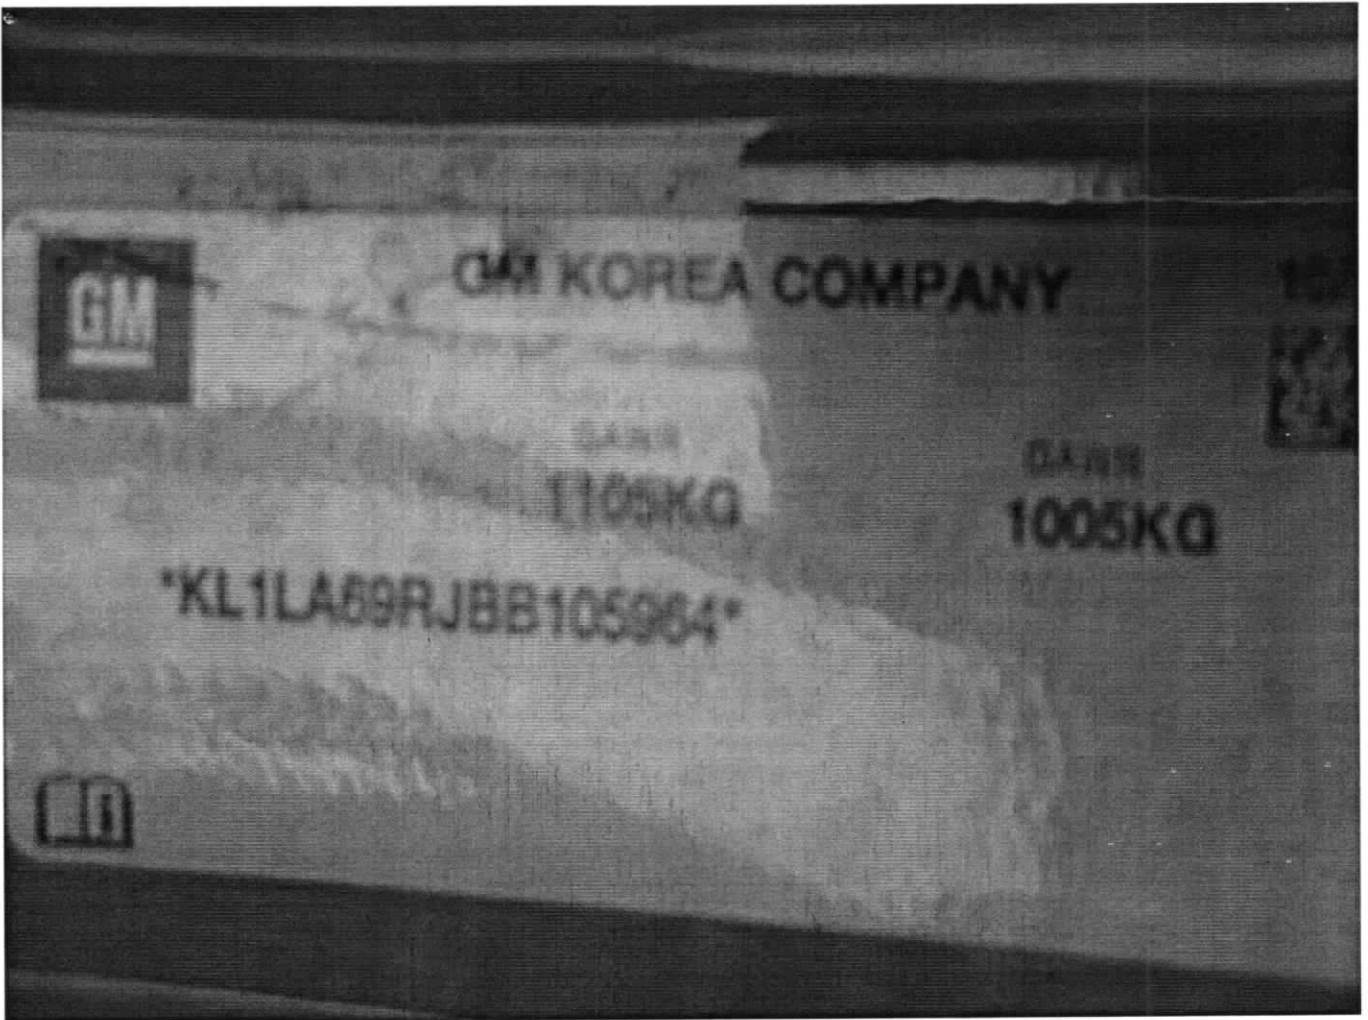
Accident Photo

Frt N/S

Qty	Description of Parts	Condition	Estimate By Workshop (\$)	Our Adjusted (\$)
	<u>REPLACEMENT OF PARTS</u>			
1	FRONT BUMPER	CRACKED	1,202.00	1,202.00
1	FRONT BUMPER REINFORCEMENT	TO REPAIR SEE LABOUR	295.25	-
1	FRONT BUMPER LOWER ABSORBER	SERVICEABLE	180.00	-
1	RADIATOR GRILLE (GRILLE A-RAD)	SERVICEABLE	367.00	-
1	FRONT BUMPER RETAINER RH	SERVICEABLE	102.00	-
1	FRONT BUMPER RETAINER LH	SERVICEABLE	102.00	-
1	HEADLAMP LH (LAMP A-HEAD LH)	SERVICEABLE	816.00	-
1	HEADLAMP RH (LAMP A-HEAD RH)	SERVICEABLE	816.00	-
1	CENTRE "CHEVROLET LOGO	SERVICEABLE	144.30	-
	LESS 10% DISCOUNT		-402.46	-120.20
			3,622.09	1,081.80
	<u>SPECIAL NETT ITEMS</u>			
1	SET FRONT BUMPER FASTENER CLIP (SN)	NECESSARY	24.00	24.00
1	FRONT LICENCE PLATE WITH HOLDER (SN)	SERVICEABLE	80.00	-
1	SET RADIATOR GRILLE CLIP (SN)	NOT NECESSARY	35.00	-

139.00	24.00
	<u>LABOUR</u>			
	TO CHECK ELECTRICAL LIGHTING CONCERNED.		120.00	10.00
	PANEL BEATING, KNOCKING AND STRAIGHTENING THE NECESSARY PORTION, REMOVE AND RENEWAL OF PARTS, ADJUST AND REALIGN THE SAME. INCLUSIVE OF THE REPAIR OF FRONT BUMPER REINFORCEMENT.		840.00	200.00
	PUTTY AND SPRAY PAINTING OF THE AFFECTED PORTION.		810.00	200.00
	TO RUST-PROOFING OF THE AFFECTED AREAS.	NOT NECESSARY	170.00	-
			1,940.00	410.00
	GRAND TOTAL		5,701.09	1,515.80

RECOMMENDED COST OF LUMP SUM REPAIRS (TO ITS PRE-ACCIDENT CONDITION)			1,200.00
---	--	--	-----------------
