NS/INC18019381 / K11b2

TP Claims against NTUC Income: Follow-Through Survey

4. Description of Damages				
THE VEHICLE SUSTAINED DAMAGES AT THE FRONT PORTION. DAMAGES SEE DETAILS.				
5. General Information				
Accident Date	22/10/2018	Inspection Date	24/10/2018	
Survey held at	COMFORTDELGRO ENGINEERING PTE LTD 59 LOYANG DRIVE SINGAPORE 508969			
5a. Remarks

ADJUSTMENT ON REPAIR COST FOR VEHICLE NO. SH 8310K

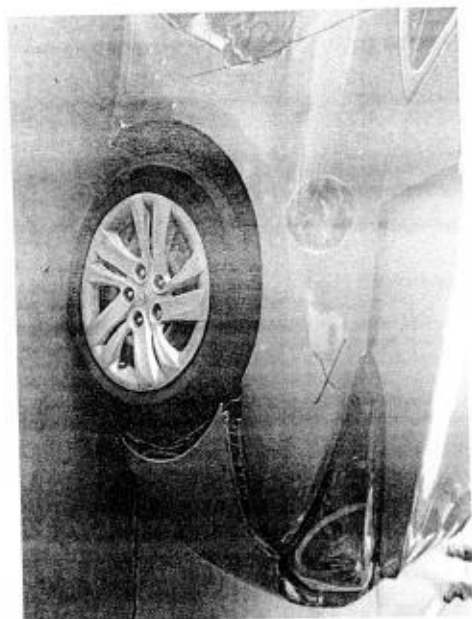
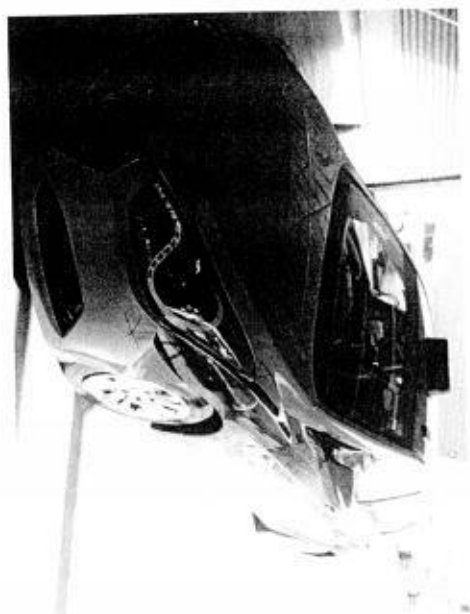
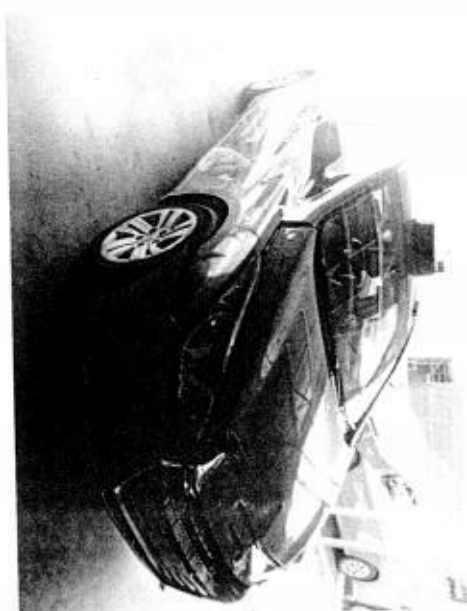
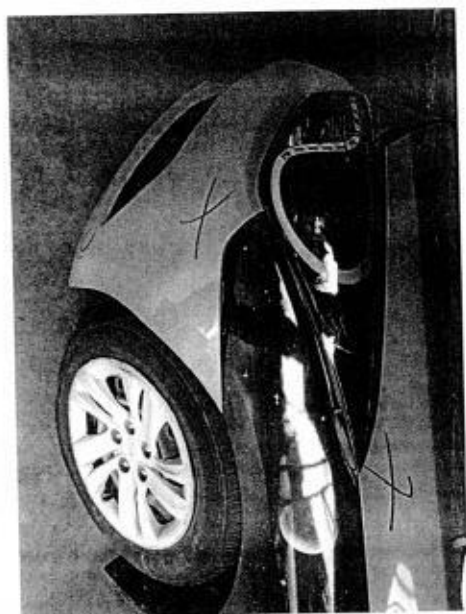
Veh No: SH8310K Yr Regn: Jan, 2017
 Type: M/Car / M/Cycle / Bus / Van / Lorry / Taxi / Prime Mover /
 Truck / Trailer or _____
 Make: Hyundai C.C. 1600
 Colour: Blue A/C: Insured / Std / NI / NA
 Sp. Reading: 3 62788 T/Radio: Insured / Std / NI / NA
 Eng/No: _____
 C/No: KMHLCB41UMH4098/86
 Gen. Cond: Good / Fair / Poor / Burnt
 Steering: Inorder / Jammed / Leaked / Burnt or _____
 Brake: Inorder / Jammed / Leaked / Burnt or _____
 Modi: Nil / S/Rim / STD / Rim or _____
 Tyre Size: F: 205/60R16
 R: _____
 BS / DUN / EXNOVA / GY / FS / LIZA / MIC / OHTSU / PIR / SUMI /
 TOYO / YOKO or Hankook
 Front Rear
 R/Bal. 7 mm R/Bal. 7 mm
 L/Bal. 7 mm L/Bal. 7 mm
 D.O.A. 22/10/18 D.O.I. 24/10/18
 Survey held at CDGE (Loyang)
 Des. of Damages: Frt / Rear / O/S / N/S / U/C / Rooftop or
Front.
 The U/C / Chassis frame / Body Structure affected due to collision.

Qty	Description of Parts	Condition	Estimate By Workshop (\$)	Our Adjusted (\$)
REPLACEMENT OF PARTS				
1	BONNET	BUCKLED	2,265.90	2,265.90
2	BONNET HINGE (LH/RH) @\$41.00	BENT	82.00	82.00
1	RADIATOR GRILLE	CRACKED	1,110.10	1,110.10
1	RADIATOR GRILLE H EMBLEM	CRACKED	39.50	39.50
1	FRONT BUMPER COVER	DEFORMED	1,052.20	1,052.20
1	FRONT BUMPER SPONGE	TORN	99.20	99.20
1	FRONT BUMPER REINFORCEMENT	BENT	402.10	402.10
1	FRONT BUMPER LIP	SERVICEABLE	54.90	-
2	FRONT BUMPER BRACKET TOP (LH/RH) @\$22.40	CRACKED	44.80	44.80
2	FRONT BUMPER BRACKET (LH/RH) @\$24.60	CRACKED	49.20	49.20
1	HEADLAMP SUPPORT TOP COVER	SERVICEABLE	222.60	-
1	HEADLAMP SUPPORT PANEL ASSY	CRACKED	907.40	907.40
2	HEADLAMP (LH/RH) @\$1388.00	CRACKED	2,776.00	2,776.00
1	RADIATOR	BENT	698.30	698.30
1	RADIATOR FAN BLADE,COWLING,MOTOR ASSY	CRACKED	792.95	792.95
2	RADIATOR BRACKET (LH/RH) @\$6.50	SERVICEABLE	13.00	-
2	RADIATOR GUARD @\$20.00	SERVICEABLE	40.00	-

2	HORN UNIT (LH/RH) @\$73.80	CRACKED	147.60	147.60
1	AIR DUCT	SERVICEABLE	134.60	-
1	AIRCON CONDENSER	BENT	927.50	927.50
1	INTER COOLER	BENT	1,032.50	1,032.50
1	INTER COOLER MOUNTING (2 PCS)	SERVICEABLE	25.90	-
1	BONNET LOWER LOCK	BENT	36.90	36.90
1	WIRING HARNESS-FEM	TORN	107.30	107.30
1	RADIATOR HOSE-LOWER	CRACKED	36.80	36.80
1	IDLER PULLEY	TORN	59.60	59.60
1	V BELT	TORN	61.70	61.70
1	GUARD RADIATOR	CRACKED	20.00	20.00
	LESS 20% DISCOUNT		-2,648.11	-2,549.91
			10,592.44	10,199.64
