REF: CS/CT#18019388/Dcd302 Special Instruction:

To Inspect Vehicle No:

SHD 4767D

VEHICLE DAMAGE INSPECTION REPORT

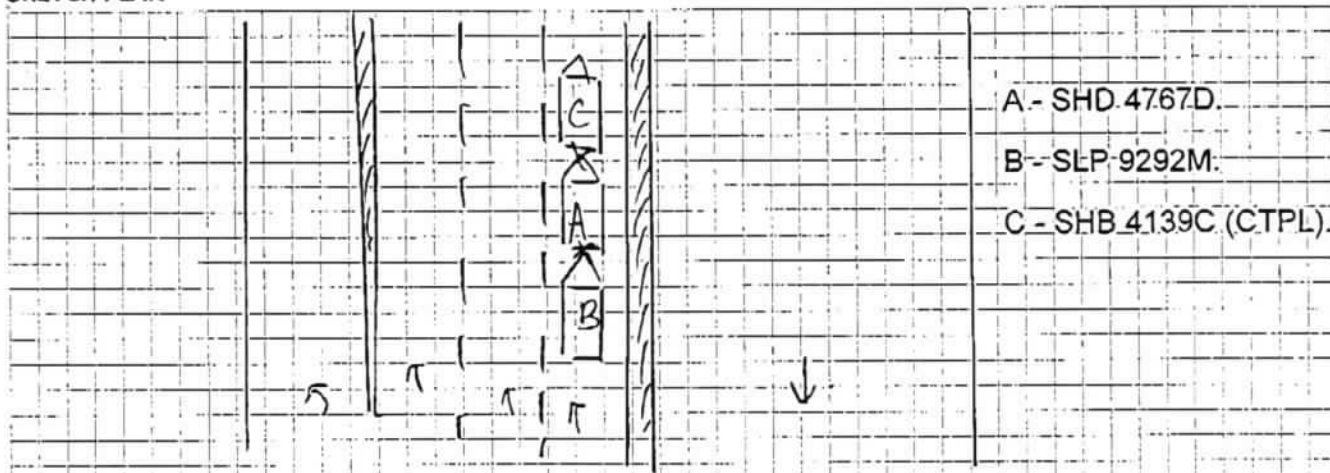
SKETCH PLAN

A - SHD 4767D.

B - SLP 9292M.

C - SHB 4139C (CTPL).

Along AYE Twds City Near Alexandra Rd Exit.

On 24.10.2018 at about 09:15 hrs, I was travelling along AYE towards City near Alexandra Rd exit with one female passenger on board.

I was travelling on the extreme right lane. I saw in front of my vehicles slowing down and stopped. Therefore, I applied E-brake. Before I came to a complete stop, I felt an impact from behind and came to know that veh (B) (SLP 9292M) hit my taxi (A) rear portion.
