NTUC INCOME INSURANCE CO-OPERATIVE LTD Ref: NS/INC18019441/K1rbe2

1. Policy Particulars :- THIRD PARTY CLAIM

Insured Veh.	SJC 7100P	Veh. Inspected	SHD 4424T
Policy No.	5066335541-03	Coverage (\$)	0.00
Claim No.	MT/1017192-002	Excess (\$)	0.00
Assign From		Assign Date	25/10/2018

ADJUSTMENT ON REPAIR COST FOR VEHICLE NO. SHD 4424T

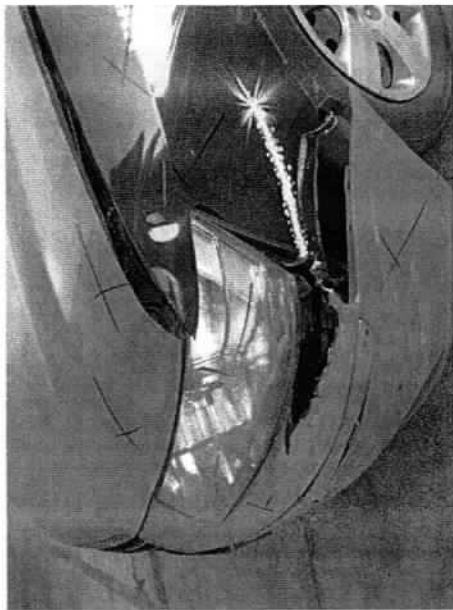
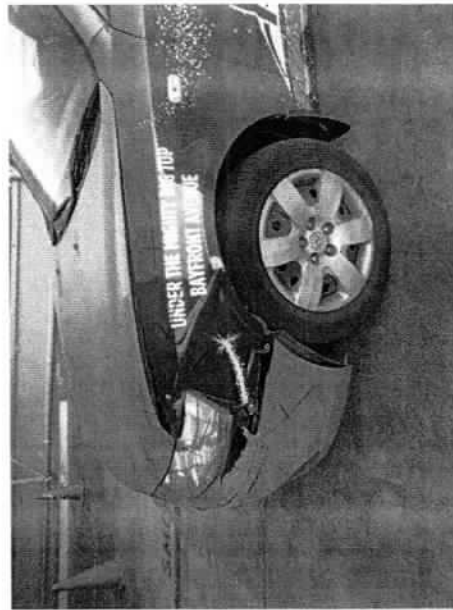
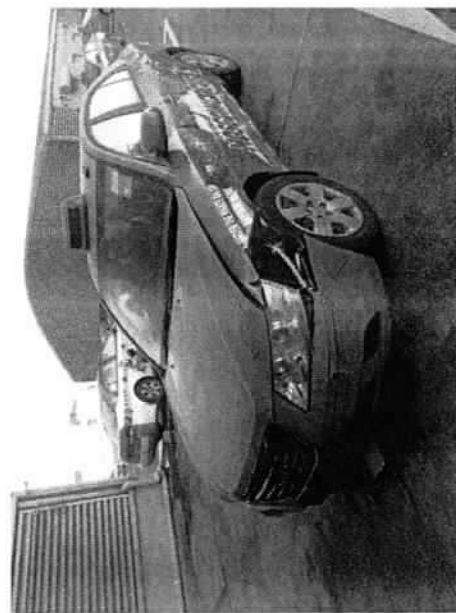
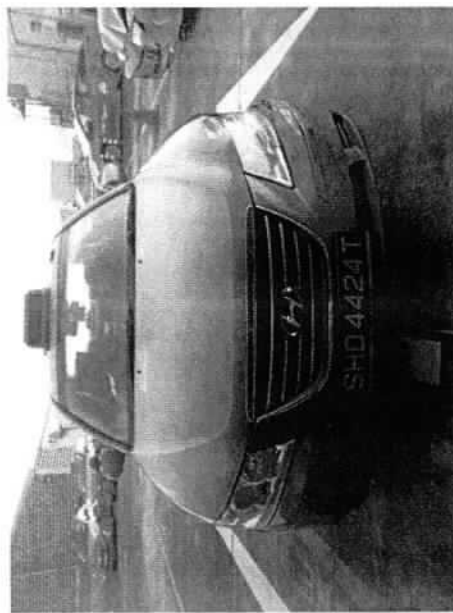
Remark: The veh had commenced its repair at the time of inspection.

N/S Front

The U/C / Chassis frame / Body Structure affected due to collision.

THE VEHICLE SUSTAINED DAMAGES AT THE N/S FRONT PORTION. DAMAGES SEE DETAILS.

-	-
			-	-
			1,550.00	1,050.00
	GRAND TOTAL		5,427.84	4,486.00
	RECOMMENDED COST OF LUMP SUM REPAIRS (TO ITS PRE-ACCIDENT CONDITION)			3,600.00
