SLE 3692P

**- PRE-REPAIR INSPECTION - ACCIDENT INVOLVING OUR INSURE...**

**NOTICE TO INSURER TO CONDUCT PRE-REPAIR INSPECTION WITHIN 2 WORKING DAYS PURSUANT TO PRE-ACTION PROTOCOL FOR NON INJURY MOTOR ACCIDENT CASES ROAD TRAFFIC ACCIDENT INVOLVING MOTOR VEHICLES SLE 3692P & SLB 4060Y ON 25.10.2018 @ 09:15HRS ALONG JUNCTION BEDOK NORTH ROAD & BEDOK RESERVOIR ROAD**

## VEHICLE DAMAGE INSPECTION REPORT

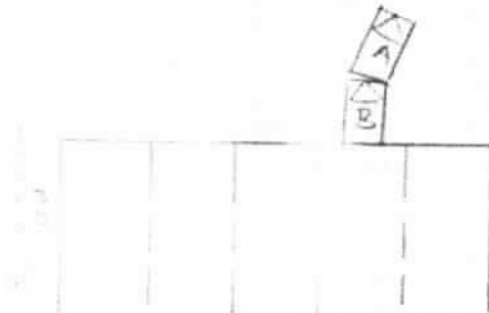
SKETCH PLAN

| Type Of Accident | COLLISION - HEAD TO REAR |

ON STATED DATE AND TIME, MY VEHICLE WAS STATIONARY STOPPED ALONG LANE 2 AS THERE WAS INCOMING VEHICLES TRAVELLING VERY FAST ALONG OPPOSITE DIRECTION OF BEDOK NORTH RD. SUDDENLY I FELT AN IMPACT OF MY VEHICLE. I ALIGHT FROM MY VEHICLE AND REALIZE THAT VEHICLE B HIT ONTO MY VEHICLE REAR PORTION.
